# Northwood Lake | Watershed Survey Results

**TO:** Brian Lobao, Northwood Lake Watershed Association (NLWA)  
**FROM:** Christine Bunyon, FB Environmental Associates (FBE)  
**SUBJECT:** **Northwood Lake Watershed Survey Results**  
**DATE:** July 23, 2026  
**CC:** Laura Diemer & Evan Ma, FB Environmental Associates

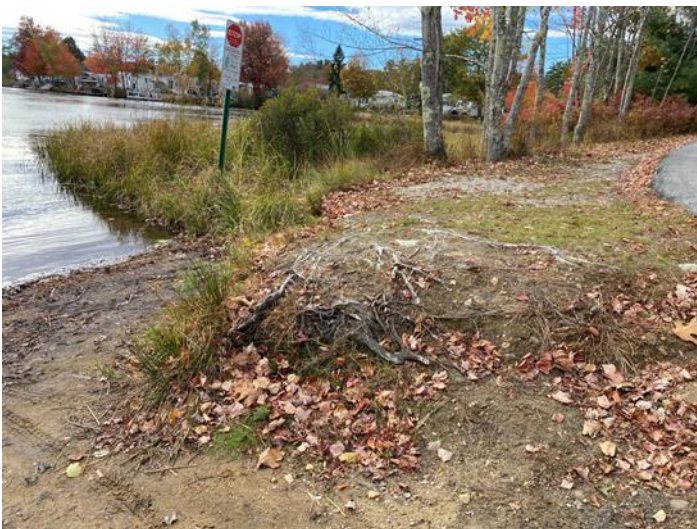
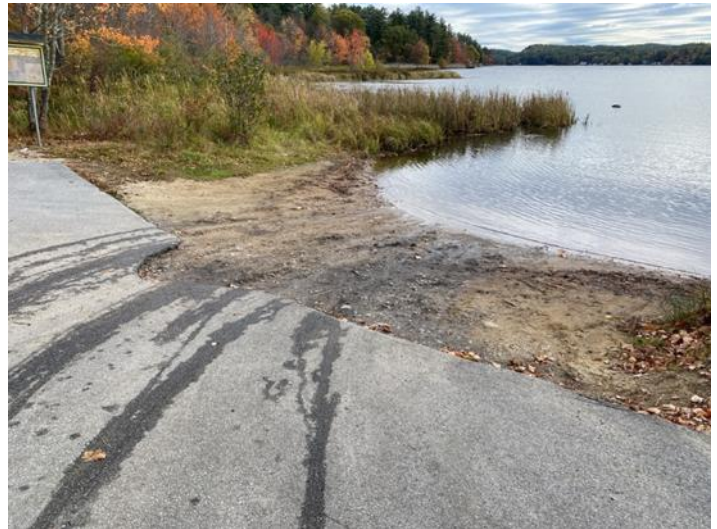
*(Left) Exposed roots and a steep drop off of the shoreline to the water's edge indicating erosion, (right) the end of the paved boat ramp where it meets the water.*

**Recommendations:** Continue to support the Lake Host program to monitor invasive aquatic plants that may enter or exit Northwood Lake. Redirect stormwater flow from the access road to the northern side of the access road via two broad based dips, one at the first bend in the road, and one halfway between the first and the end of the ramp area, into the northern shoulder and to the established wetland. Increase the vegetated buffer along the shoreline with native shrubs and trees where possible to stabilize the shoreline and encourage foot traffic to stay on the paved areas. Note that the lake water level was low during the time of the survey due to a drought.

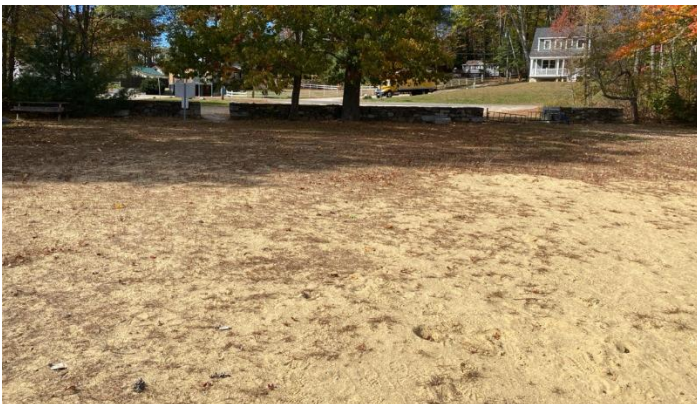
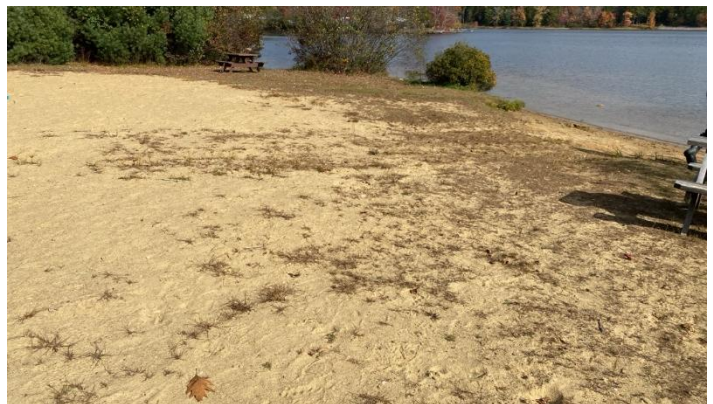
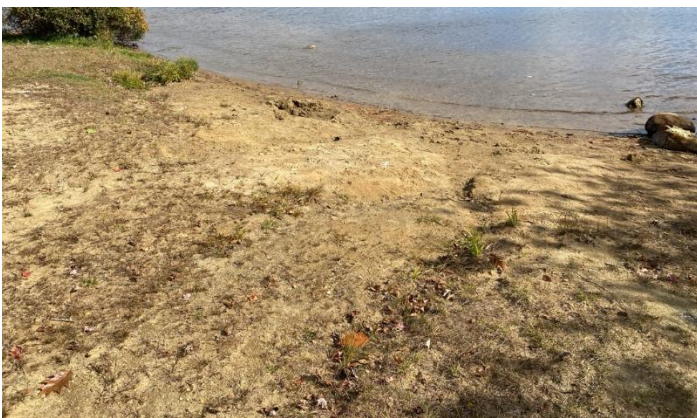
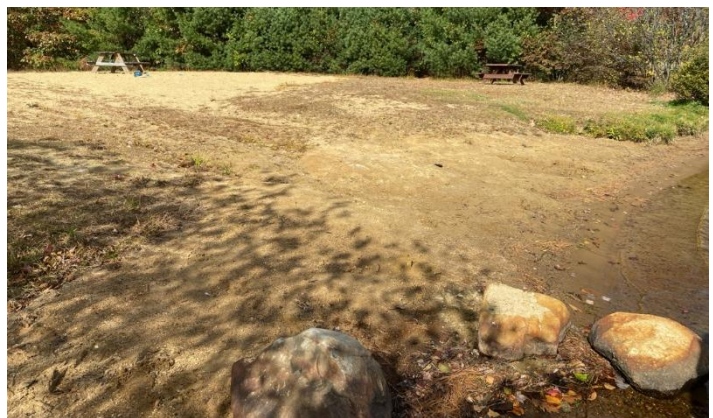
**Observations:** Northwood Town Beach is enjoyed by many during the summer months and is used as an access point for activities on the ice in the winter. Members of the community noted that although dogs are not allowed, many are brought to the beach and pet waste has been an ongoing problem in addition to general trash disposal. Additionally, geese regularly congregate within this cove and likely influence the bacteria concentrations within the cove. The beach hosts a portable toilet in the summer which helps protect the lake, though not for 2026. The beach area is a large relatively flat plot of land that is mostly comprised of sand with scattered weeds and grass. The area adjacent to the lake slopes downward to the water and erosion gullies were observed through the sand.

*(Top left) View of the beach area facing the entrance gates, (top right) view of the beach area as it slopes to the water's edge, (bottom left) erosion gullies were observed between the beach area and the water's edge, (bottom right) side view of the sloping area to the shoreline.*

**Recommendations:** Define pathways across high-traffic areas from the entrance gates using steppingstones spaced apart or interlocking permeable grid pavers. Observe the beach during heavy rainfall to note where flow paths are being created, then regrade the area as needed to divert stormwater flow into a rain garden or vegetated swale rather than continuing across the surface to the water. Reestablish vegetation (native grass, shrubs, groundcover) in all sandy areas that are not used for sand play. Install geese deterrents and revegetate the shoreline to the sides of the primary access point, as geese are less likely to congregate when their line of access between the water and shore is obstructed. To further address localized bacterial and phosphorus loading from the resident flock, specific management steps should include planting tall (24–30 inch) native shoreline buffers, installing low-profile temporary perimeter wire during summer molting periods, enforcing "Do Not Feed Waterfowl" signage, and letting turf grass grow taller near the water's edge to reduce attractive grazing habitat. This beach would also be an excellent location for a pollinator garden and educational signs about lake health.

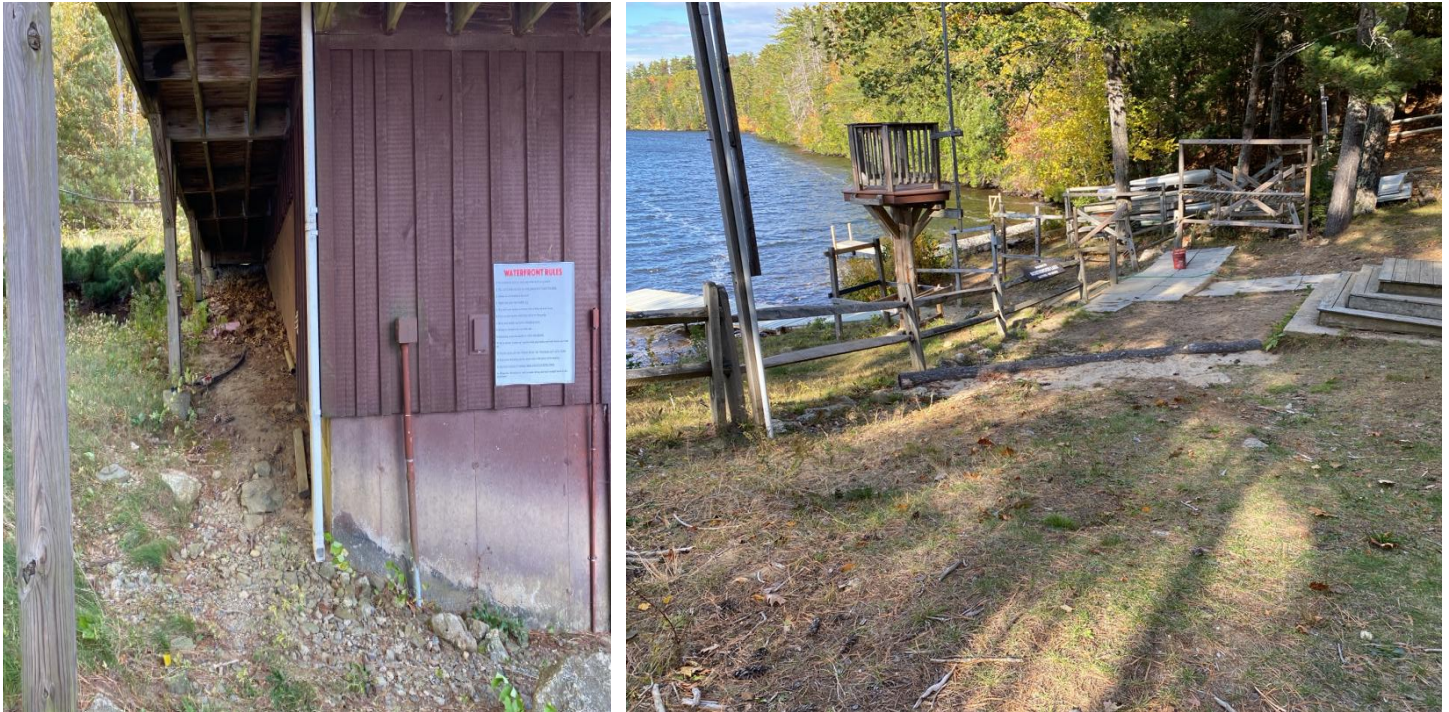
**Observations:** The Camp Boat House area is heavily used by campers throughout the summer. The camp staff have observed stormwater flows along the sides of the building and have installed a gutter along the roof line. Fencing keeps the water access to a defined area and fencing above the building keeps campers from walking down the northern slope to the water. Due to the slope of the land and foot traffic, stormwater and people travel to the lowest point, the break in the fence, and to the dock.

*(Left) the evidence of erosion from roof runoff prior to gutter installation along with the white gutter downspout. (Right) the water access area sloping to the lake with fencing to define access points.*

**Recommendations:** Direct gutter downspouts into a French drain for subsurface infiltration. Consider installing a broad-based dip across the primary access way (photo on the right) to direct any stormwater flow into the vegetated area on the lake side of the fence in a vegetated retention basin (or rain garden).

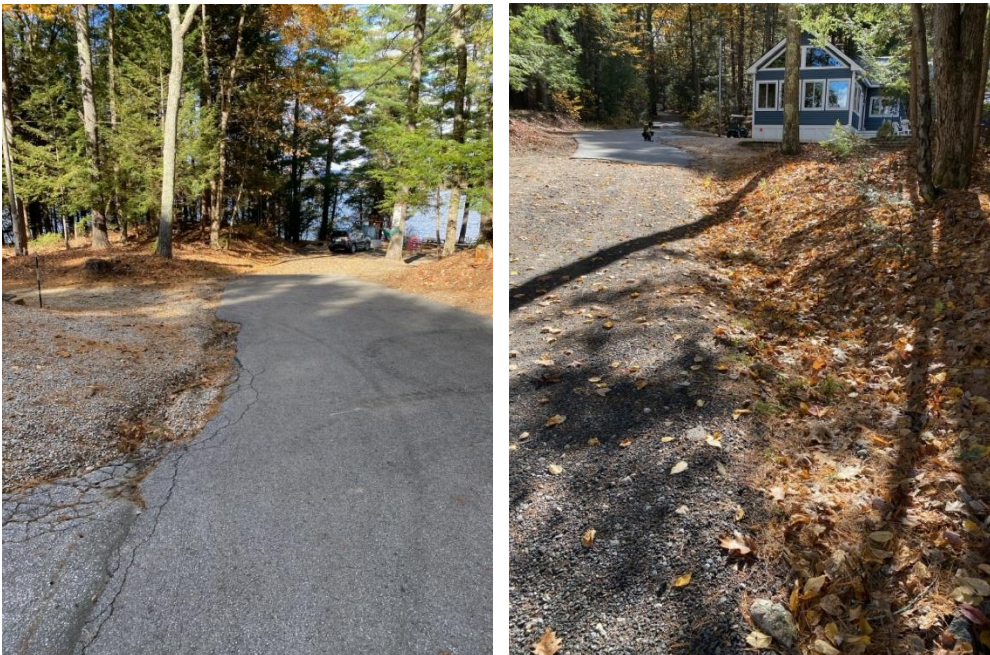
**Observations:** A small shoulder road gully was observed along the western edge of the community beach access road, parking area, and beach. This gully originates higher up the road, above the residential property.

*(Left) View of Pine Point Road shoulder facing the lake, (right) View of the road shoulder gully facing up hill, away from the lake.*

**Recommendations:** Add broad dip to across Pine Point Road about fifty feet down Pine Point road from the current paved swale that leads to the wooded area. Direct the new dip to the west and into the wooded area south of the residential home. Continue to look for signs of stormwater flowing down Pine Point Road towards the parking area by the beach and direct to infiltration areas as needed.

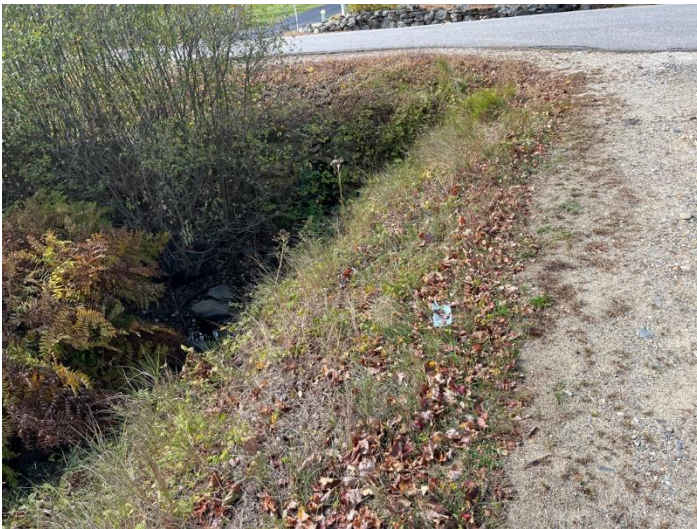
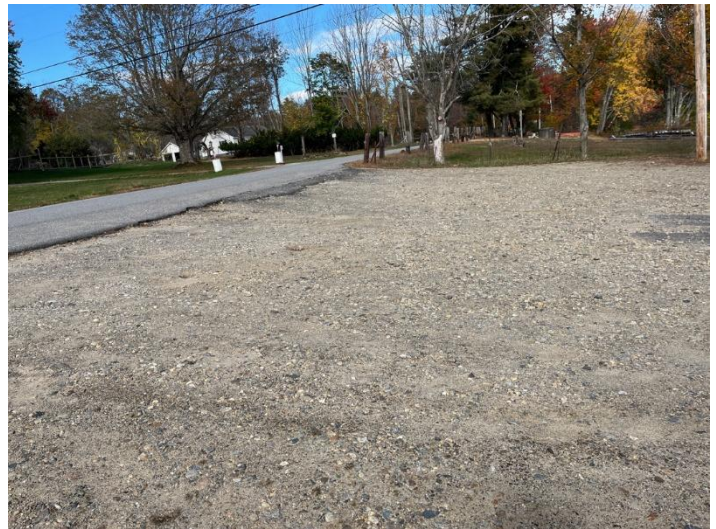
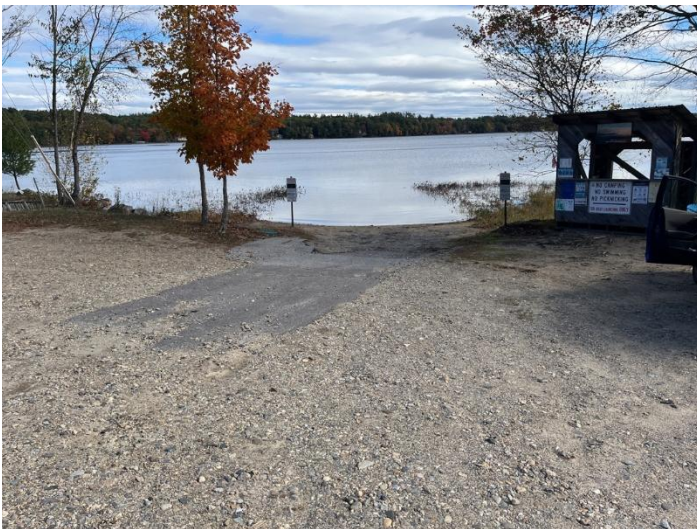
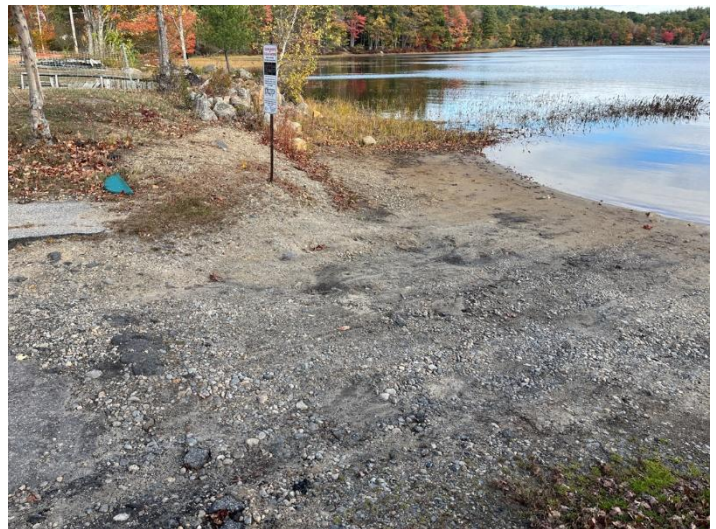
**Observations:** The Jenness Pond boat shows signs of erosion, especially the unpaved portion. Stormwater can likely flow from the nearby road over the unpaved section and to the ramp, carrying sediment, associated nutrients, and material into the pond. A stream was also observed directly to the south of the boat ramp.

*(Top Left) A stream runs parallel to the south side of the boat ramp. (Top Right) The boat ramp parking/driving area is wide and unpaved. (Bottom Left) The boat ramp is mostly unpaved with a small, paved portion near the water's edge. (Bottom Right) There is moderate erosion at the bottom of the boat ramp; note that water levels were likely lower than typical at the time of the survey.*

**Recommendations:** Engage an engineer to re-design the boat ramp and parking/driving area, which may include using interlocking permeable pavers to prevent erosion while also allowing stormwater to infiltrate. There may be areas where impervious cover may be removed from the site (to the south near the stream bank or to the north by the neighboring lawn) to further promote infiltration. Bare soil areas should be stabilized, and silt fences may be used as a temporary measure in shoreline areas that are not used for the boat ramp to prevent un-stabilized sediment from entering the pond.

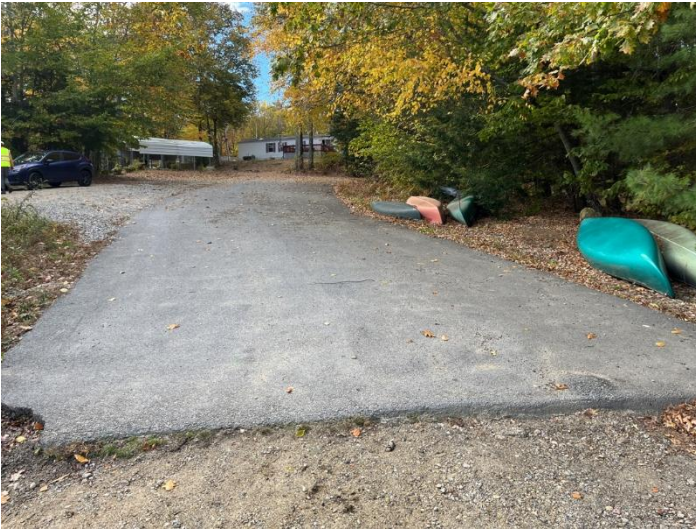
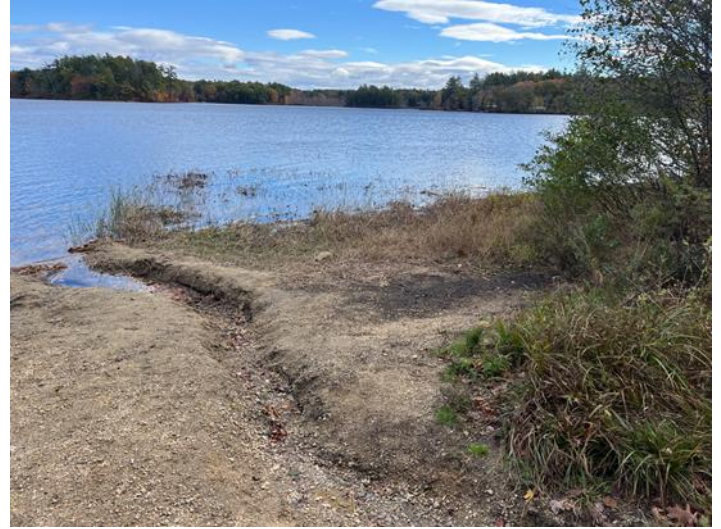
*(Right) The steeply sloped paved area directs stormwater to the lake. (Left) A large gully has formed at the bottom of the boat launch.*

**Recommendations:** Stabilize the gully with large, crushed stone and divert stormwater into the forested area by either re-crowning the road, using water bars, or creating a swale so that stormwater does not directly enter the lake. Reinststate the shoreline buffer in shoulder areas of the boat launch that are not used for recreation. Consider using cleared areas for a plunge pool for diverted stormwater or as a vegetated area for stormwater to infiltrate.

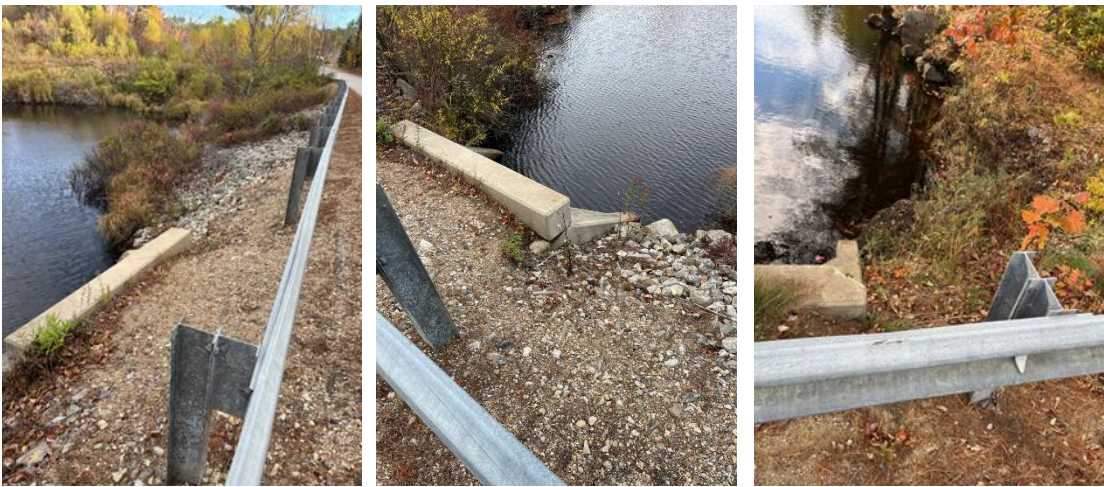
**Observations:** Exposed soil was observed at the culvert inlet and outlet of the Tucker Brook stream crossing on Harmony Road. On both sides of the culvert, there are clear paths where stormwater has traveled down the bank, carrying stormwater and sediment from the road and road shoulder into the stream. Most of the culvert inlet is armored with rip rap, but the culvert outlet is not.

*(Left) The bare road shoulder above the culvert outlet site, (middle & right) stormwater has eroded the shoreline, providing paths for stormwater to directly enter Tucker Brook.*

**Recommendations:** Armor the culvert outlet with additional rip rap to prevent bank erosion. Divert stormwater away from the site by using a berm along the road shoulder to direct water into the adjacent vegetated shoreline areas. Revegetate bare areas and assess with low growing shrubs or a ground cover if possible.

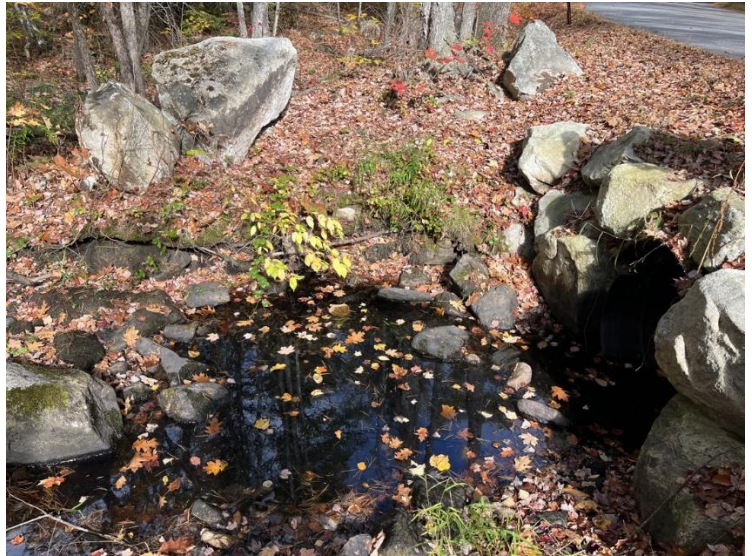
**Observations:** There is an undersized and cracked culvert on Harvey Lake Road that is contributing to minor bank erosion at the culvert outlet. The culvert currently restricts the natural flow of Kelsey Brook due to its size

*An undersized culvert is causing bank scours at the culvert outlet.*

**Recommendations:** Enlarge or replace the culvert with an open bottom crossing to promote natural flow.

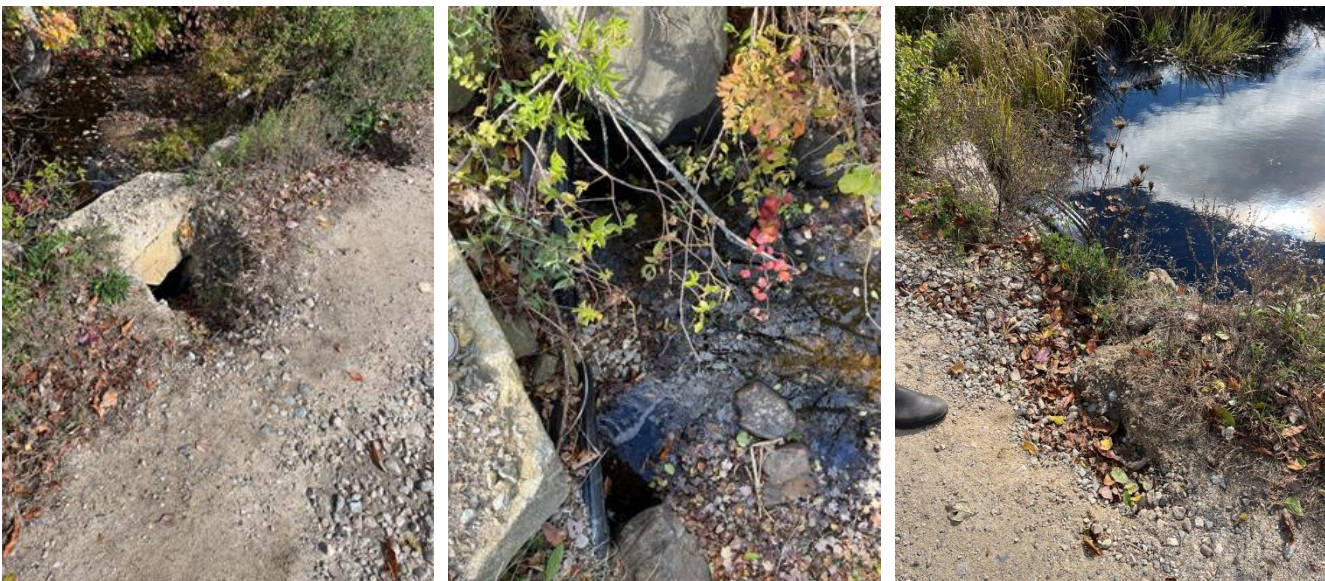
**Observations:** Severe erosion was observed at the culvert outlet on Olde Canterbury Road, and minor erosion was observed at the culvert inlet. There are twin culverts at the site that carry Kelsey Brook under Olde Canterbury Road near its confluence with Narrows Brook.

*(Left) Severe erosion at the culvert outlet. (Middle) View of twin culverts. (Right) There is minor erosion at the culvert inlet.*

**Recommendations:** Stabilize the culvert inlet and outlet with rip rap to prevent future erosion. Consider recrowning the road. Berms along the road shoulders may be used to direct stormwater into vegetated areas rather than directly into the stream at the culvert inlet and outlet.

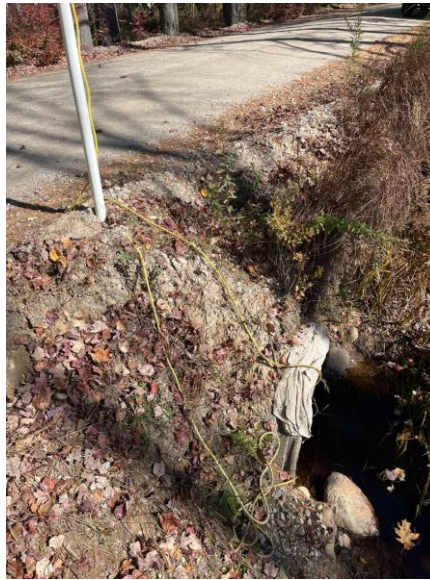
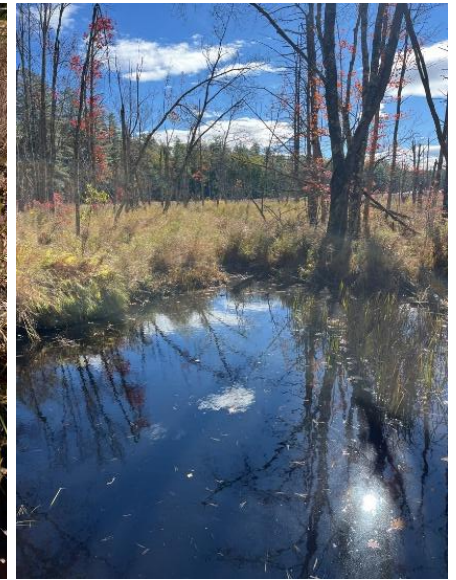
*(Left) The streambank at the culvert outlet is eroding, partly due to a crumbling berm. (Right) The stream is part of a larger wetland complex.*

**Recommendations:** Reinstall the berm and stabilize bare soil at the culvert outlet, either using live stake plantings or rip rap.

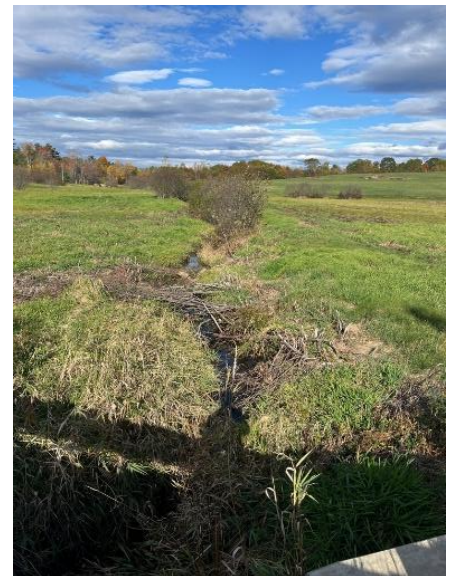
*Griffin Brook lacks a riparian buffer on an agricultural property.*

**Recommendations:** Consider improving the buffer to 20-50 feet on each side of the stream to allow agricultural runoff to be intercepted and nutrients retained by the plants rather than entering Griffin Brook. Use native plants and shrubs as recommended in the [Native Shoreland/Riparian Buffer Plantings for New Hampshire guide](#) to stabilize the soil and decrease nutrient laden runoff from entering Griffin Brook.

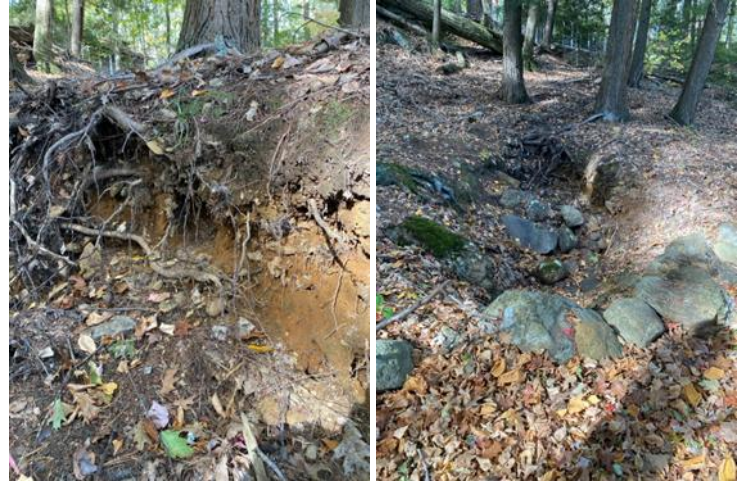
**Observations:** A small, intermittent stream crossing was observed on Lagoon Road. The stream channel leads to a culvert underneath Lagoon Road. The inlet area to the culvert has a large area of eroded soil and exposed tree roots indicating stormwater flows may be large and fast during heavy amounts of precipitation. A local resident noted that during heavy flows, stormwater often overtops the road.

*(Left) The upgradient side of the culvert showing the large, eroded basin. (Right) View of the eroded soils and exposed tree roots on the upstream side of the culvert.*

**Recommendations:** Begin by stabilizing the inlet side of the culvert with the exposed tree roots. Add large rip rap stones to stabilize the edges and base. Stabilize the outlet side with rip rap as well. Consider installing check dams in the flow path that leads to this culvert to slow the speed of stormwater and stream flow and promote infiltration along the way.

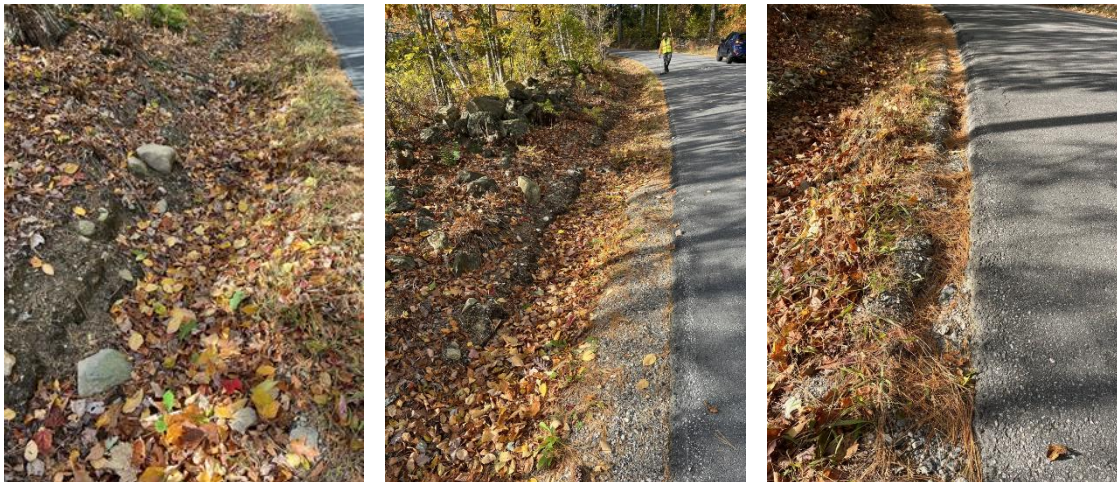
*(Left & Middle) A well-defined gully is present in the road shoulder ditch, which is typically bare, but was filled with fallen leaves at the time of the survey. (Right) The road shoulder of Harmony Road is eroding into the ditch.*

**Recommendations:** Reshape the ditch into a U-shape. Armor the ditch and backslope with rip rap if revegetation with grass is not possible.

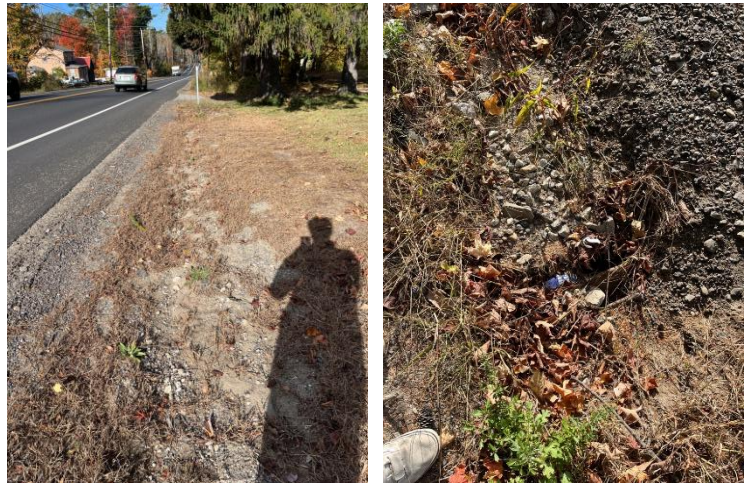
*(Left) Road shoulder erosion leading to a catch basin. (Right) The catch basin is buried in gravel.*

**Recommendations:** Clean out the catch basin and remove debris/gravel from the grate. Enlarge the catch basin area and stabilize the catch basin with rip rap. Check dams may be used across the road shoulder ditch to slow stormwater and settle out sediment before reaching the catch basin.

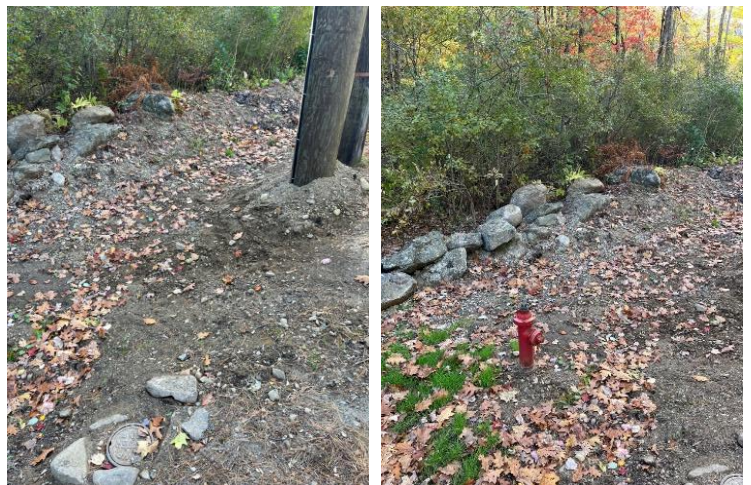
*Bare soil areas in the road shoulder ditch.*

**Recommendations:** Seed the ditch to create a grass swale and stabilize loose soil.

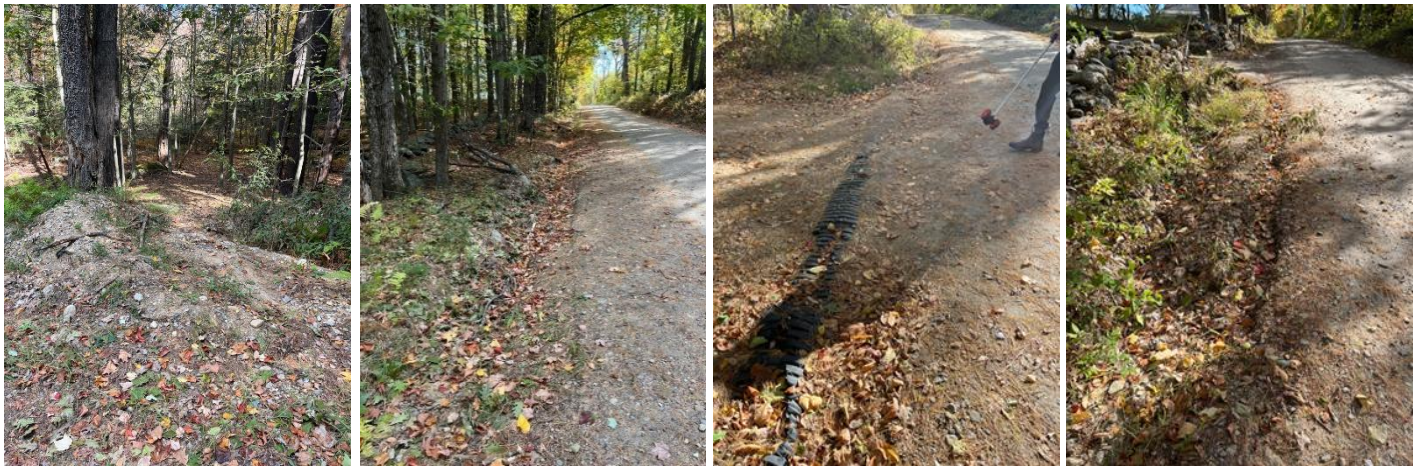
**Observations:** Stormwater on Range Road has caused road surface and shoulder erosion. Stormwater from the top of the hill erodes the road surface instead of entering the roadside ditch. It eventually enters the ditch and turns out into the forested area. There is a large sediment pile at the turnout, which is likely a result of plowing and erosion over many years. There is no stream channel near the turnout, but the area is mapped as a wetland, and there are multiple sediment deposits in the forest. Stormwater also completely bypasses an under-driveway culvert, which also has become exposed, indicating that the driveway surface has eroded. This culvert is more vulnerable to damage due to being exposed.

(1) The turnout on Range Road has accumulated sediment at its end. (2) The road shoulder ditch is eroding. (3) An under-driveway culvert is exposed. (4) The road surface of Range Road is eroding.

**Recommendations:** Replace the under-driveway culvert and add surface material to cover it. Create a U-shaped (cross-section) road shoulder ditch and armor it with rip rap. Install a plunge pool at the bottom of the turnout to prevent sediment from accumulating in the wetland. Dig ditches to connect the culverts to the road shoulder ditch and prevent surface erosion; regrade the road if needed.

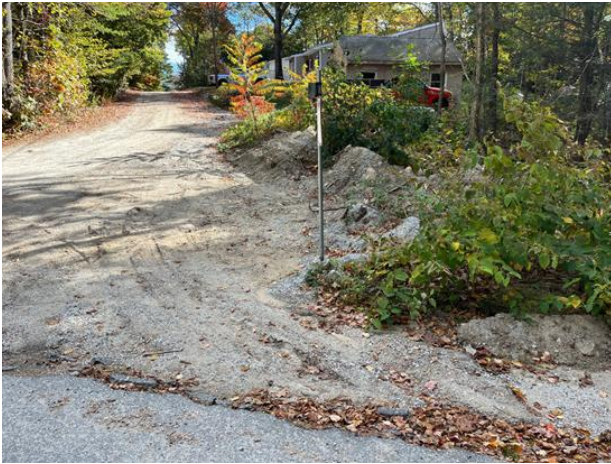
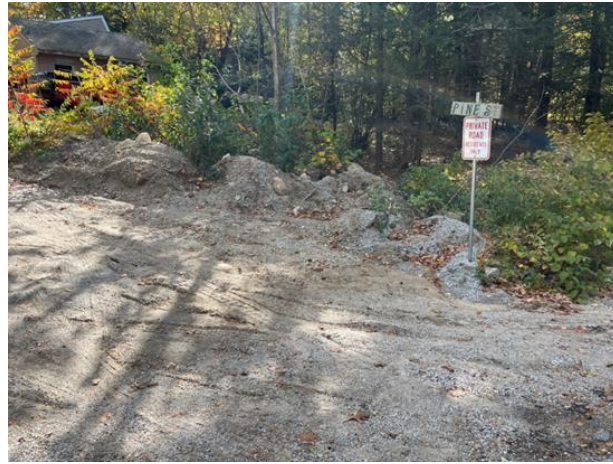
*Stormwater and/or winter plowing on Pine Street carries sediment down to the intersection with Harvey Lake Road.*

**Recommendations:** Remove the accumulated sediment from the site. If possible, revegetate the area; if establishing vegetation is not possible, armor it with rip rap. If the area is used for plow piles and snow storage, remove accumulated sediment each spring and mind how far plows push snow (and road surface material) towards the culvert area.

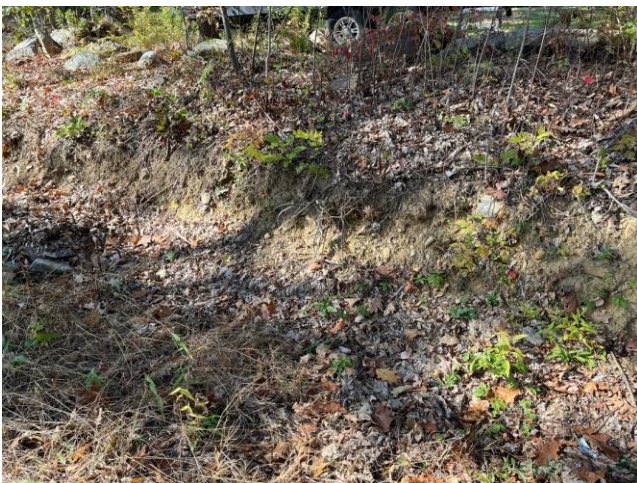
*(Left) The backslope of the road shoulder ditch. (Middle) The ditch on Jenness Pond Road. (Right) Stormwater from the ditch enters the intermittent stream at the culvert.*

**Recommendations:** Reshape the ditch into a U-shape and armor it with rip rap. Use multiple check dams to slow stormwater flow and settle out sediment before it reaches the stream.

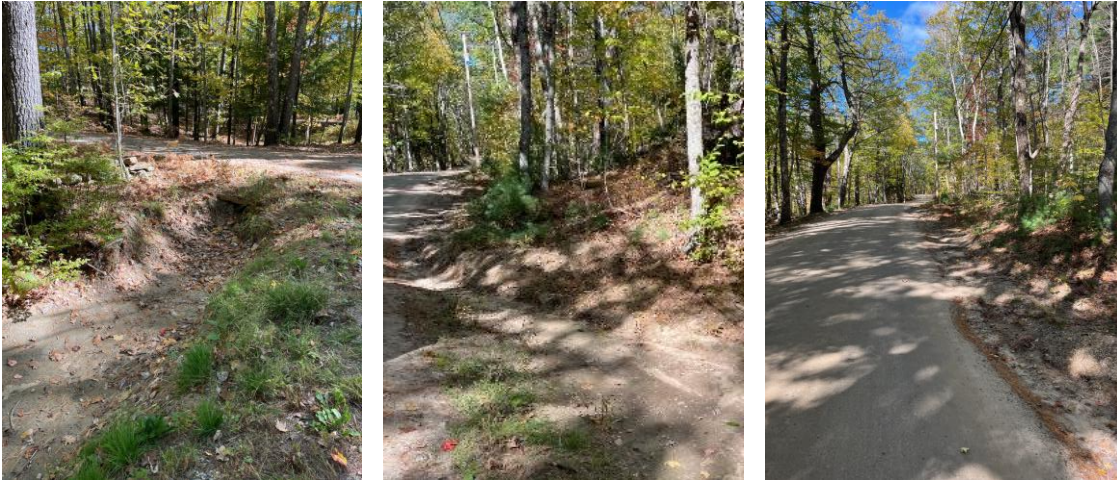
**Observations:** Large amounts of road shoulder erosion were observed along Clough Road with a gully nearly 500 feet long. Stormwater follows the road shoulder until reaching a culvert that leads to a stream that feeds Jenness Pond. The culvert inlet is perched, meaning stormwater settles and may infiltrate before moving downstream under low flow conditions. The area around the culvert inlet is completely bare and shows signs of erosion.

*(Left) The culvert inlet has bare soil. (Middle) The end of the gully is a wide, bare soil area. (Right) The gully extends 500 feet up the road.*

**Recommendations:** Reshape the road shoulder into a U-shaped ditch and armor it with rip rap and check dams. Install turnouts wherever the slope of the adjacent forest allows. Remove accumulated sediment from the site; consider installing a check dam and plunge pool at the end of the ditch and stabilizing the area with vegetation or rip rap.

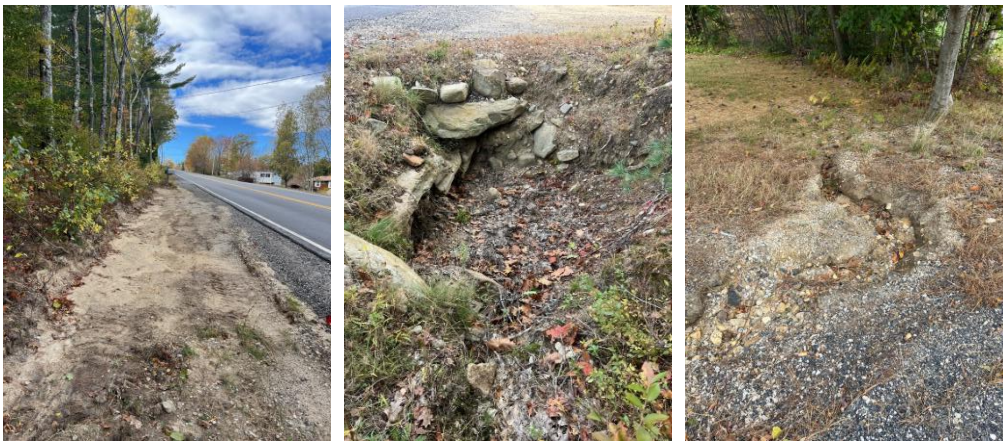
**Observations:** The road shoulder at the site is very wide, completely bare, and composed of loose sand. This area is actively eroding, and stormwater travels from the site through a culvert. The soil around the culvert inlet also shows signs of erosion. A gully on the downflow side of the road leads towards Jenness Pond.

*(Left) The road shoulder is composed of loose, bare sand. (Middle) The culvert inlet also shows signs of erosion. (Right) The gully created by the outflow.*

**Recommendations:** Revegetate road shoulder. Armor bare areas of the culvert inlet with rip rap. Stabilize the culvert outlet with a vegetated swale and armored swale outlet to prevent breakthrough gullies from forming.

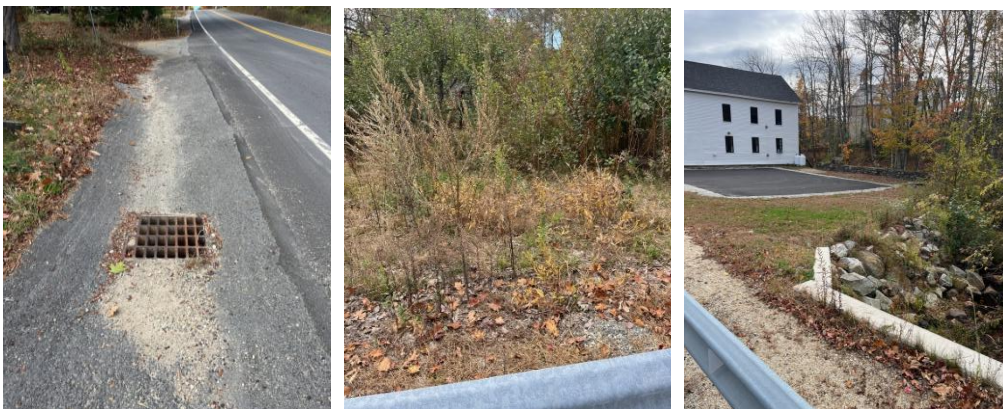
**Observations:** A paved swale on Main Street leads to a catch basin that outfalls to Narrows Brook. Sediment was observed on the road surface leading to the catch basin. While paved swales prevent erosion, they channelize untreated stormwater directly to the receiving location, and mobilize other pollutants that have accumulated on the road surface.

*(Left) Sediment from the road enters the catch basin through the paved swale. (Middle & Right) Vegetated areas that may be used to infiltrate stormwater.*

**Recommendations:** Multiple options exist to treat stormwater at the site. One option is to direct stormwater from the catch basin to a nearby vegetated area that could be used as an infiltration area for stormwater. The area could also be converted to an engineered stormwater control measure, such as a rain garden or bioretention basin.

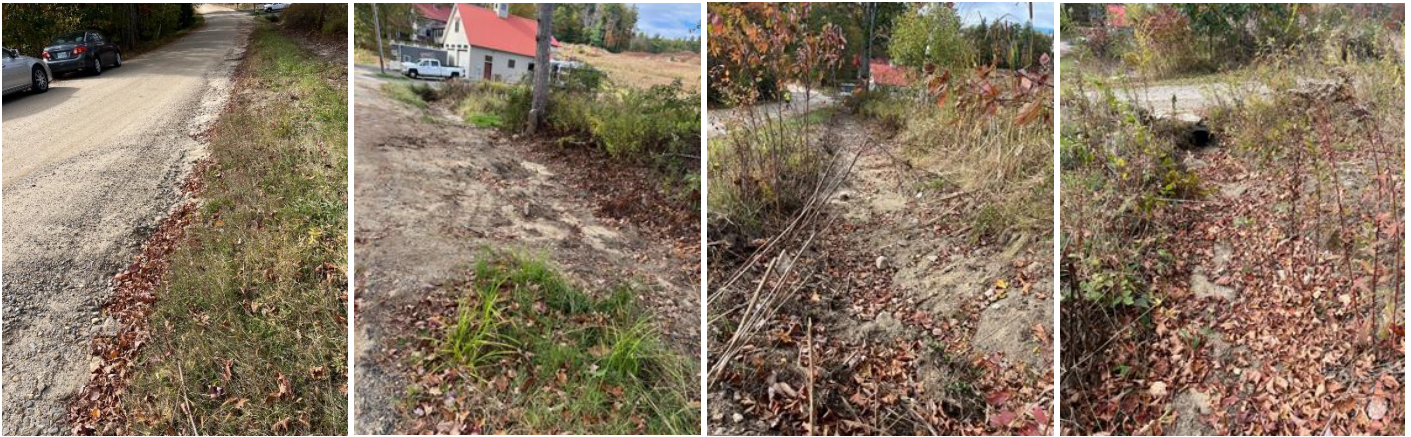
**Observations:** Large amounts of erosion were observed along the road shoulder of Ye Olde Canterbury Road leading to a culvert that routes stormwater into a nearby stream. Road surface erosion was also observed at the site. Erosion begins at the unpaved section of the road. Runoff from a nearby residential property appears to be directed toward the road.

(Photos 1-3) Road surface erosion in addition to road shoulder ditch erosion. (Bottom Left) Stormwater is eroding the road surface. (Photo 4) Stormwater enters water resources through a culvert.

**Recommendations:** Ensure that residential stormwater runoff enters the road shoulder ditches rather than the road surface where it could cause erosion. Re-crown the road to divert stormwater into road shoulder ditches. Stabilize the road shoulder ditches with vegetation and/or rip rap, if possible.

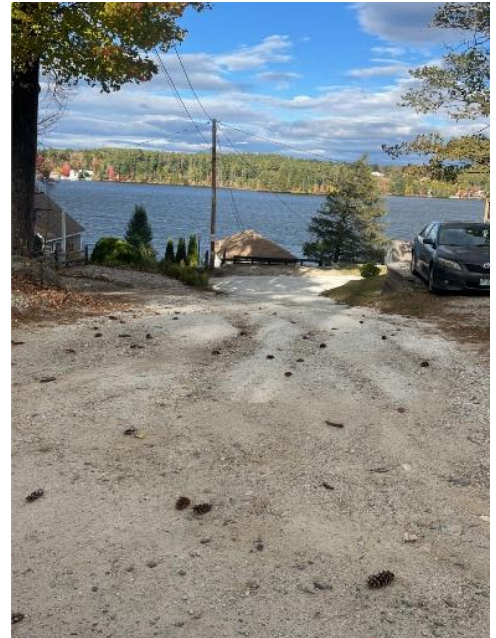
**Observations:** Moderately sized erosion gullies were observed on Lynn Lane, carrying sediment directly to Northwood Lake.

Road surface erosion on Lynn Lane leading to Northwood Lake.

**Recommendations:** Stormwater control measures such as a broad-based dip or water bars may be used to divert stormwater to road shoulders and other designated areas for infiltration. Assess if there are open space areas downhill (possibly private property) to infiltrate stormwater and filter sediment and nutrients. Consider removing excess impervious cover downhill if needed to accommodate an area to infiltrate stormwater.

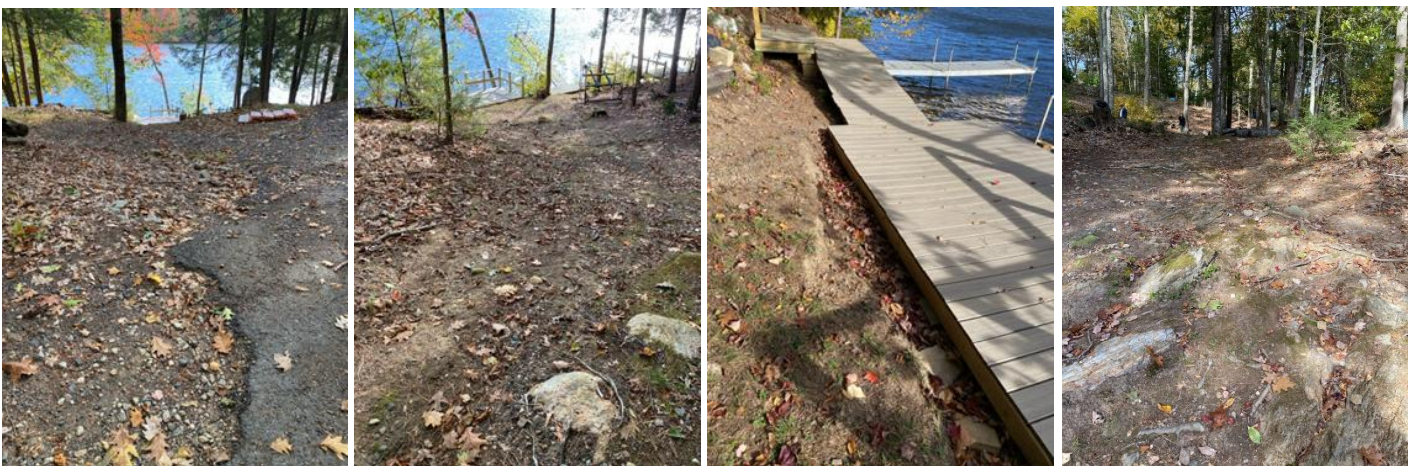
**Observations:** A long gully in the pathway at the end of Lagoon Road was observed leading down the hill to the dock at the bottom. The substrate was loose sandy gravel.

*(Lef two) Lagoon Road slopes steeply to the side towards the lake. (Right two) Gullies lead to the dock along the water.*

**Recommendations:** Collaborate with the homeowners in this area to promote residential stormwater BMPs to reduce the volume of water reaching this hillside. Consider installing water bars across the pathway to direct stormwater runoff to the adjacent vegetated area. Consider re-grading the road just before this driveway/walkway to drain away from the lake and into a stable road shoulder ditch and infiltration basin.

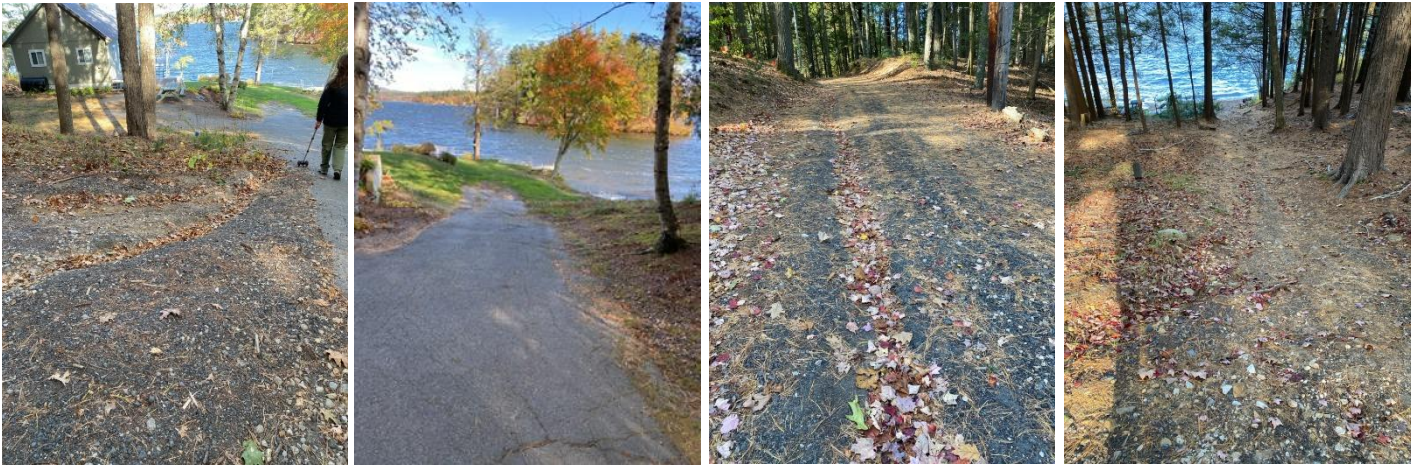
**Observations:** Stormwater likely flows down Pine Point Road (unpaved) towards both a foot path and a driveway along the most northern section of the road. The footpath (unpaved) and driveway (paved) are steeply sloped towards the lake. Gullies were observed along Pine Point Road within the tire track lines that continue to both downhill slopes.

(1) Gullies were present along Pine Point Road leading to the north east bend in the road to a steeply sloped driveway in the second photo. (3) Gullies were also present on the northern stretch of Pine Point Road that lead to an unpaved walkway straight down to the lake (4).

**Recommendations:** Consider installing rubber razors or broad-based dips across Pine Point Road to direct stormwater flow into the wooded areas rather than continuing down the roadway. Alternatively, crowning the road and establishing road shoulder ditches with turnouts would be helpful. Consider adjusting the location of the pathway to create a meandering path with infiltration basins on the bends and rubber razors across the pathway as needed to redirect stormwater from its current straight pathway downhill.

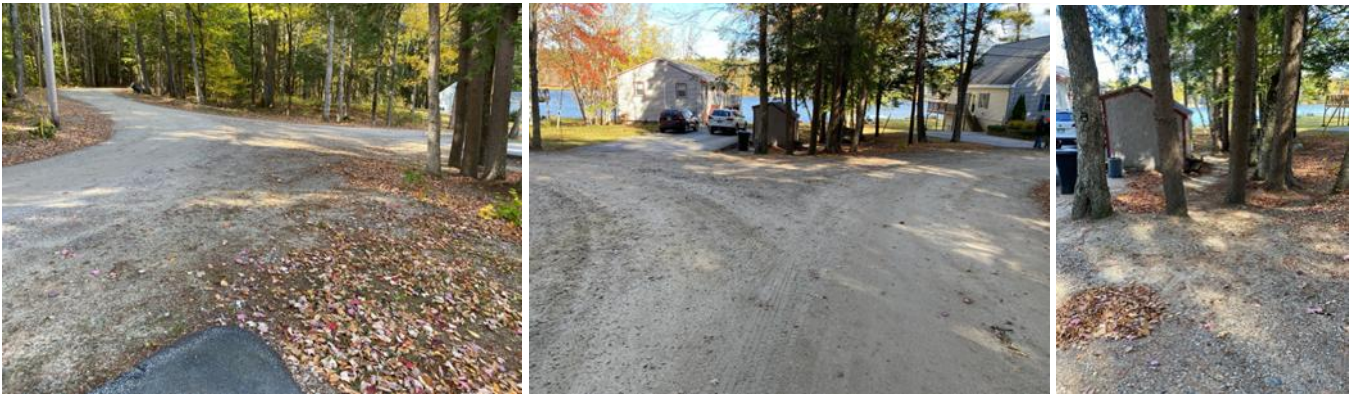
**Observations:** A wide (unpaved) intersection on Sleepy Hollow Road is present where the primary road splits in two directions to access the shoreline homes. A small stormwater erosion gully was observed through the patch of pine trees behind the small shed, likely coming from sheet flow across the roadway. Further up the hill on Sleepy Hollow Road, away from the lake, the road shoulder directed stormwater flow to a turnout which seemed to be working well as sediment was observed in the turnout and in the nearby wooded area.

*(Left) Sleepy Hollow Road intersection looking up the roadway where it splits to access shoreline properties. (Middle) Sleepy Hollow Road intersection looking downhill, towards Northwood Lake. (Right) Stormwater flows through the patch of pine trees behind the little shed.*

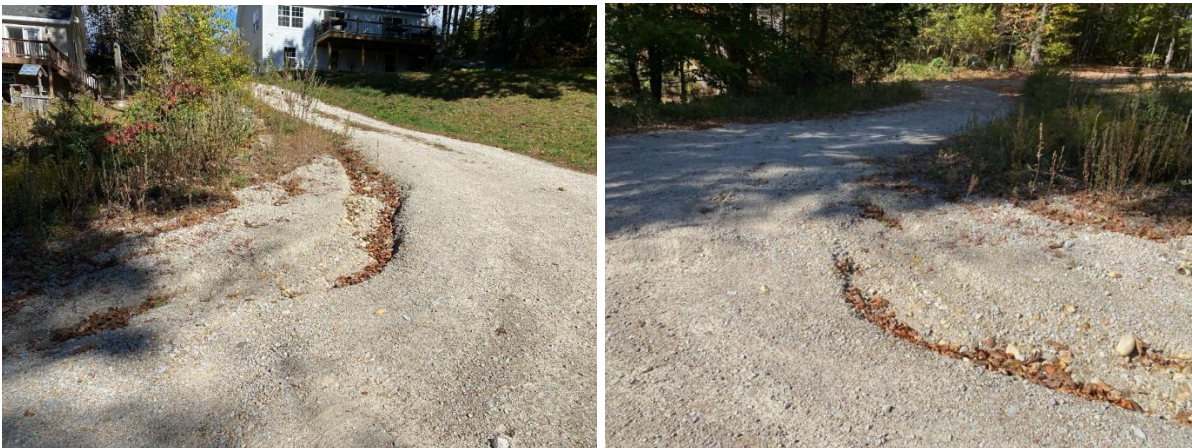
*Erosion gully at the base of the driveway turning onto Maple Avenue.*

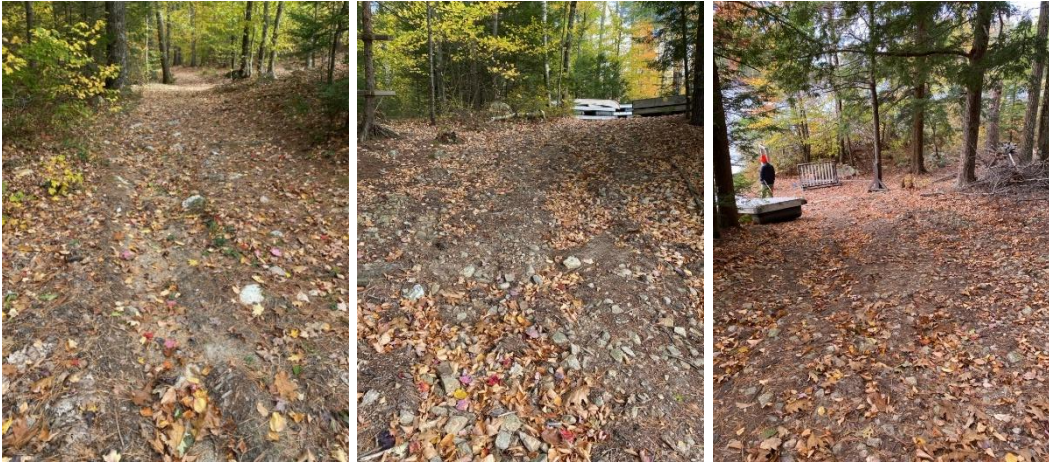
*(Left) Camp road with gully, (center and right) camp road as it slopes down to the water from the dock storage area.*
