# Northwood Lake | Watershed Survey Results

**TO:** Brian Lobao, Northwood Lake Watershed Association (NLWA)  
**FROM:** Christine Bunyon, FB Environmental Associates (FBE)  
**SUBJECT:** **Northwood Lake Watershed Survey Results**  
**DATE:** July 23, 2026  
**CC:** Laura Diemer & Evan Ma, FB Environmental Associates

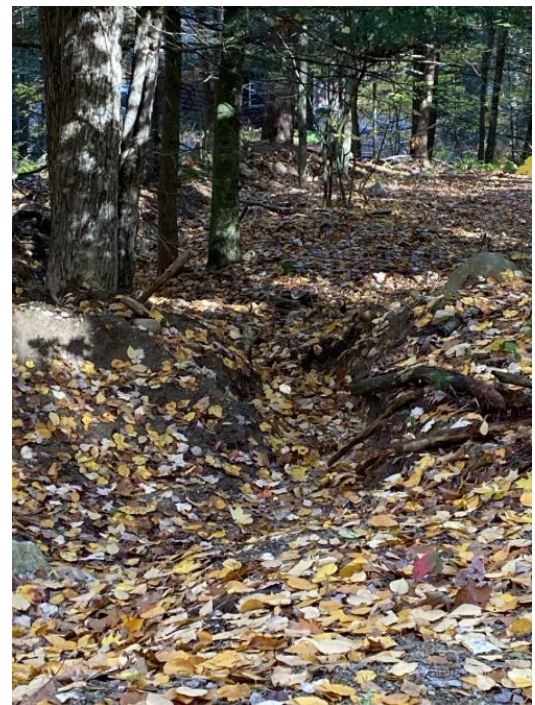
*The downhill view of the ditch/flow path with caving edges and exposed roots.*

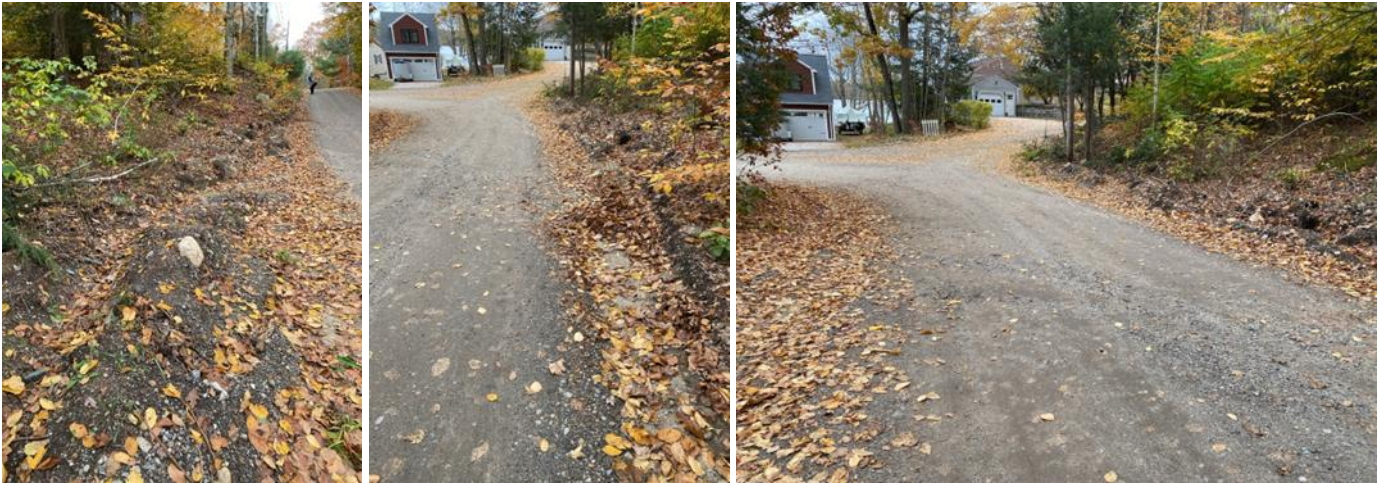
*(Left) Southern road shoulder gully looking uphill. (Middle) Southern road shoulder gully looking downhill. (Right) Flow path of the road shoulder flow crossing Birch Street to the intersection with Shore Drive.*

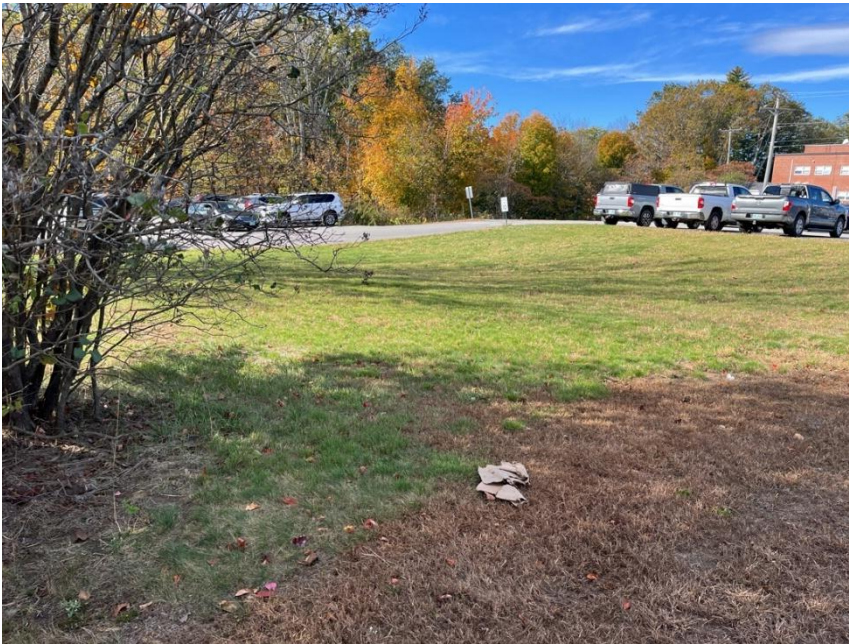
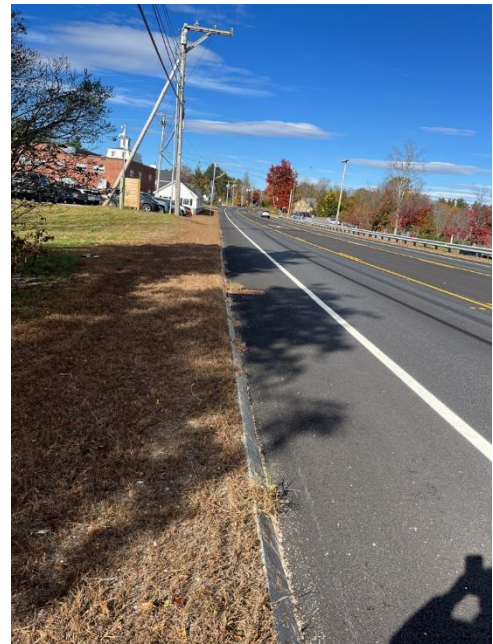
*(Left) Open area near parking lot may be used for a rain garden, vegetated swale or other engineered stormwater control measure. (Right) Untreated stormwater from Route 4 enters catch basins.*

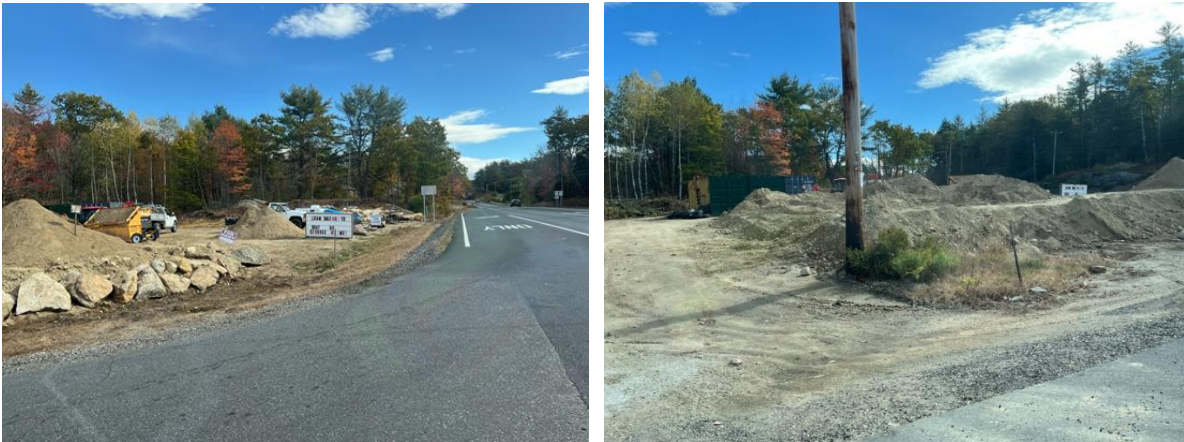
*Bare soil and sediment piles at the construction site on Route 4.*

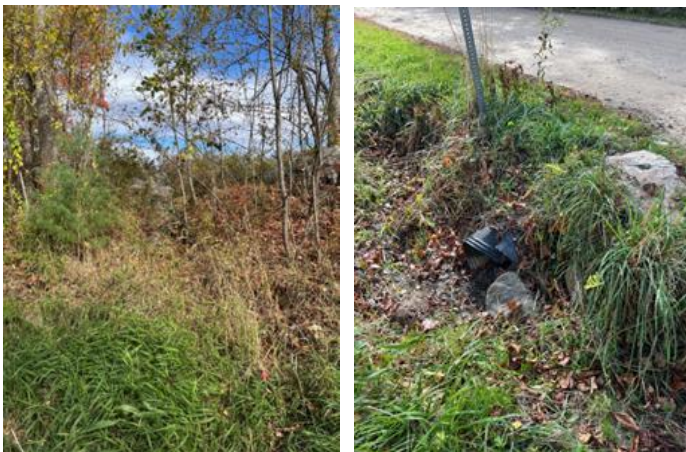
*(Left) Trail of rip rap leading from an agricultural property to the road shoulder ditch, obscured by vegetation in the photo. (Right) Slightly crushed culvert outlet at the site.*

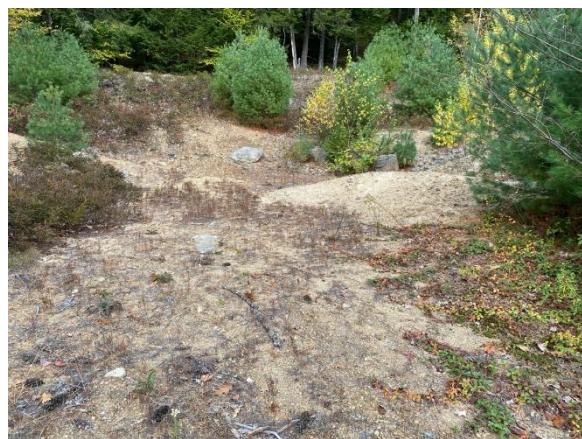
Loose sand piles were present to the east of pond #3, though a berm between the piles and the pond would keep any of this sediment from entering the pond.

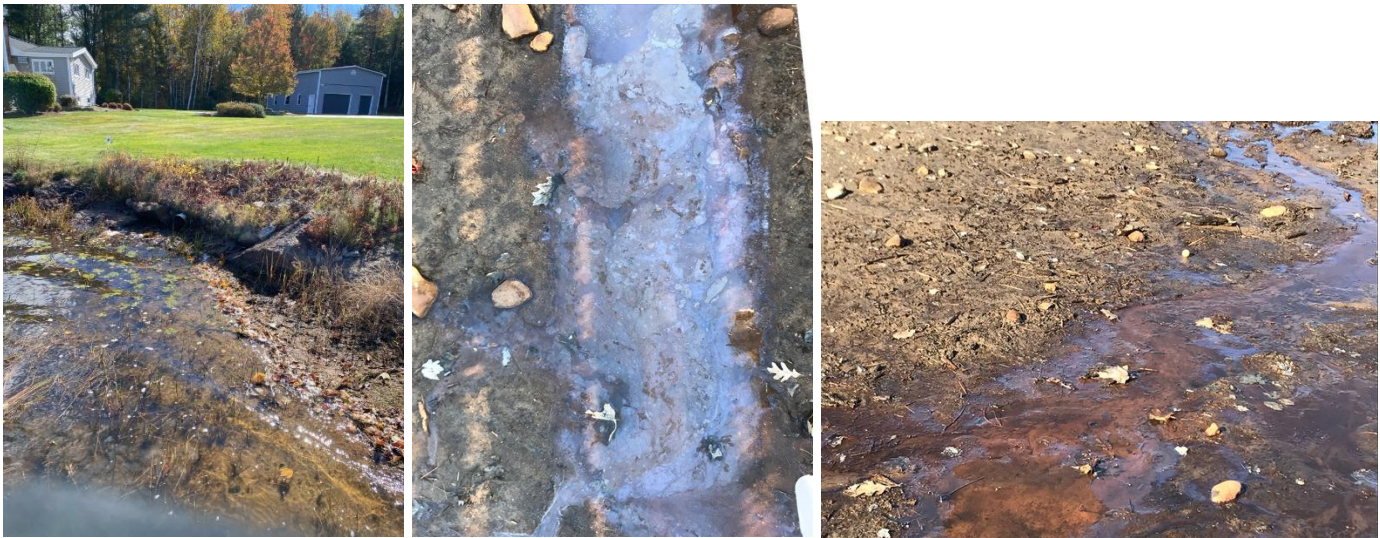
*(Left) the shoreline where the pipe outlets on the day of the watershed survey. (Middle and right) The oil sheen as observed by a local resident.*
