# Northwood Lake

## DRAFT Watershed-Based Management Plan

August 2026

Prepared by  
FB Environmental Associates

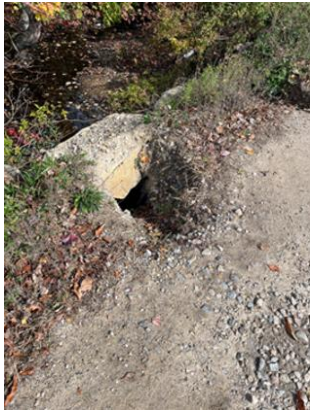
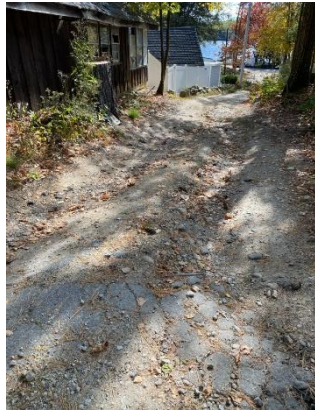
#### **Regrade and Stabilize Unpaved Road Surfaces**

Regrade, re-crown, or change road materials to hardpack gravel on unpaved roads and pathways to prevent tire rutting, stormwater scouring, and structural erosion.

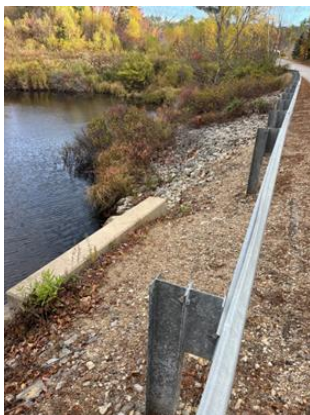
#### **Stabilize Eroded Road Shoulders and Banks**

Use riprap, landscape fabric, netting, or engineered infiltration steps to lock down steep, exposed sandy embankments scoured by runoff.

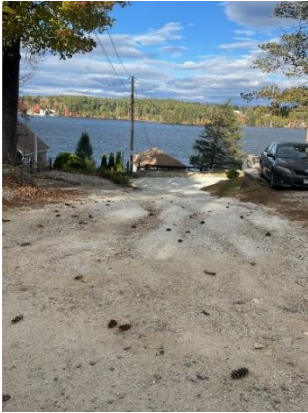
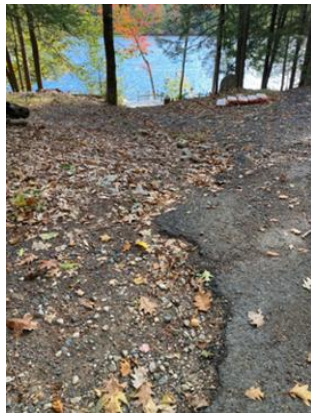
### **Install Water Bars, Swales, or Berms**

Construct formalized ditches, broad-based dips, rubber razors, swales, and water bars to redirect concentrated flow away from fragile roads and paths into vegetated buffers.

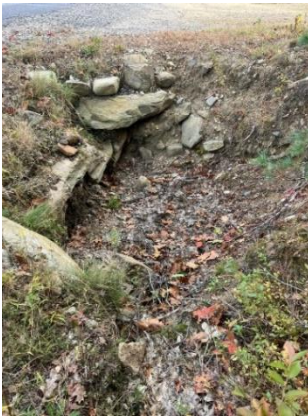
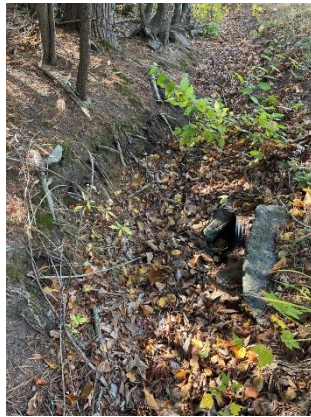
### **Clean and Maintain Drainage Culverts**

Routinely clear out accumulated sediment, leaves, and debris from blocked or degrading culverts and catch basins, replacing damaged pipes where necessary to restore natural stormwater flow.

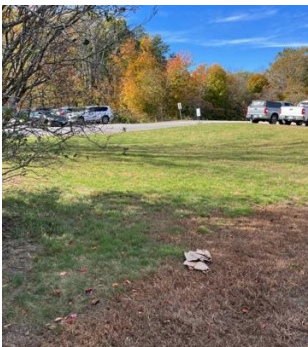
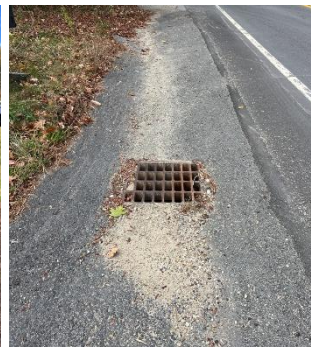
### **Install or Enhance Stormwater Basins and Infiltration Systems**

Implement infiltration sumps, retention basins, rain gardens, or sediment forebays to capture, settle, and treat heavy stormwater inputs before they reach the lake.

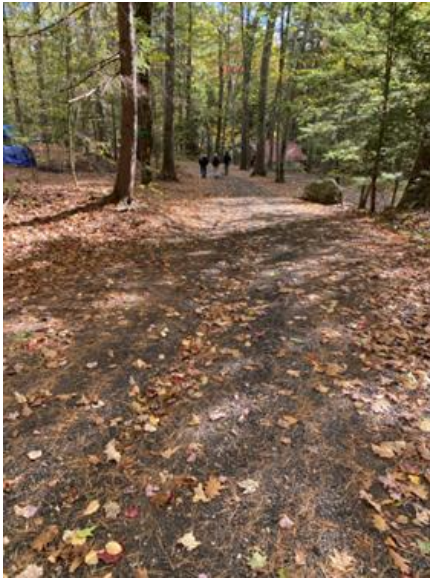
### Priority Site #1 NWL-27: Frary Road (Northwood)

*Unpaved Frary Road.*

**Observations:** Frary Road (unpaved) is known to wash out frequently with rain events, causing a loss of surface material. Frary Road was resurfaced earlier in 2025, and there is a small drainage ditch on the eastern side of the road behind the houses that leads to the lake.

**Recommendations:** To prevent future washouts, consider installing water bars across Frary Road to direct stormwater runoff into the adjacent forested area.

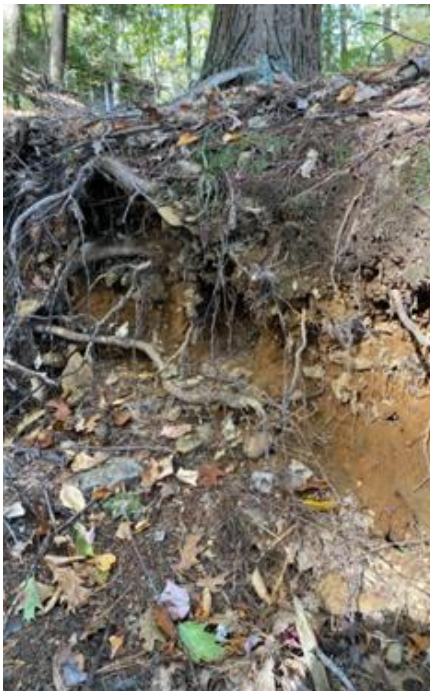
### Priority Site #2 NWL-29: Lagoon Road – Stream Crossing (Northwood)

*The upgradient side of the culvert showing the large, eroded basin.*

**Observations:** A small, intermittent stream crossing was observed on Lagoon Road. The stream channel leads to a culvert underneath Lagoon Road. The inlet area to the culvert has a large area of eroded soil and exposed tree roots indicating stormwater flows may be large and fast during heavy amounts of precipitation. A local resident noted that during heavy flows, stormwater often overtops the road.

**Recommendations:** Begin by stabilizing the inlet side of the culvert with the exposed tree roots. Add large rip rap stones to stabilize the edges and base. Stabilize the outlet side with rip rap as well. Consider installing check dams in the flow path that leads to this culvert to slow the speed of stormwater and stream flow and promote infiltration along the way.

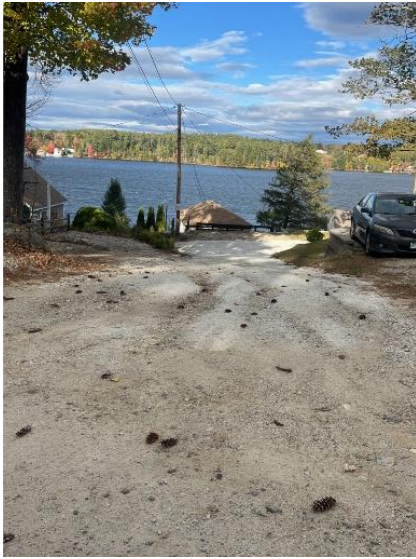
### **Priority Site #3 NWL-26: Lynn Lane (Northwood)**

*Road surface erosion on Lynn Lane leading to Northwood Lake.*

**Observations:** Moderately sized erosion gullies were observed on Lynn Lane, carrying sediment directly to Northwood Lake.

**Recommendations:** Stormwater control measures such as a broad-based dip or water bars may be used to divert stormwater to road shoulders and other designated areas for infiltration. Assess if there are open space areas downhill (possibly private property) to infiltrate stormwater and filter sediment and nutrients. Consider removing excess impervious cover downhill if needed to accommodate an area to infiltrate stormwater.

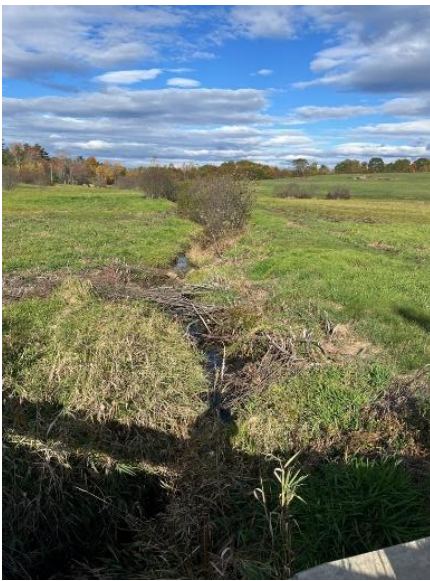
### **Priority Site #4 NWL-25: Griffin Brook at Route 107 (Epsom)**

*Griffin Brook lacks a riparian buffer on an agricultural property.*

**Observations:** Griffin Brook lacks an adequately wide and dense riparian vegetated buffer on a private agricultural land near its crossing with Route 107 and Ritchie Road. Much of the riparian buffer is mowed grass. Where there are shrubs, the buffer is only as wide as one plant.

**Recommendations:** Consider improving the buffer to 20-50 feet on each side of the stream to allow agricultural runoff to be intercepted and nutrients retained by the plants rather than entering Griffin Brook. Use native plants and shrubs as recommended in the [Native Shoreland/Riparian Buffer Plantings for New Hampshire guide](#) to stabilize the soil and decrease nutrient laden runoff from entering Griffin Brook.

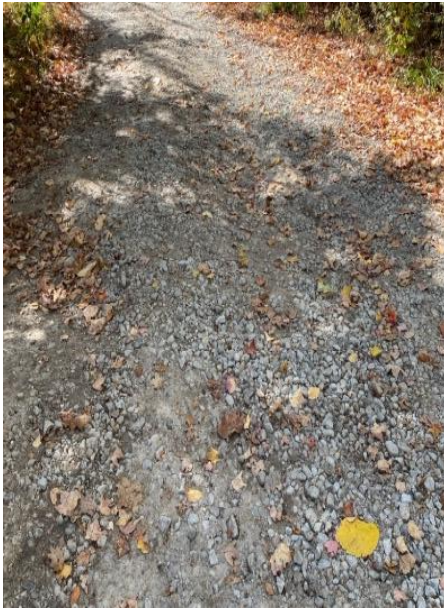
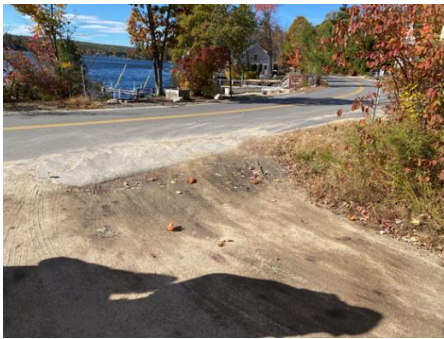
**Priority Site #5 NWL-38 Wildwood Ave to Lakeshore Drive (Northwood)**

**Observations:** Wildwood Ave and Park Ave are the two most used roadways into this neighborhood off Lakeshore Dr. Wildwood Ave is unpaved and comprised of a more gravelly substrate than Park Ave. Uphill stormwater issues at sites NWL-36 and NWL-37 are contributing to the erosion occurring on Wildwood Ave, which has evidence of sheet flow erosion and channelization. The road was created less than 10 years ago and has not been maintained since.

*Photos of Wildwood Ave (unpaved) from the intersection with Maple Ave to the intersection with Lakeshore Dr. (paved).*

**Recommendations:** Work with residents in this neighborhood to establish a road maintenance committee. In conjunction with addressing recommendations for sites NWL-36 and NWL-37, consider installing rubber razors across Maple Ln to direct stormwater flow into the vegetated area to the west.

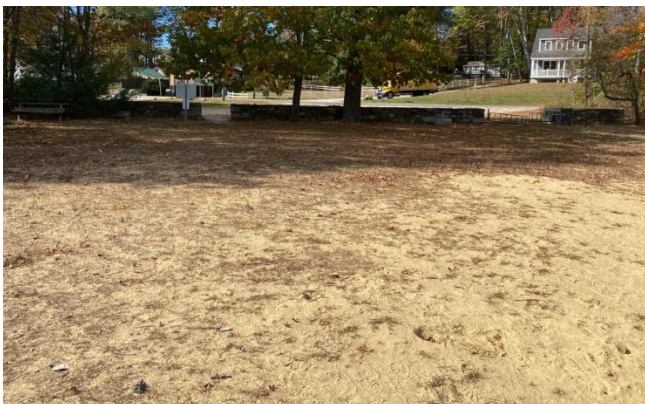
**Priority Site #6 NWL-39: Northwood Town Beach (Northwood)**

*View of the beach area facing the entrance gates.*

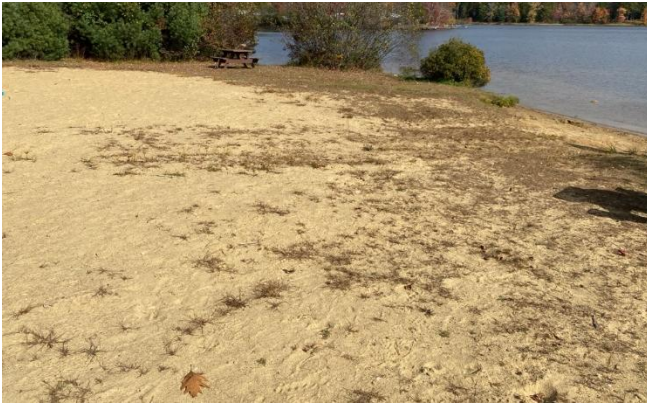
**Observations:** Northwood Town Beach is enjoyed by many during the summer months and is used as an access point for activities on the ice in the winter. Members of the community noted that although dogs are not allowed, many are brought to the beach and pet waste has been an ongoing problem in addition to general trash disposal. Additionally, geese regularly congregate within this cove and likely influence the bacteria concentrations

*View of the beach area as it slopes to the water's edge.*

**Recommendations:** Define pathways across high-traffic areas from the entrance gates using steppingstones spaced apart or interlocking permeable grid pavers. Observe the beach during heavy rainfall to note where flow paths are being created, then regrade the area as needed to divert stormwater flow into a rain garden or vegetated swale rather than continuing across the surface to the water. Reestablish vegetation (native grass, shrubs, groundcover) in all sandy areas that are not used for sand play. Install geese deterrents and revegetate the shoreline to the sides of the primary access point, as geese are less likely to congregate when their line of access between the water and shore is obstructed. To further address localized bacterial and phosphorus loading from the resident flock, specific management steps should include planting tall (24–30 inch) native shoreline buffers, installing low-profile temporary perimeter wire during summer molting periods, enforcing "Do Not Feed Waterfowl" signage, and letting turf grass grow taller near the water's edge to reduce attractive grazing habitat. This beach would also be an excellent location for a pollinator garden and educational signs about lake health.

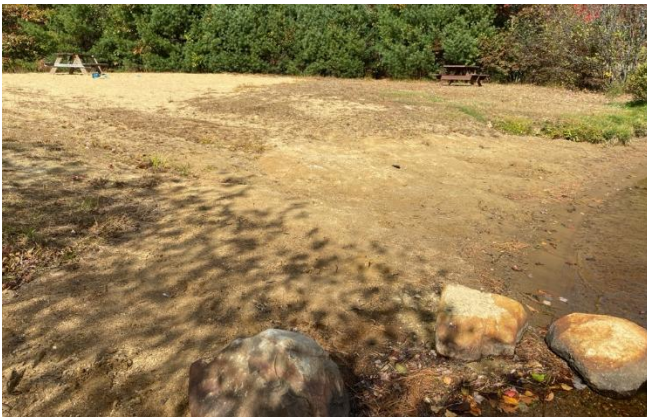
*Side view of the sloping area to the shoreline.*

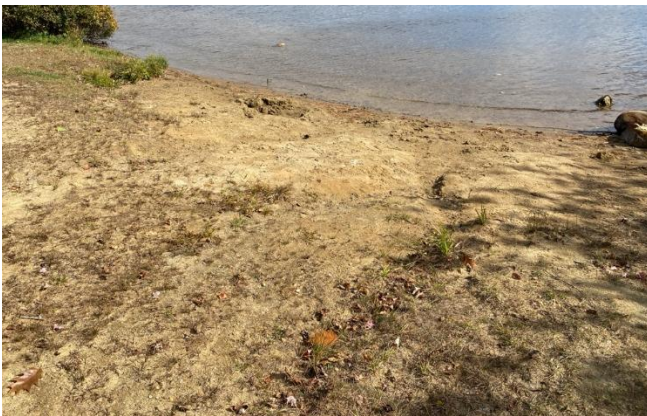
*Erosion gullies were observed between the beach area and the water's edge.*

within the cove. The beach hosts a portable toilet in the summer which helps protect the lake, though not for 2026. The beach area is a large relatively flat plot of land that is mostly comprised of sand with scattered weeds and grass. The area adjacent to the lake slopes downward to the water and erosion gullies were observed through the sand.

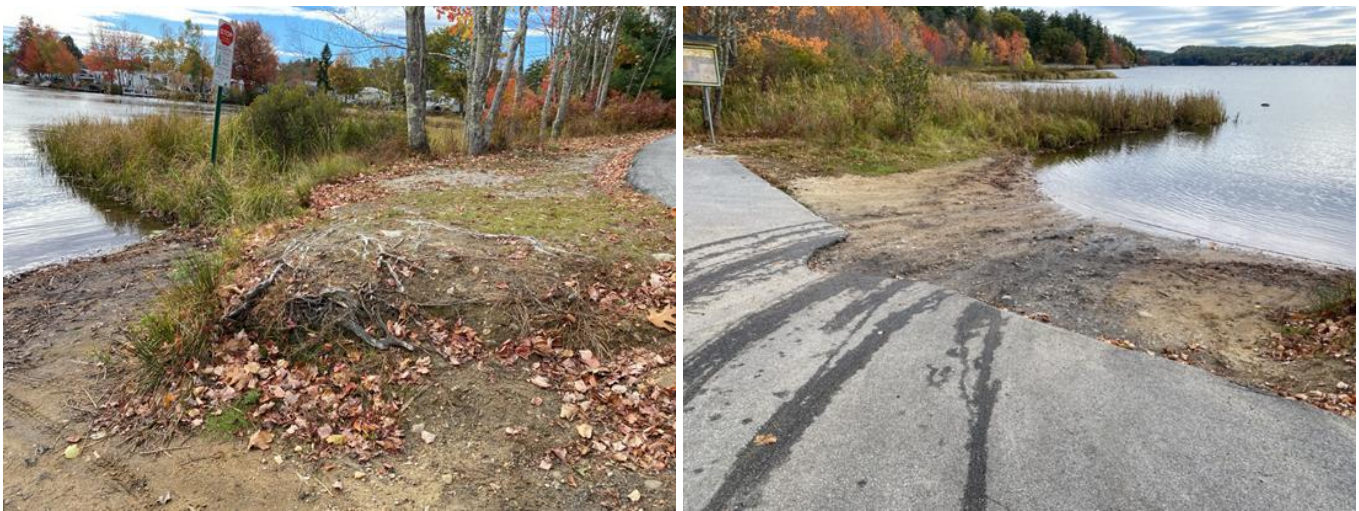
*(Left) Exposed roots and a steep drop off of the shoreline to the water's edge indicating erosion, (right) the end of the paved boat ramp where it meets the water.*

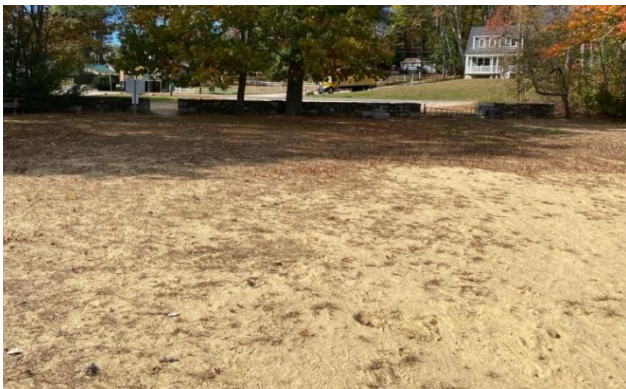
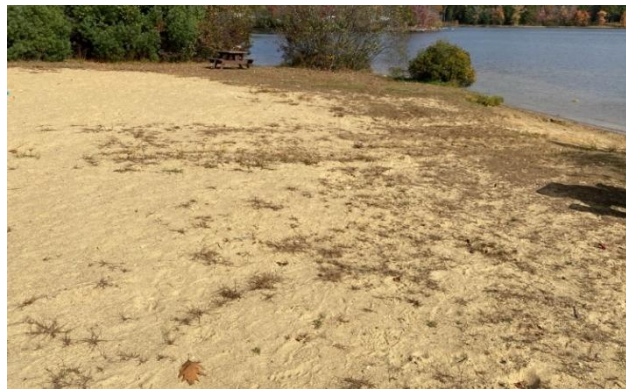
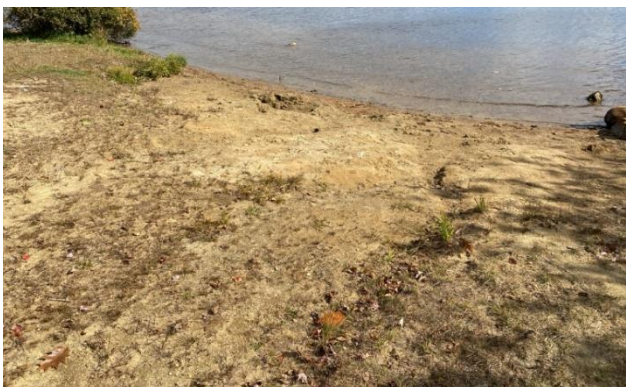
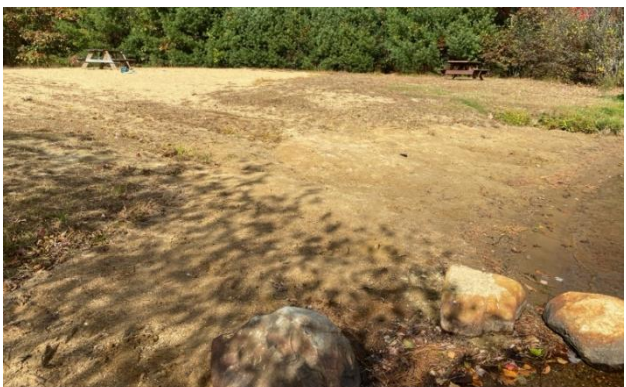
**Observations:** Northwood Town Beach is enjoyed by many during the summer months and is used as an access point for activities on the ice in the winter. Members of the community noted that although dogs are not allowed, many are brought to the beach and pet waste has been an ongoing problem in addition to general trash disposal. Additionally, geese regularly congregate within this cove and likely influence the bacteria concentrations within the cove. The beach hosts a portable toilet in the summer which helps protect the lake, though not for 2026. The beach area is a large relatively flat plot of land that is mostly comprised of sand with scattered weeds and grass. The area adjacent to the lake slopes downward to the water and erosion gullies were observed through the sand.

*(Top left) View of the beach area facing the entrance gates, (top right) view of the beach area as it slopes to the water's edge, (bottom left) erosion gullies were observed between the beach area and the water's edge, (bottom right) side view of the sloping area to the shoreline.*

**Recommendations:** Define pathways across high-traffic areas from the entrance gates using steppingstones spaced apart or interlocking permeable grid pavers. Observe the beach during heavy rainfall to note where flow paths are being created, then regrade the area as needed to divert stormwater flow into a rain garden or vegetated swale rather than continuing across the surface to the water. Reestablish vegetation (native grass, shrubs, groundcover) in all sandy areas that are not used for sand play. Install geese deterrents and revegetate the shoreline to the sides of the primary access point, as geese are less likely to congregate when their line of access between the water and shore is obstructed. To further address localized bacterial and phosphorus loading from the resident flock, specific management steps should include planting tall (24–30 inch) native shoreline buffers, installing low-profile temporary perimeter wire during summer molting periods, enforcing "Do Not Feed Waterfowl" signage, and letting turf grass grow taller near the water's edge to reduce attractive grazing habitat. This beach would also be an excellent location for a pollinator garden and educational signs about lake health.

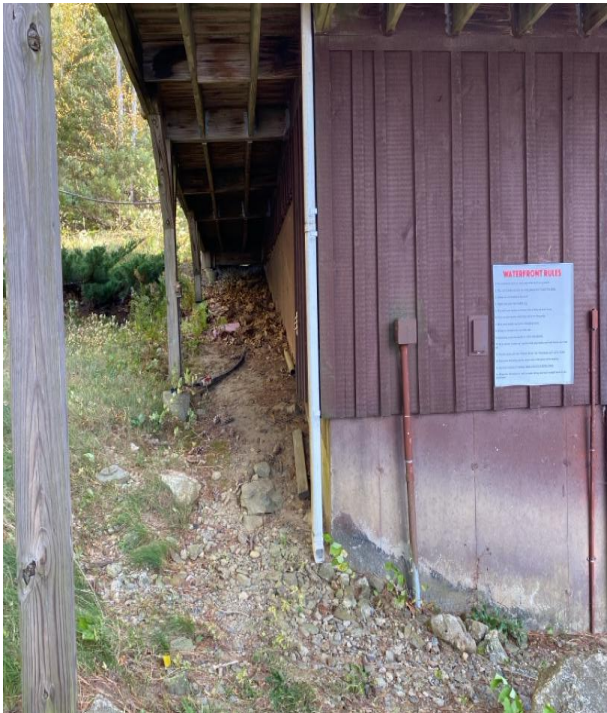
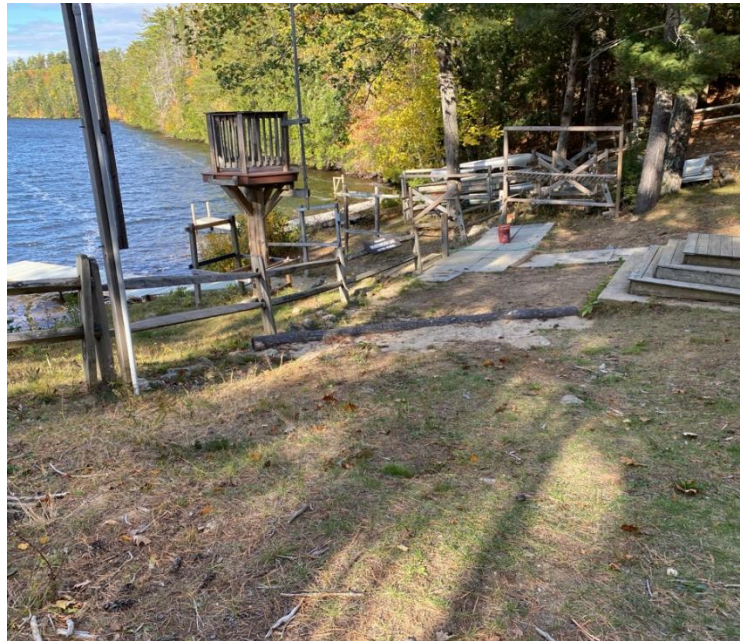
*(Left) the evidence of erosion from roof runoff prior to gutter installation along with the white gutter downspout. (Right) the water access area sloping to the lake with fencing to define access points.*

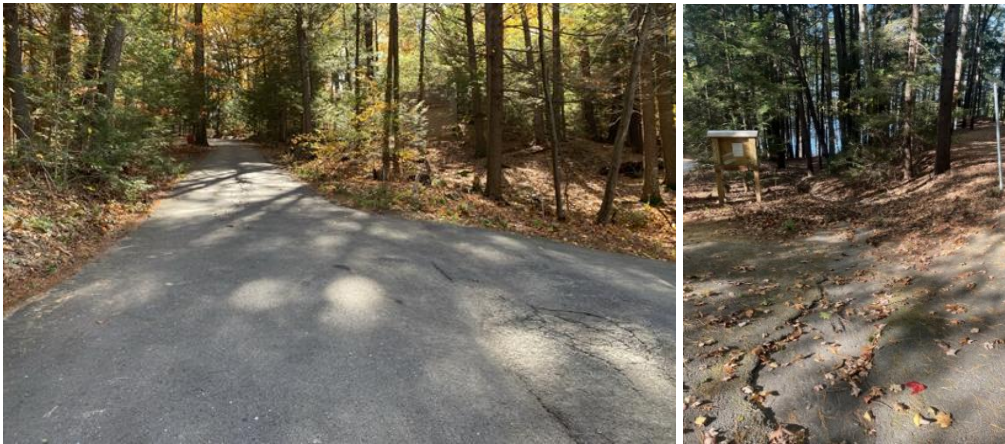
**Observations:** A community beach is present at the end of Cole Road. This beach has a small parking area, a large sandy beach area, and a clubhouse. Many stormwater management initiatives have been completed at this site already and are quite effective, transforming a potentially high impact site into a low impact site. Stormwater flows down the paved and unpaved sections of Cole road to the fork with Pine Point Lane. At this intersection, a paved swale was created to direct stormwater runoff into the forested area between these two roads. Stormwater then is directed via a riprapped swale to a series of infiltration basins. It is evident that the retention basins are working due to the accumulation of sediment within them and lack of large break-through flow paths. Eventually, stormwater might make its way to the last retention basin near the clubhouse steps where it would travel through a grate (next to the orange cone in the photo) and through a pipe that outlets about 10 feet from the lake.

*(Left) View up Cole Road with the paved swale in the bottom right corner, (right) the paved swale entering the forest.*

**Recommendations:** Continue maintaining the series of infiltration basins and check dams through the wooded area. To increase storage potential, periodically remove accumulated sand and debris from the retention basins and maintain as needed to the stabilizing edges. Deepen the last basin, closest to the lake, so the outlet serves as an overflow outlet rather than a drain. Consider adding water-tolerant plants this last basin as well to promote nutrient uptake. Consider adding an educational sign about the use of rain gardens for pollinators and stormwater/nutrient management for the lake.

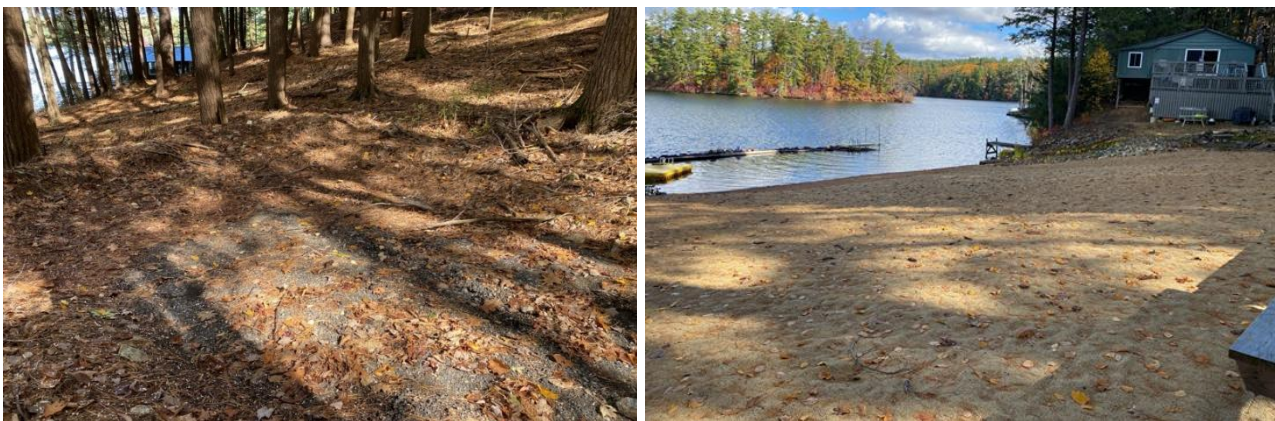
*(Left) The first retention basin with lots of accumulated road surface material. (Right) No large erosion gullies were observed across the beach area.*

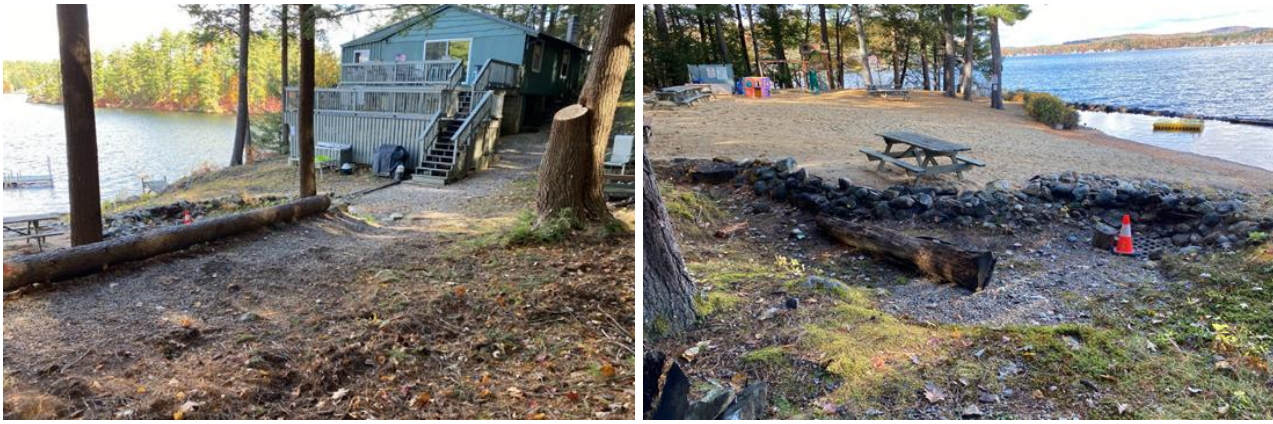
*(Left) a walkway leading to the club house with a tree trunk for stabilization. (Right) The last retention basin with the outflow grate next to the orange cone.*

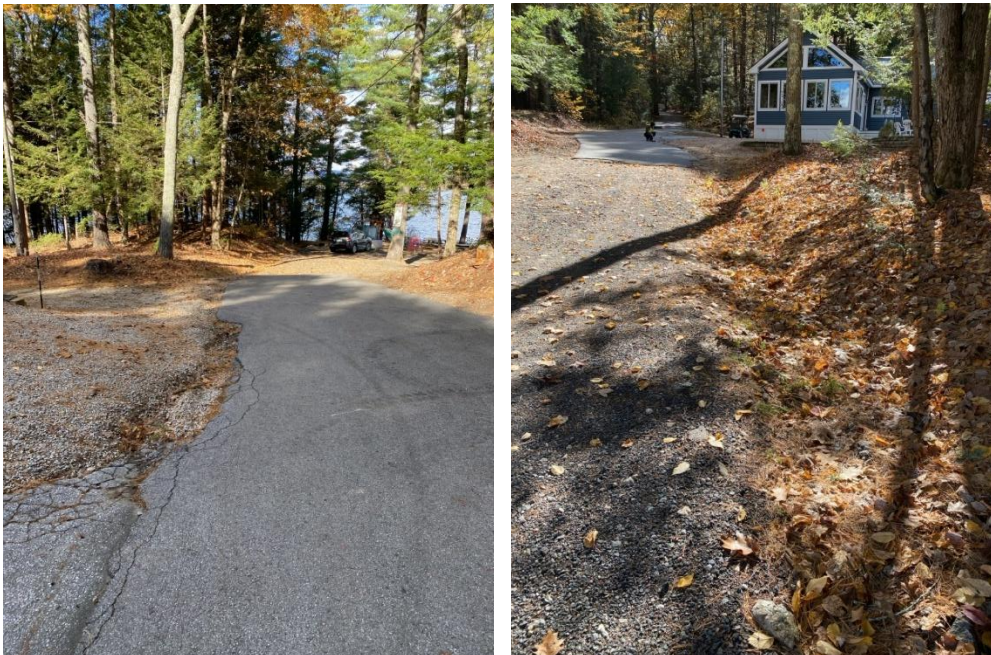
*(Left) View of Pine Point Road shoulder facing the lake, (right) View of the road shoulder gully facing up hill, away from the lake.*

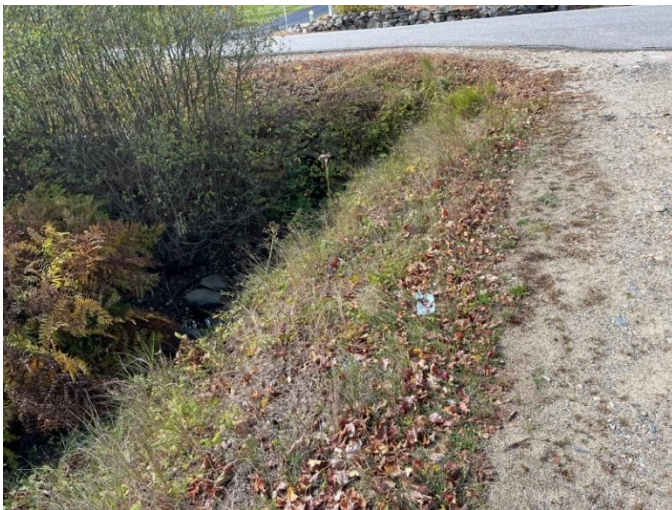
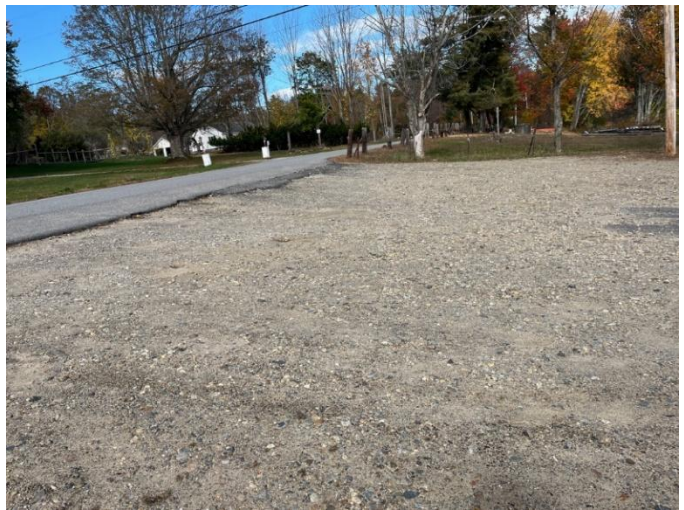
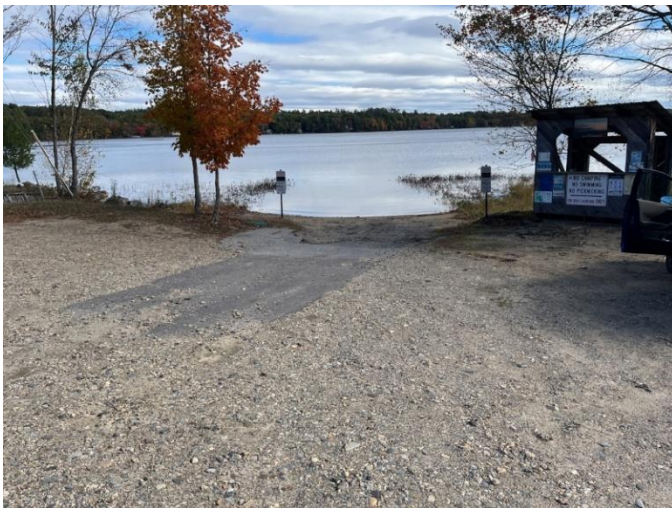
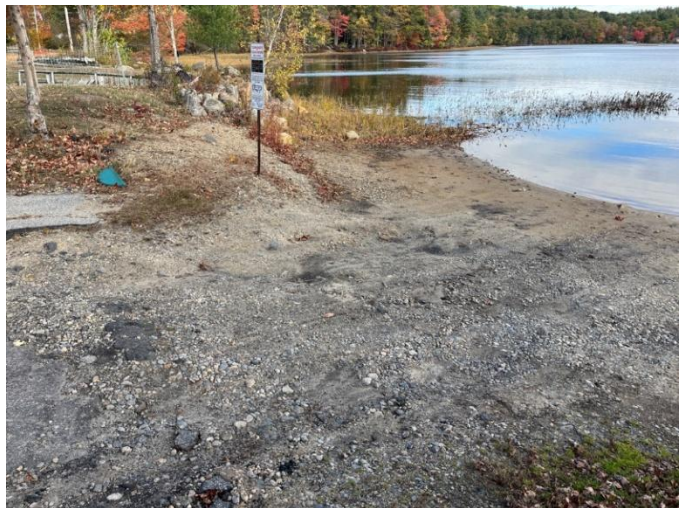
*(Top Left) A stream runs parallel to the south side of the boat ramp. (Top Right) The boat ramp parking/driving area is wide and unpaved. (Bottom Left) The boat ramp is mostly unpaved with a small, paved portion near the water's edge. (Bottom Right) There is moderate erosion at the bottom of the boat ramp; note that water levels were likely lower than typical at the time of the survey.*

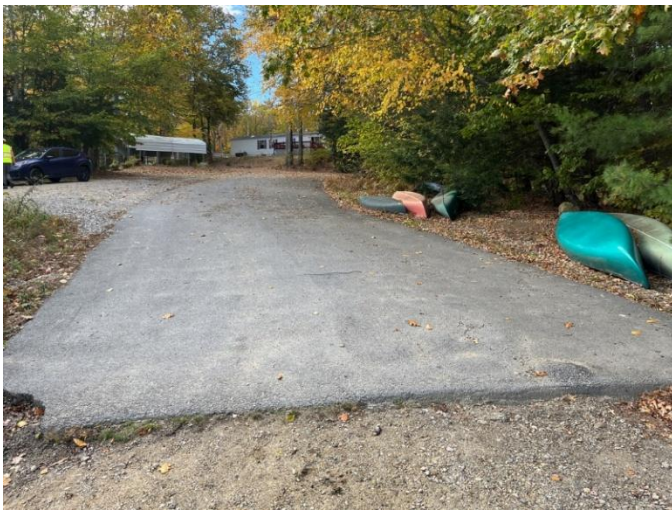
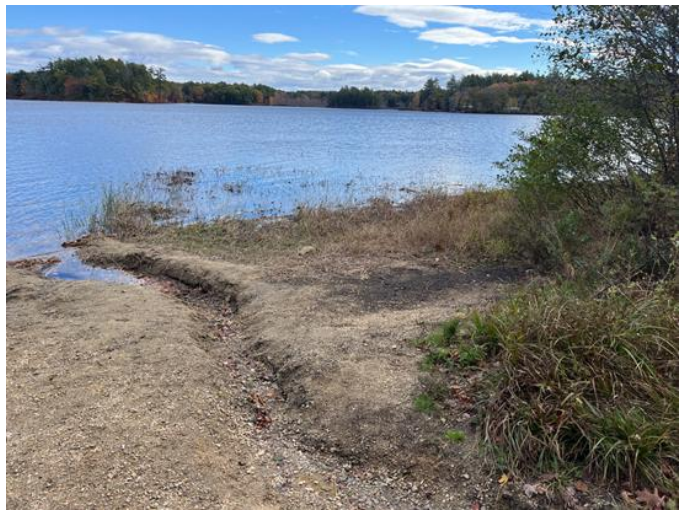
*(Right) The steeply sloped paved area directs stormwater to the lake. (Left) A large gully has formed at the bottom of the boat launch.*

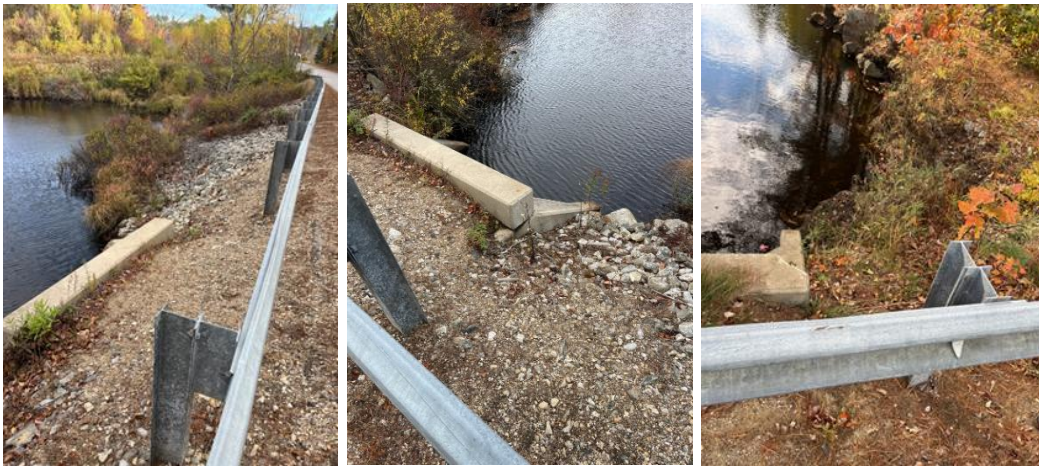
*(Left) The bare road shoulder above the culvert outlet site, (middle & right) stormwater has eroded the shoreline, providing paths for stormwater to directly enter Tucker Brook.*

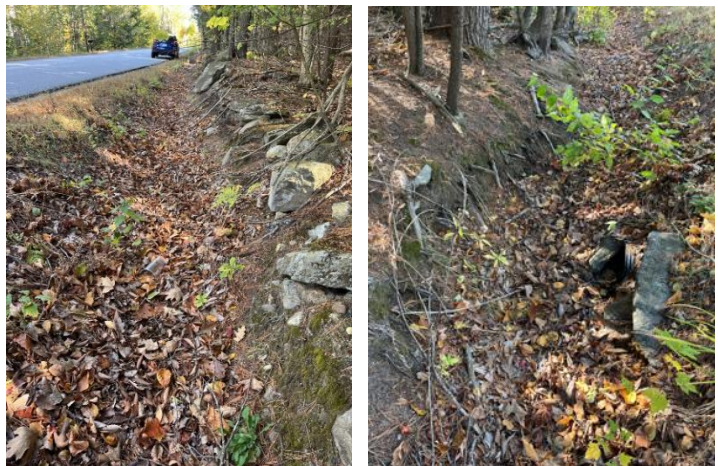
**Observations:** Though this is an intermittent headwater stream, the cross-road culvert on Ridge Road is partially blocked by a large stone and is filled in with leaves and sediment. This would likely cause stormwater to back up at the site and erode the backslope, which abuts the forest. Impacts to water quality are only minor at the site as the culvert outlet does not have a well-defined stream channel. Stormwater from the site would likely form the headwaters of Tucker Brook if a stream channel formed during high flows.

*(Left) Road shoulder erosion leading to a catch basin. (Right) The catch basin is nearly completely buried in gravel.*

**Recommendations:** Clean out the culvert and remove the large stone that is blocking it. Armor the culvert inlet, outlet and the backslope with rip rap.

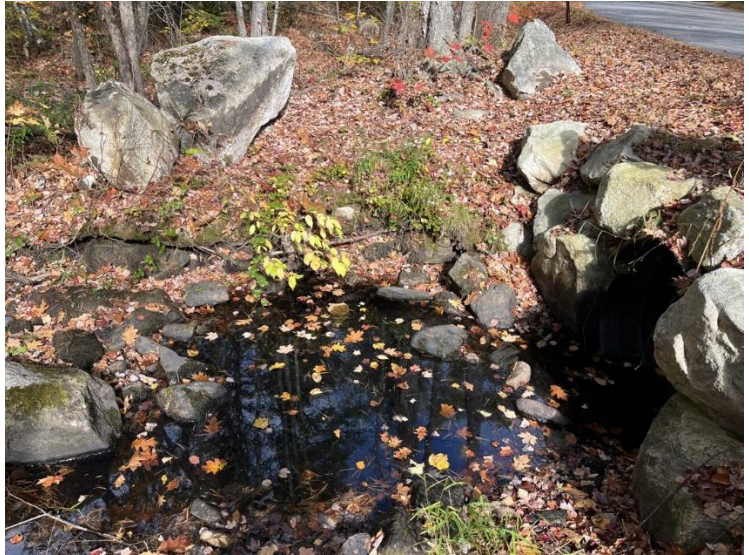
*An undersized culvert is causing bank scours at the culvert outlet.*

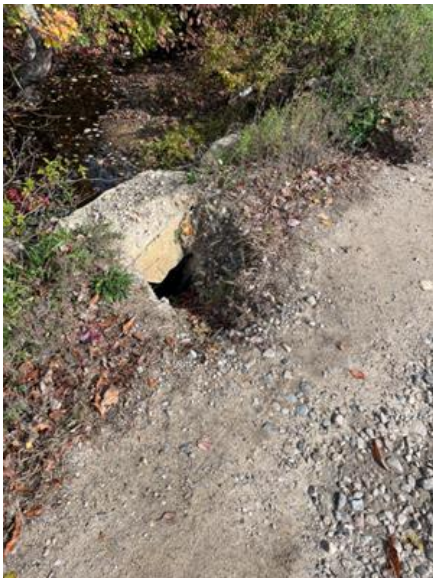
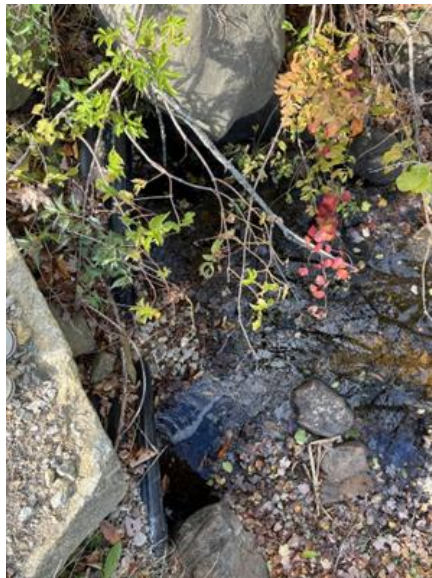
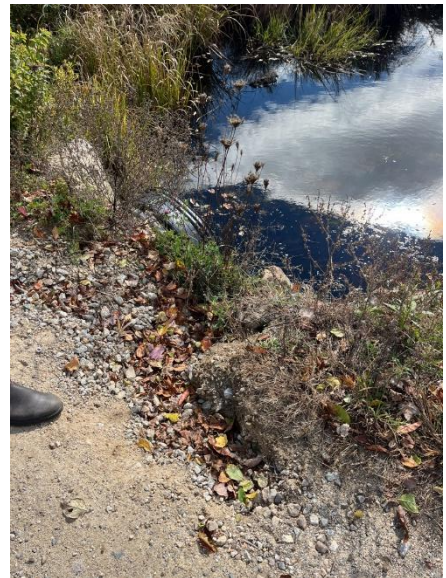
**Observations:** Severe erosion was observed at the culvert outlet on Olde Canterbury Road, and minor erosion was observed at the culvert inlet. There are twin culverts at the site that carry Kelsey Brook under Olde Canterbury Road near its confluence with Narrows Brook.

*(Left) Severe erosion at the culvert outlet. (Middle) View of twin culverts. (Right) There is minor erosion at the culvert inlet.*

**Recommendations:** Stabilize the culvert inlet and outlet with rip rap to prevent future erosion. Consider recrowning the road. Berms along the road shoulders may be used to direct stormwater into vegetated areas rather than directly into the stream at the culvert inlet and outlet.

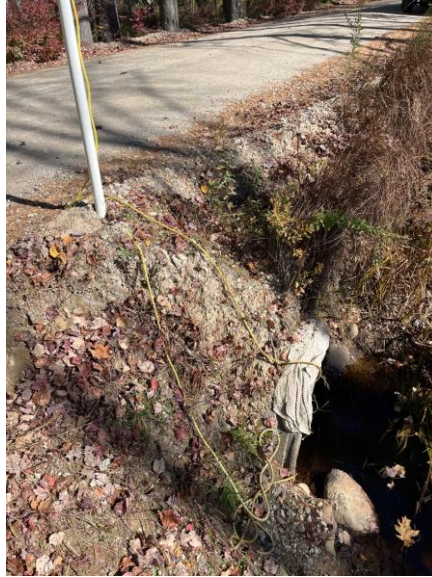
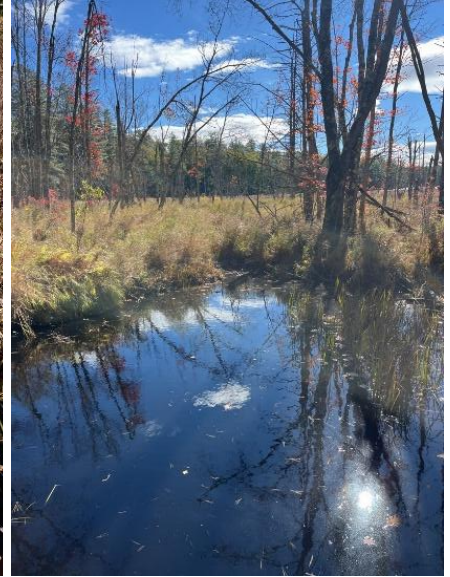
**Observations:** Long Pond Road directly abuts a stream crossing, which is part of a larger wetland complex upstream of Durgin Pond. Part of the stream bank at the culvert outlet is eroding. On the road surface, a berm was installed to prevent stormwater from entering the stream, instead directing it into vegetated areas along the stream bank. Stormwater bypasses the berm in some locations and is eroding the bank

*(Left) The streambank at the culvert outlet is eroding, partly due to a crumbling berm. (Right) The stream is part of a larger*

**Recommendations:** Reinstall the berm and stabilize bare soil at the culvert outlet, either using live stake plantings or rip rap.

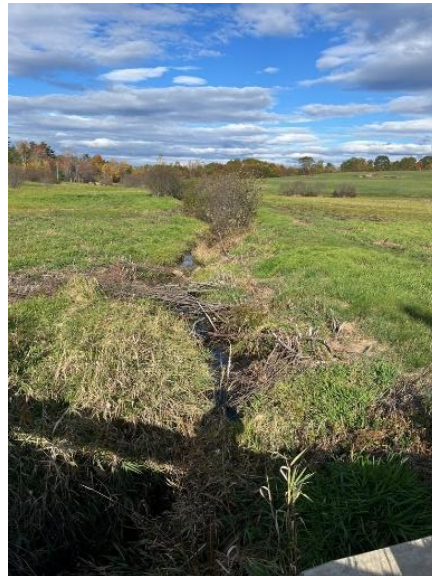
**Observations:** Griffin Brook lacks an adequately wide and dense riparian vegetated buffer on a private agricultural land near its crossing with Route 107 and Ritchie Road. Much of the riparian buffer is mowed grass. Where there are shrubs, the buffer is only as wide as one plant.

*Griffin Brook lacks a riparian buffer on an agricultural property.*

**Recommendations:** Consider improving the buffer to 20-50 feet on each side of the stream to allow agricultural runoff to be intercepted and nutrients retained by the plants rather than entering Griffin Brook. Use native plants and shrubs as recommended in the [Native Shoreland/Riparian Buffer Plantings for New Hampshire guide](#) to stabilize the soil and decrease nutrient laden runoff from entering Griffin Brook.

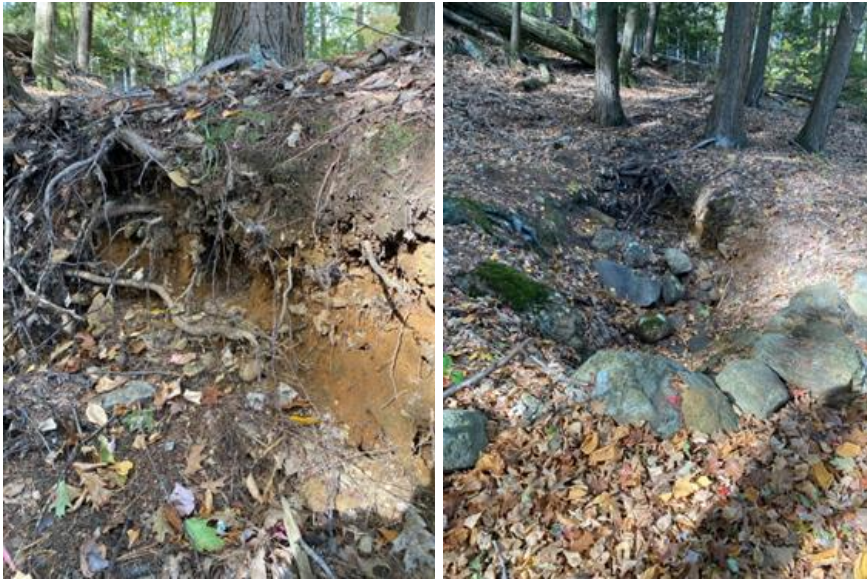
*(Left) The upgradient side of the culvert showing the large, eroded basin. (Right) View of the eroded soils and exposed tree roots on the upstream side of the culvert.*

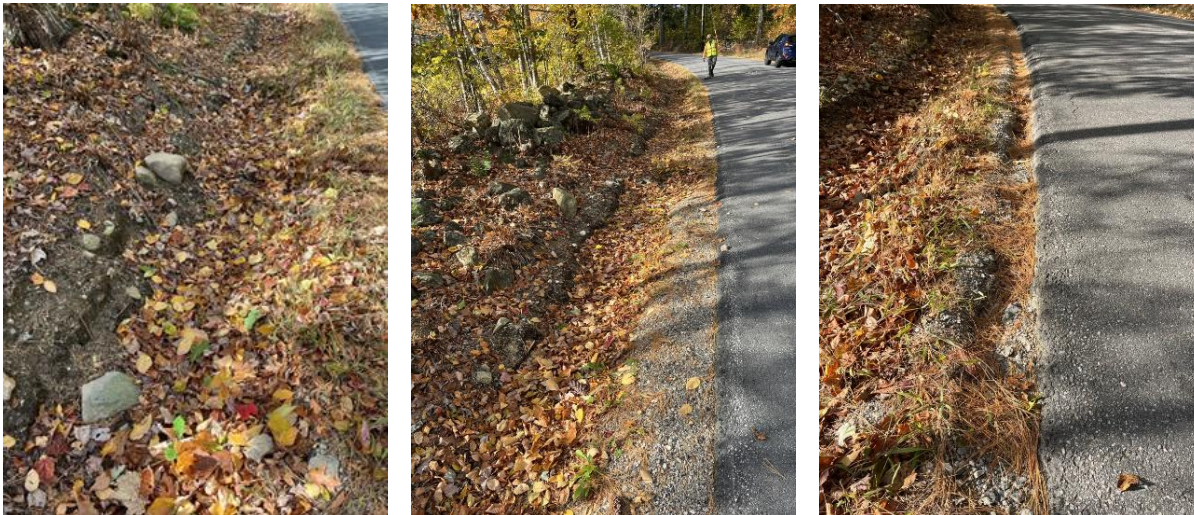
*(Left & Middle) A well-defined gully is present in the road shoulder ditch, which is typically bare, but was filled with fallen leaves at the time of the survey. (Right) The road shoulder of Harmony Road is eroding into the ditch.*

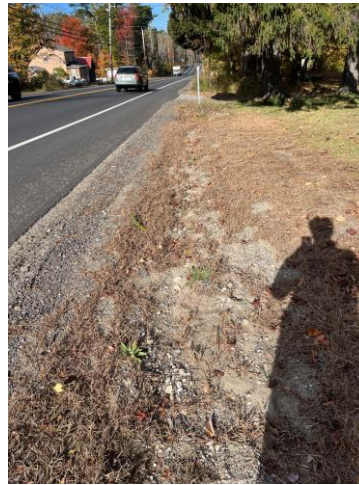
**Observations:** There is moderate road shoulder erosion on the north side of Route 4 between Gary Road and Town Works Way. The erosion channel cuts through the sandy gravel in the road shoulder and a nearby lawn, leading to a blocked catch basin; the catch basin is filled with sediment and blocked at the surface by gravel. Erosion begins at the mailbox of house 702 and extends west to the following driveway.

*(Left) Road shoulder erosion leading to a catch basin.*

**Recommendations:** Clean out the catch basin and remove debris/gravel from the grate. Enlarge the catch basin area and stabilize the catch basin with rip rap. Check dams may be used across the road shoulder ditch to slow stormwater and settle out sediment before reaching the catch basin.

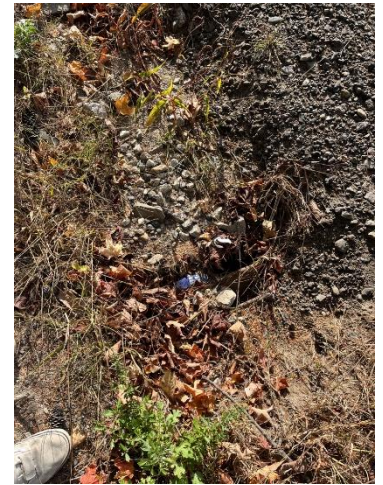
*(Right) The catch basin is buried in gravel.*

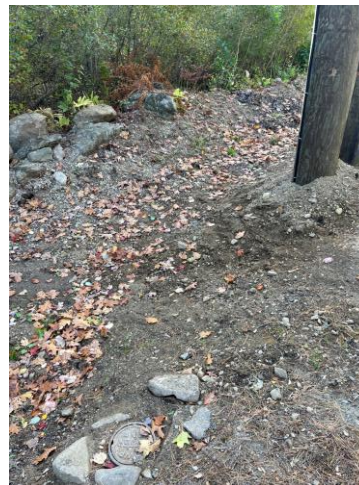
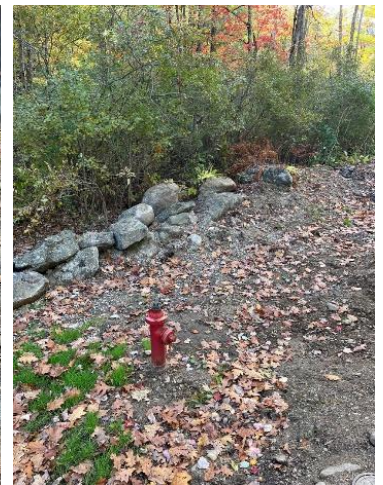
**Observations:** The road shoulder ditch on Ridge Road has exposed, bare soil and minor erosion. Downhill of this ditch, there is a vegetated swale with minor erosion. It appears that recent work was done on the utility pole, which may account for some of the bare soil in the ditch.

*Bare soil areas in the road shoulder ditch.*

**Recommendations:** Seed the ditch to create a grass swale and stabilize loose soil.

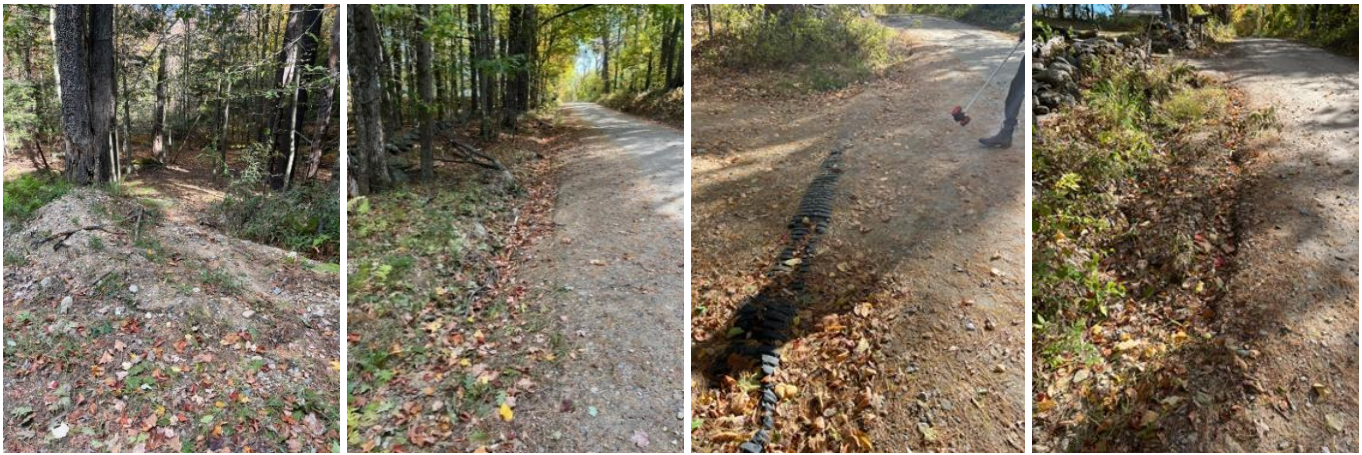
(1) The turnout on Range Road has accumulated sediment at its end. (2) The road shoulder ditch is eroding. (3) An under-driveway culvert is exposed. (4) The road surface of Range Road is eroding.

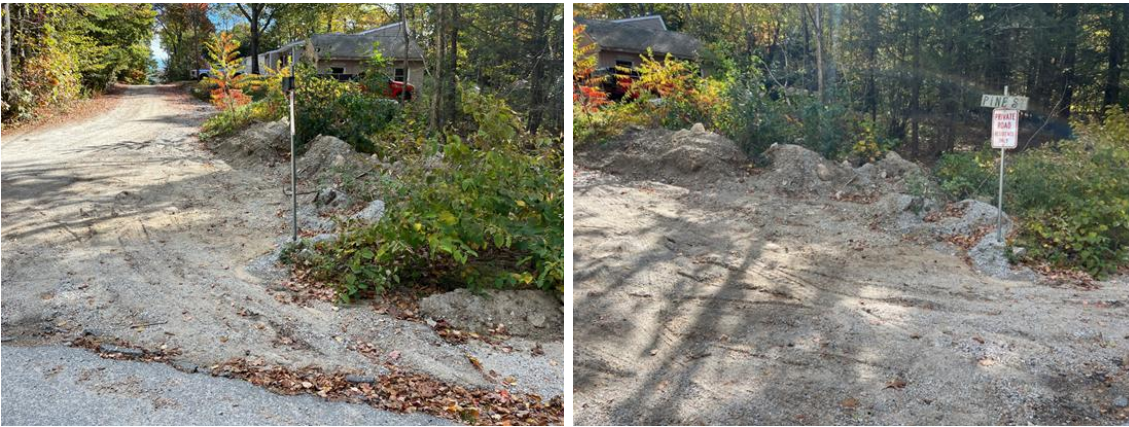
*Stormwater and/or winter plowing on Pine Street carries sediment down to the intersection with Harvey Lake Road.*

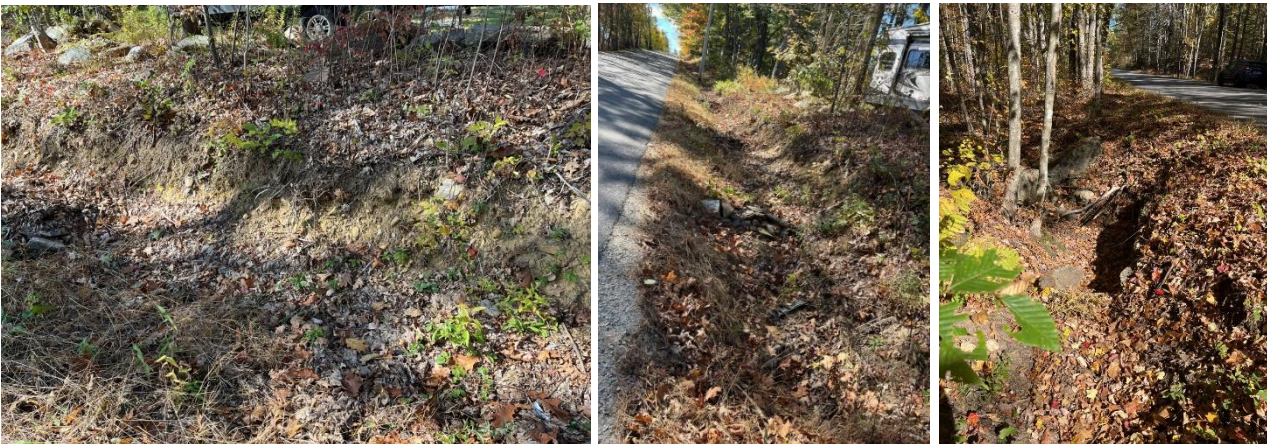
**Observations:** There is minor ditch erosion on Jenness Pond Road. In some stretches, the ditch is bare (beneath the leaves). This ditch leads directly to an intermittent stream. There is one check dam installed further uphill at the site. The intermittent stream likely flows into Durgin Pond.

*(Left) The backslope of the road shoulder ditch. (Middle) The ditch on Jenness Pond Road. (Right) Stormwater from the ditch enters the intermittent stream at the culvert.*

**Recommendations:** Reshape the ditch into a U-shape and armor it with rip rap. Use multiple check dams to slow stormwater flow and settle out sediment before it reaches the stream.

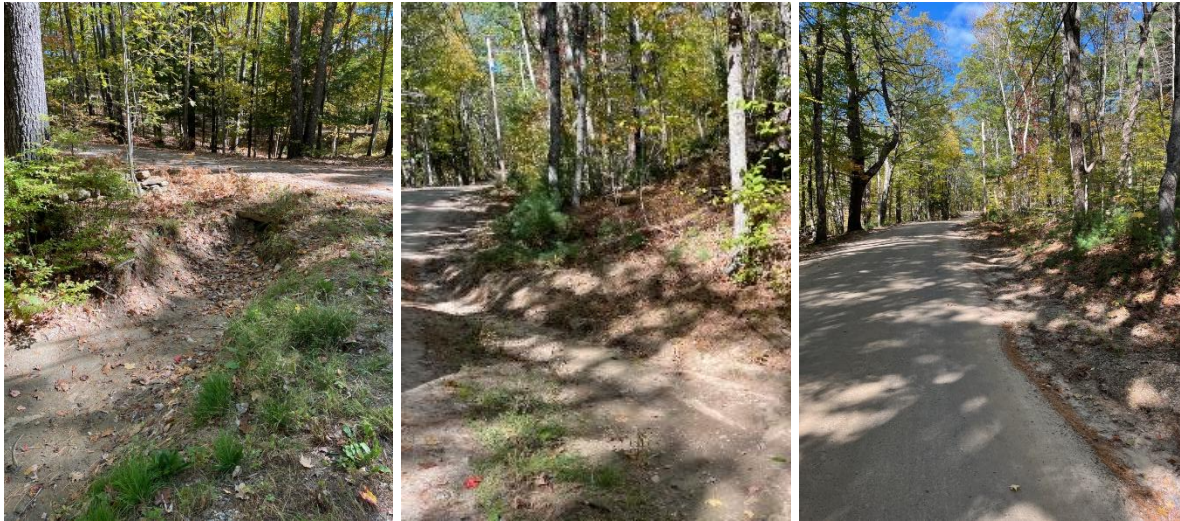
*(Left) The culvert inlet has bare soil. (Middle) The end of the gully is a wide, bare soil area. (Right) The gully extends 500 feet up the road.*
