# Northwood Lake

## DRAFT Watershed-Based Management Plan

August 2026

Prepared by  
FB Environmental Associates

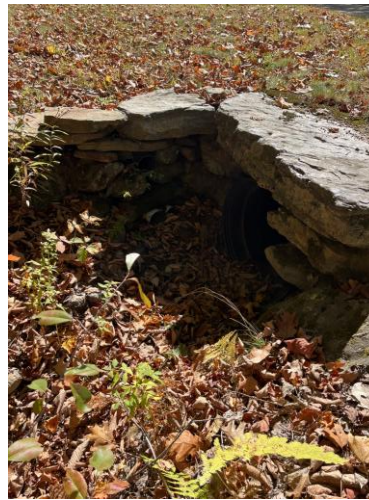
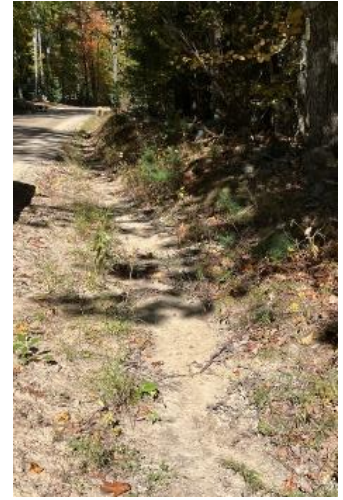
**Observations:** The road shoulder on Clough Road (unpaved) is eroding, depositing sediment into a nearby stream channel. At the culvert outlet of the stream crossing, the banks are slightly incised, suggesting that there may be high or flashy stormwater flows here. There are also three pipes leading to the culvert from a nearby home; the sources of these pipes are unknown.

*(Left) Three pipes appear to route water from a nearby home to the culvert inlet. (Right) Road shoulder ditch erosion at the site.*

**Recommendations:** Remove accumulated sediment from the road shoulder ditch. Vegetate the road shoulder wherever possible. Armor the road shoulder ditch with rip rap where vegetation is not feasible. Install check dams across the ditch and at the end of the ditch to slow down stormwater and settle out sediment. Investigate the source of the three pipes and consider re directing pipe outflows into residential BMPs. For examples of residential BMPs, see the [New Hampshire Homeowner's Guide to Stormwater Management](#).

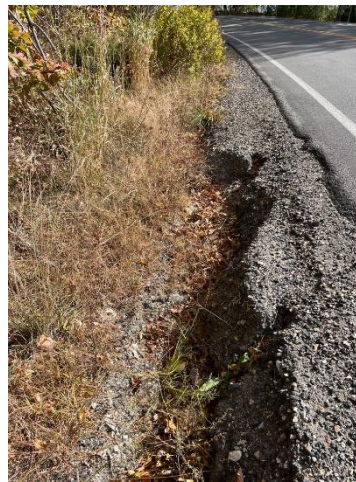
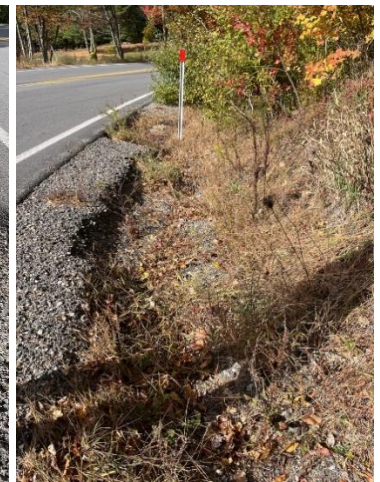
**Observations:** Very heavy road shoulder material is eroding into a catch basin on Catamount Road. Based on the weight of the material and design of the catch basin, it is likely that this stretch of the road experiences high stormwater flows. This catch basin is located in a headwater stream area.

*Road shoulder erosion on Catamount Road. Eroded material enters a catch basin designed for high stormwater velocities.*

**Recommendations:** Re-form the road shoulder ditch with more erosion resistant material, such as rip rap. If needed, convert the road shoulder ditch into a paved swale, and route stormwater from the catch basin to an engineered BMP downhill where it can be treated. An engineered BMP may be an infiltration basin, a vegetated swale basin. A standard rain garden may not be large enough to handle the amount or velocity of flow capable of causing this erosion.

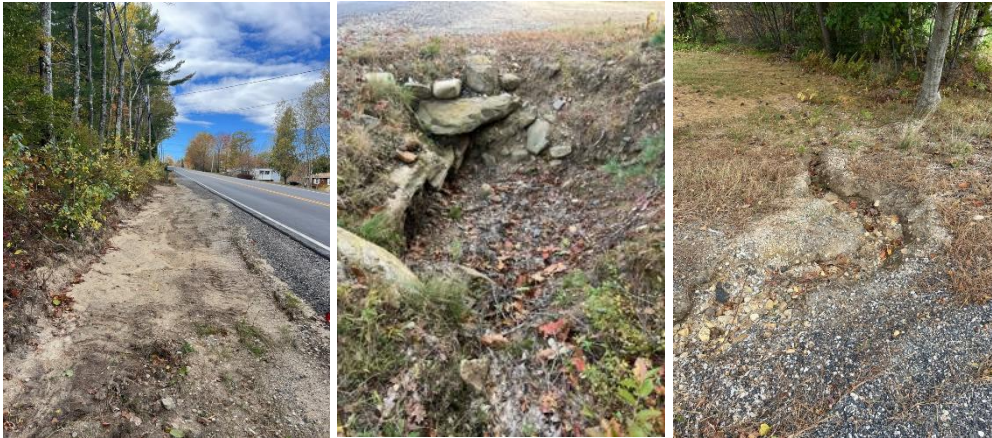
*(Left) The road shoulder is composed of loose, bare sand. (Middle) The culvert inlet also shows signs of erosion. (Right) The gully created by the outflow.*

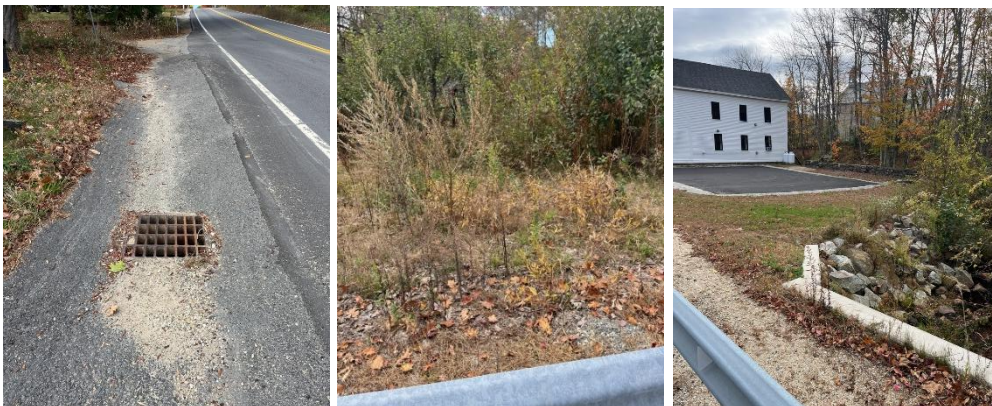
*(Left) Sediment from the road enters the catch basin through the paved swale. (Middle & Right) Vegetated areas that may be used to infiltrate stormwater.*

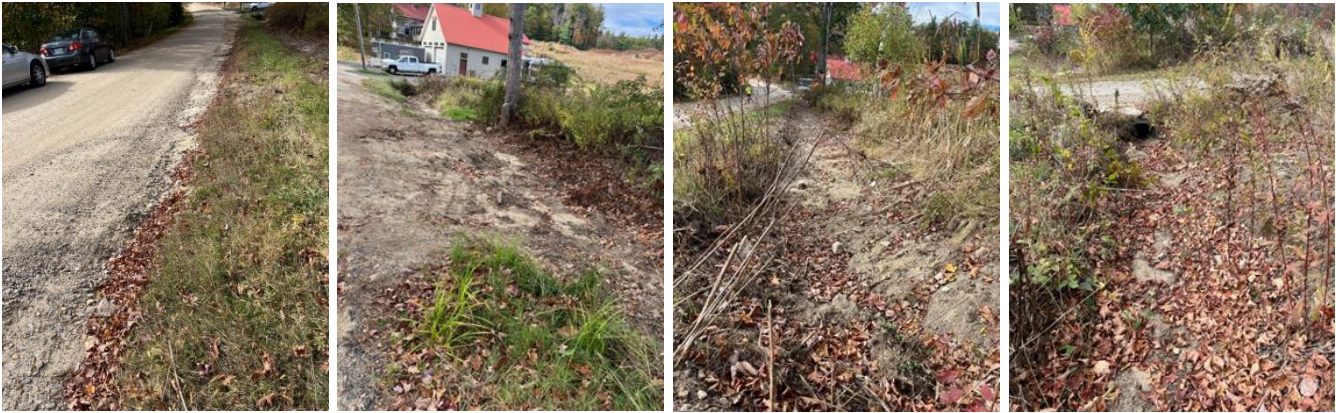
(Photos 1-3) Road surface erosion in addition to road shoulder ditch erosion. (Bottom Left) Stormwater is eroding the road surface. (Photo 4) Stormwater enters water resources through a culvert.

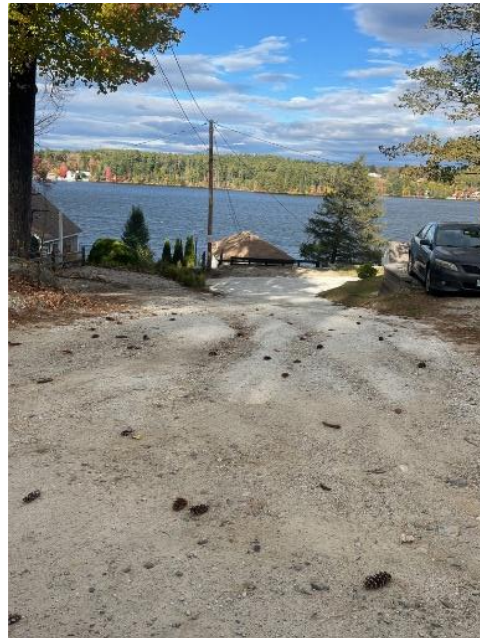
**Observations:** Moderately sized erosion gullies were observed on Lynn Lane, carrying sediment directly to Northwood Lake.

Road surface erosion on Lynn Lane leading to Northwood Lake.

**Recommendations:** Stormwater control measures such as a broad-based dip or water bars may be used to divert stormwater to road shoulders and other designated areas for infiltration. Assess if there are open space areas downhill (possibly private property) to infiltrate stormwater and filter sediment and nutrients. Consider removing excess impervious cover downhill if needed to accommodate an area to infiltrate stormwater.

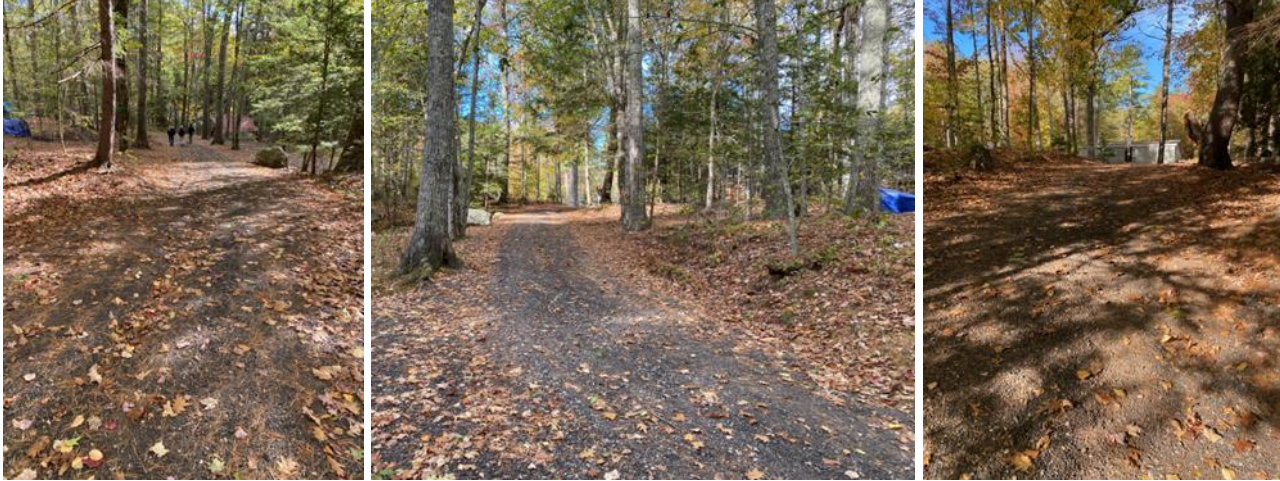
**Observations:** Frary Road (unpaved) is known to wash out frequently with rain events, causing a loss of surface material. Frary Road was resurfaced earlier in 2025, and there is a small drainage ditch on the eastern side of the road behind the houses that leads to the lake.

*(Left) Looking down Frary Road, (center) looking up Frary Road, (right) looking up Frary Road near the top.*

**Recommendations:** To prevent future washouts, consider installing water bars across Frary Road to direct stormwater runoff into the adjacent forested area.

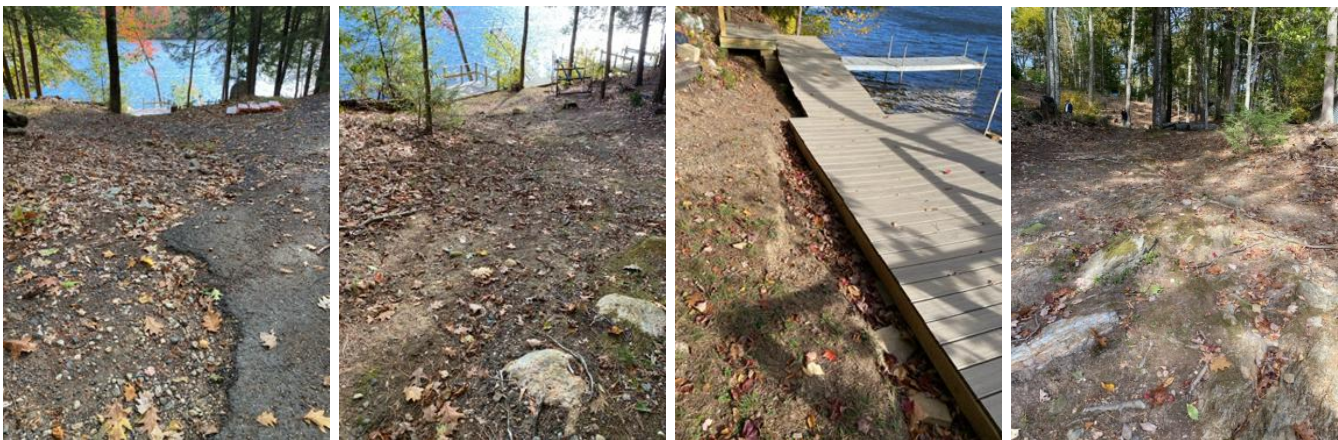
*(Lef two) Lagoon Road slopes steeply to the side towards the lake. (Right two) Gullies lead to the dock along the water.*

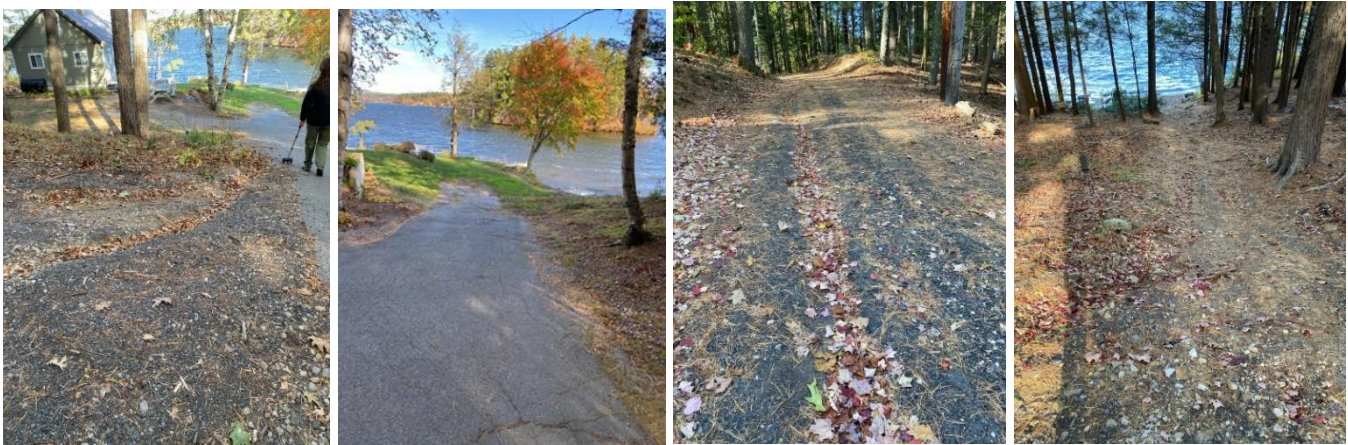
(1) Gullies were present along Pine Point Road leading to the north east bend in the road to a steeply sloped driveway in the second photo. (3) Gullies were also present on the northern stretch of Pine Point Road that lead to an unpaved walkway straight down to the lake (4).

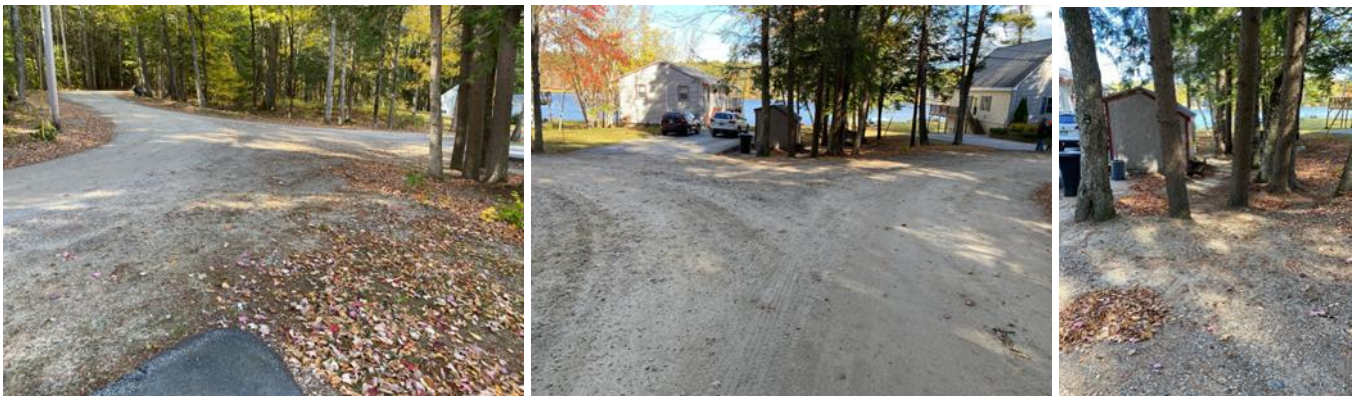
**Observations:** A wide (unpaved) intersection on Sleepy Hollow Road is present where the primary road splits in two directions to access the shoreline homes. A small stormwater erosion gully was observed through the patch of pine trees behind the small shed, likely coming from sheet flow across the roadway. Further up the hill on Sleepy Hollow Road, away from the lake, the road shoulder directed stormwater flow to a turnout which seemed to be working well as sediment was observed in the turnout and in the nearby wooded area.

*(Left) Sleepy Hollow Road intersection looking up the roadway where it splits to access shoreline properties. (Middle) Sleepy Hollow Road intersection looking downhill, towards Northwood Lake. (Right) Stormwater flows through the patch of pine trees behind the little shed.*

**Recommendations:** Create additional turnouts along Sleepy Hollow Road further downhill from the first. Consider re-grading the road surface to direct stormwater off to the side rather than down the roadway. Consider re-grading the two arms of Sleepy Hollow to drain to the uphill side, away from Northwood Lake into an established road shoulder stabilized with vegetation.

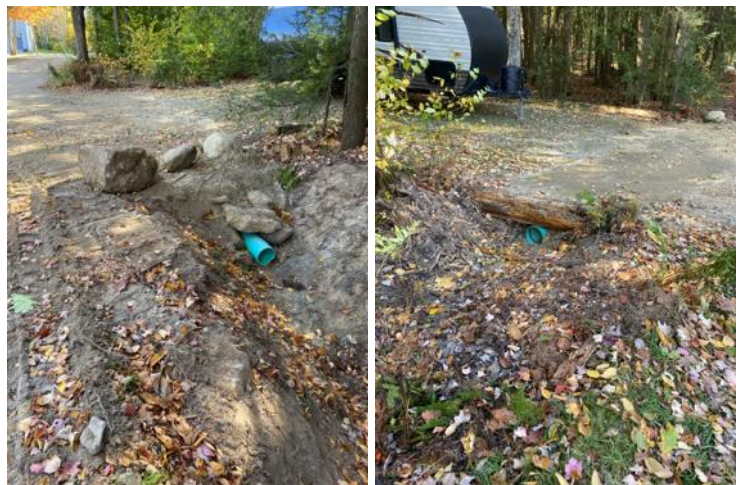
**Observations:** A relatively new stormwater infiltration basin/ditch has been established along the eastern arm of Sleepy Hollow Road next to a driveway on the southwest side of the road. The soil surface of the dug area does not appear to be stabilized, though boulders were placed at the top for vehicle safety.

*Eastern (left) and western (right) views of the small infiltration area.*

**Recommendations:** Add large, crushed stone to the basin's walls and bottom to stabilize the loose soil and prevent erosion. Additionally, the basin could be seeded and planted with water-tolerant plants and shrubs.

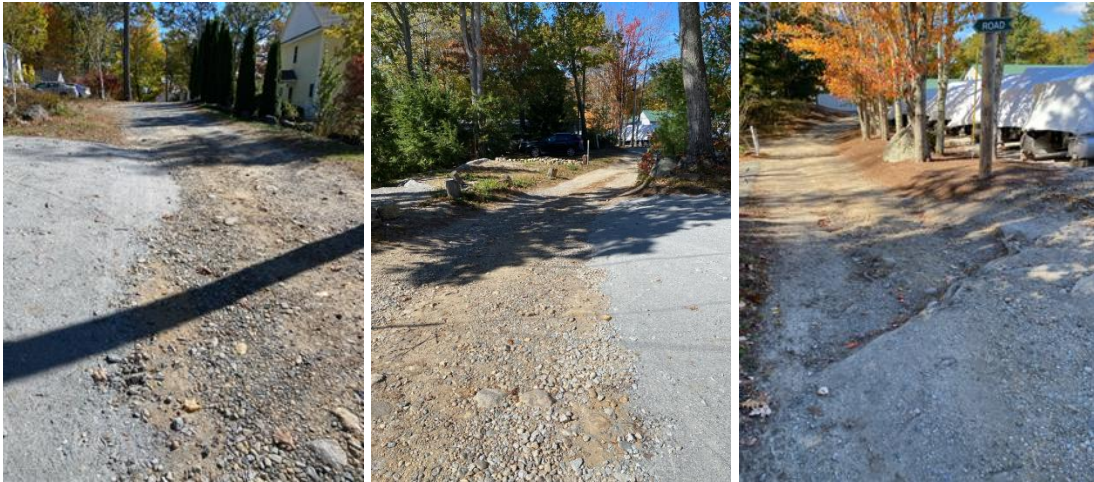
**Observations:** Lake Road, located behind the boat yard is a combination of both paved and unpaved surfaces. Where unpaved, the loose sandy gravel surface has ruts, gullies, and is at a slightly lower elevation than the paved portion. This could be due to compaction, weathering, and/or erosion.

*(Left) Lake Road facing east, (middle) west, (right) and behind the boat yard.*

**Recommendations:** Regrade the unpaved section of Lake Road with crushed. Consider paving this area and creating infiltration basins within the road shoulders that are regularly cleaned out. Work with homeowners in this area to create residential BMPs for stormwater management to decrease the volume of water flowing across and down Lake Road.

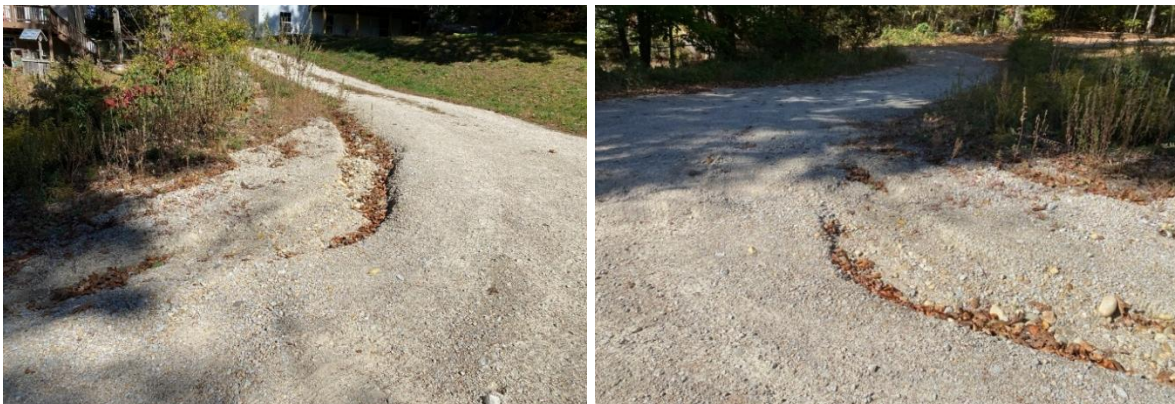
*Erosion gully at the base of the driveway turning onto Maple Avenue.*

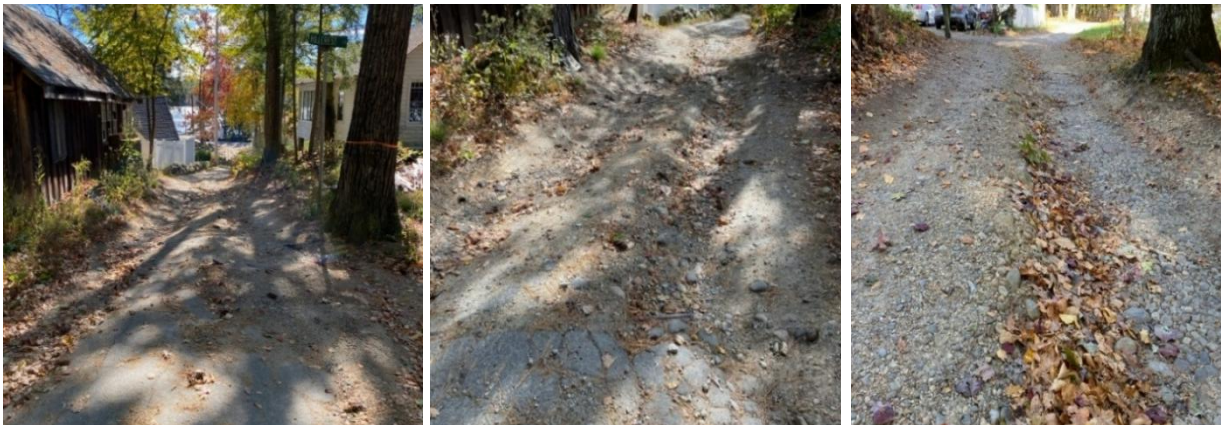
**Observations:** Park Avenue has experienced lots of stormwater erosion as evident in the long and deep gullies present which have left a prominent hump in the middle of the road. Park Avenue is not plowed in the winter or maintained during the other seasons. The road surface is comprised of hard compacted sediment and gravel. Smaller particulates have eroded away to more downhill areas towards the lake. A local resident shared that the road is used by many in the neighborhood and access is sometimes challenging, particularly for the year-round residents. Six years ago, the road was resurfaced but has not been maintained since, indicating all visible erosion occurred in the last six years.

*(Left and middle) Park Ave looking towards Lakeshore Dr. (Right) Park Ave looking uphill towards Sawyer Ln.*

**Recommendations:** Mitigating runoff and erosion at Park Avenue may be challenging due to road, neighborhood, and landscape characteristics which naturally appear to funnel high flows along the road. Collaboration with the neighborhood residents is crucial. We strongly recommend consulting with an engineer to develop a neighborhood site plan. Mitigation should not only focus on the road itself, but the sources of stormwater from residential roofs, driveways, and other areas. Beginning at the top of the hill, our preliminary recommendations are a broad-based dip or drivable berm across the road at the intersection of Sawyer Lane to divert runoff into vegetation to the east. Residential BMPs like gutters to French drains, water barrels (if emptied between storms), rain gardens, driveway rubber razors, and turnouts would decrease the volume of stormwater runoff entering Park Avenue. Once sources of stormwater runoff are mitigated, regrade the road surface and create a road shoulder ditch stabilized with rip rap and many check dams. Regularly clean any accumulated sediment, debris, and leaf litter from road shoulder ditches. Once the ditch and check dams are established, consider adding an infiltrating catch basin at the bottom of Park Avenue at Lakeshore Drive, as well as at the intersections of Hillcrest and Maple Ave and Maple Lane and Lakeshore Dr. Designate a responsible party to maintain all SCMs.

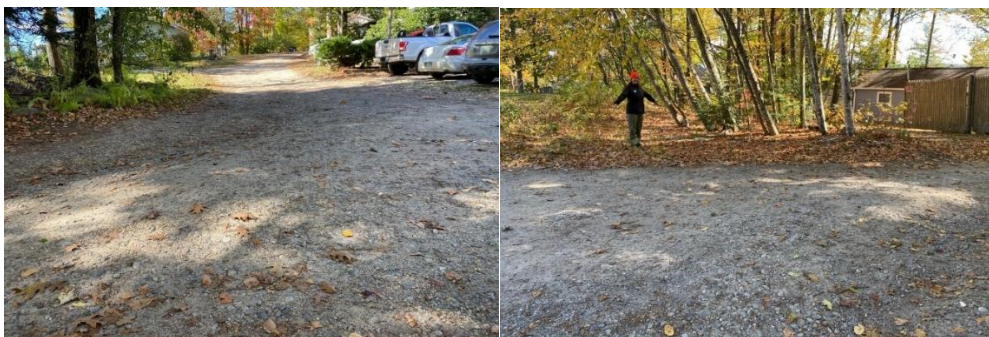
*(Left) Intersection of Park Ave and Sawyer Ln where the broad-based dip leading to the potential area for infiltration (right).*

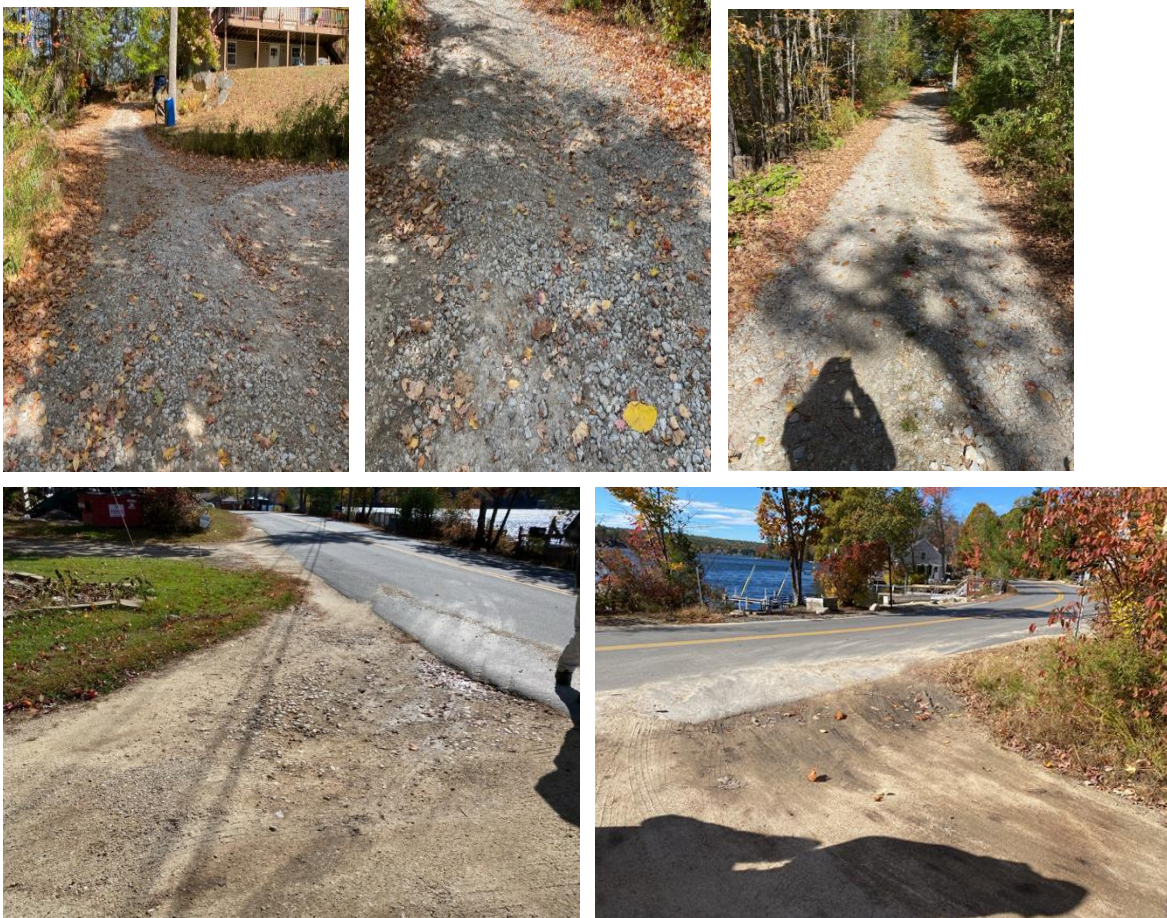
**Observations:** Wildwood Ave and Park Ave are the two most used roadways into this neighborhood off Lakeshore Dr. Wildwood Ave is unpaved and comprised of a more gravelly substrate than Park Ave. Uphill stormwater issues at sites NWL-36 and NWL-37 are contributing to the erosion occurring on Wildwood Ave, which has evidence of sheet flow erosion and channelization. The road was created less than 10 years ago and has not been maintained since.

*Photos of Wildwood Ave from the intersection with Maple Ave to the intersection with Lakeshore Dr. (paved).*

**Recommendations:** Work with residents in this neighborhood to establish a road maintenance committee. In conjunction with addressing recommendations for sites NWL-36 and NWL-37, consider installing rubber razors across Maple Ln to direct stormwater flow into the vegetated area to the west.

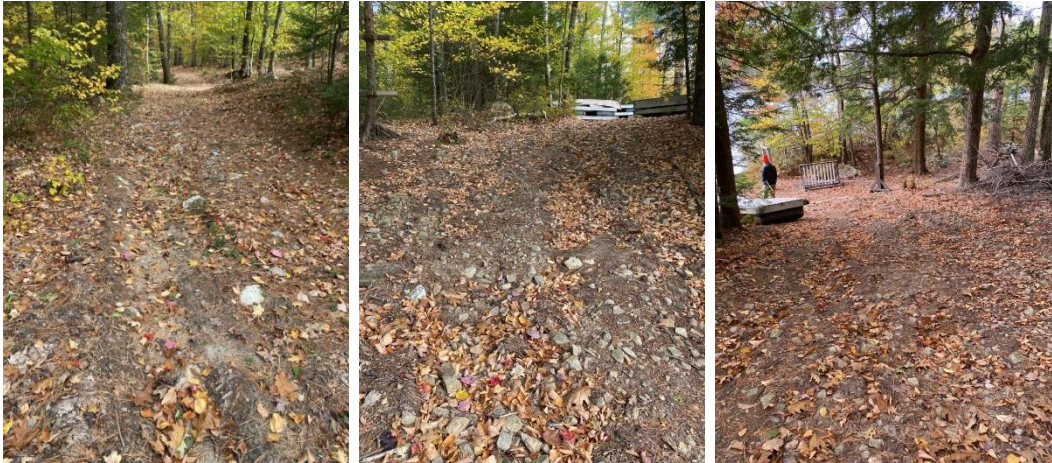
**Observations:** A gully was observed along the camp roadway that leads to the cabins (labeled as “Camp Conrad” on the camp map) and to a water access point. An accumulation of sediment was observed at the bottom of the hill near the docks.

*(Left) Camp road with gully, (center and right) camp road as it slopes down to the water from the dock storage area.*

**Recommendations:** Install broad-based dips or water bars along the camp road with turnouts to carry stormwater into the wooded area to the north of the road rather than continuing down the unpaved camp roadway. Consider creating a designated and stabilized pathway from the dock storage area down the slope to the flat area by the water’s edge.

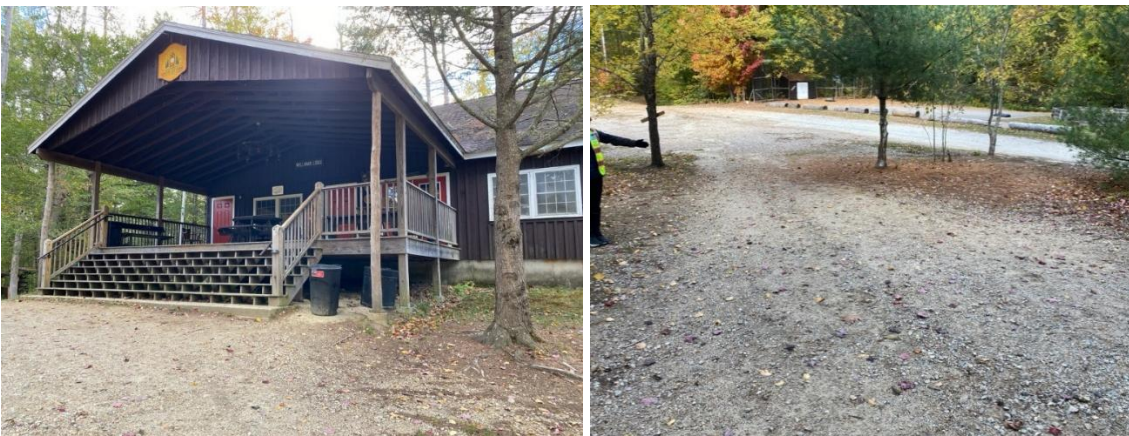
**Observations:** Runoff coming from lodge down towards the parking area washes away wood chips, exposing bare soil across the full path. Path continues to lead onto to site NWL-41, presented above.

*Williams Lodge (left) and the pathway that leads to it (right).*

**Recommendations:** Consider adding residential stormwater BMPs to Williams Lodge such as an infiltration dripline trench and a broad base dip in the pathway to divert water into a vegetated area, which could be reconfigured into a rain garden. Consider adding educational signage about the rain garden if installed.

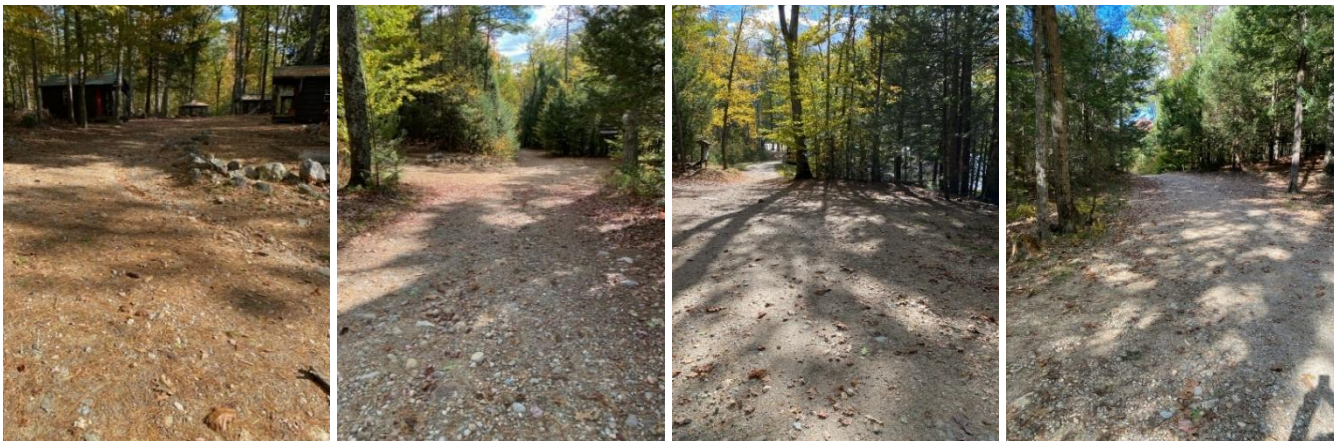
(1) Stormwater flow path coming from the cluster of cabins to the primary camp roadway (2). (3 and 4) Two of the three areas along the roadway where it widens and the infiltration basins could be created, minding snow maintenance needs.

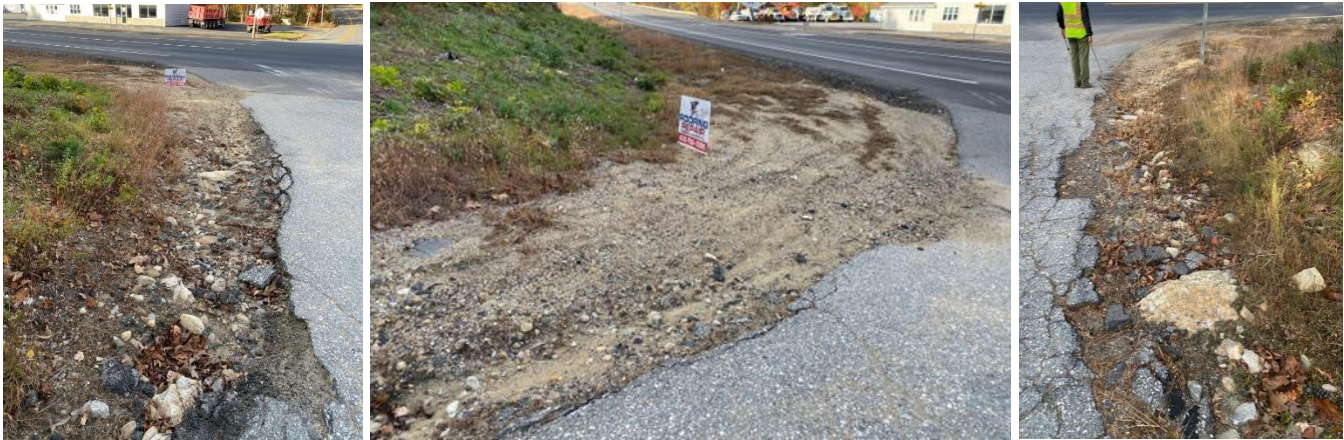
**Observations:** Two eroding gullies were observed along the road shoulders of Blake's Hill Road as it slopes to its intersection with Route 4. The road edge was also found to be crumbling into the road shoulder.

*Western road shoulder (left and right), and eastern road shoulder (right).*

**Recommendations:** Establish a road shoulder ditch, stabilized with rip rap, and crossed with check dams to decrease stormwater erosion and sediment transport. Depending on the amount of stormwater volume this site receives, consider also installing an infiltrating catch basin at the western corner (near the small advertisement sign in the first photo).

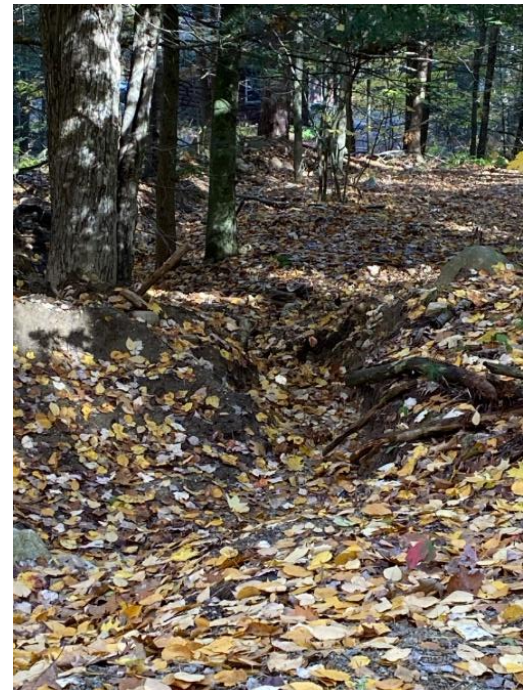
*The downhill view of the ditch/flow path with caving edges and exposed roots.*

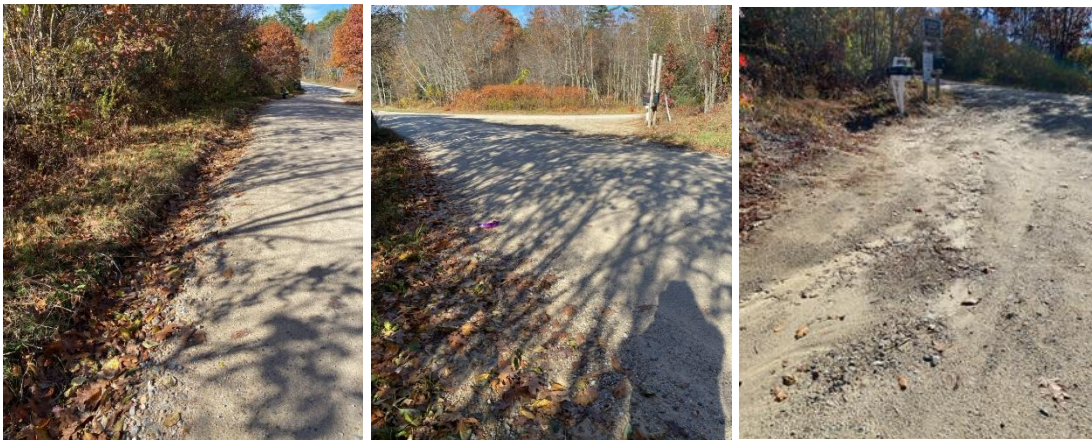
**Observations:** Road shoulder gully erosion was observed along Old Richie Road leading to Griffin Brook (the stream at site NWL-25) that flows through the mowed/hayed field. The gully travels down the hill and then across the road surface towards Northwood Lake Road. The road shoulder ditch has lost its finer sediments, which have been transported downhill and are deposited at the intersection of Northwood Lake Road.

*(Right) Southern road shoulder of Old Richie Road facing downhill towards its intersection with Northwood Lake Road (middle and right).*

**Recommendations:** Install a turnout at the top of the hill, near the opening into the hayfield but on the opposite side, so that stormwater flows on the uphill side of the rock wall and into the wooded area. Stabilize road shoulder from further erosion with large crushed stone and check dams. An infiltration area could be created near the mailboxes. Alternatively, consider re-grading the road away from the hayfield and install turnouts on the uphill side of the road before the steep edge on the northern road shoulder.

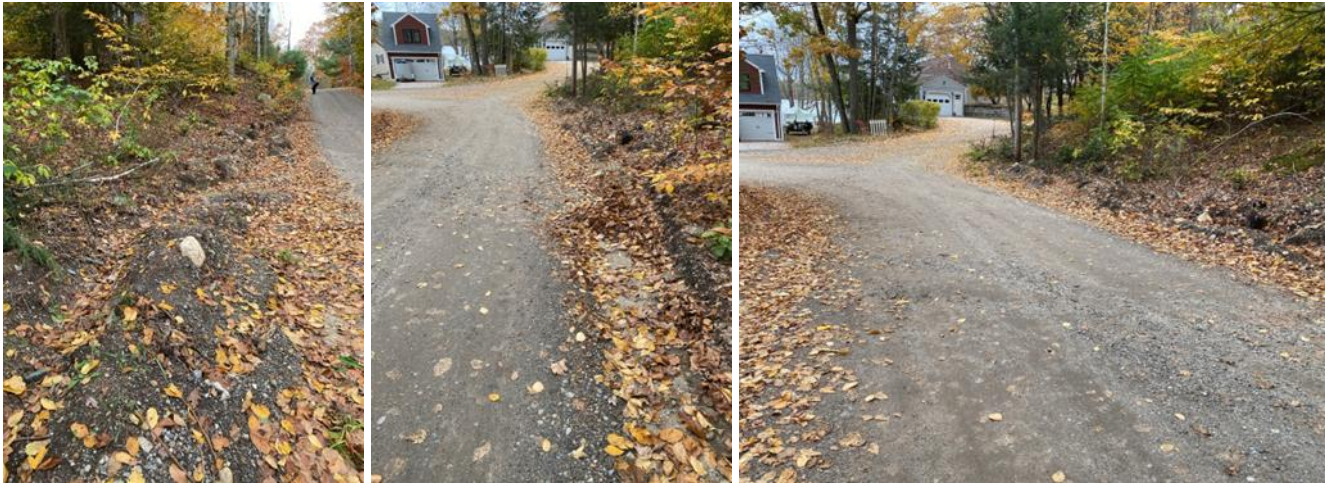
*(Left) Southern road shoulder gully looking uphill. (Middle) Southern road shoulder gully looking downhill. (Right) Flow path of the road shoulder flow crossing Birch Street to the intersection with Shore Drive.*

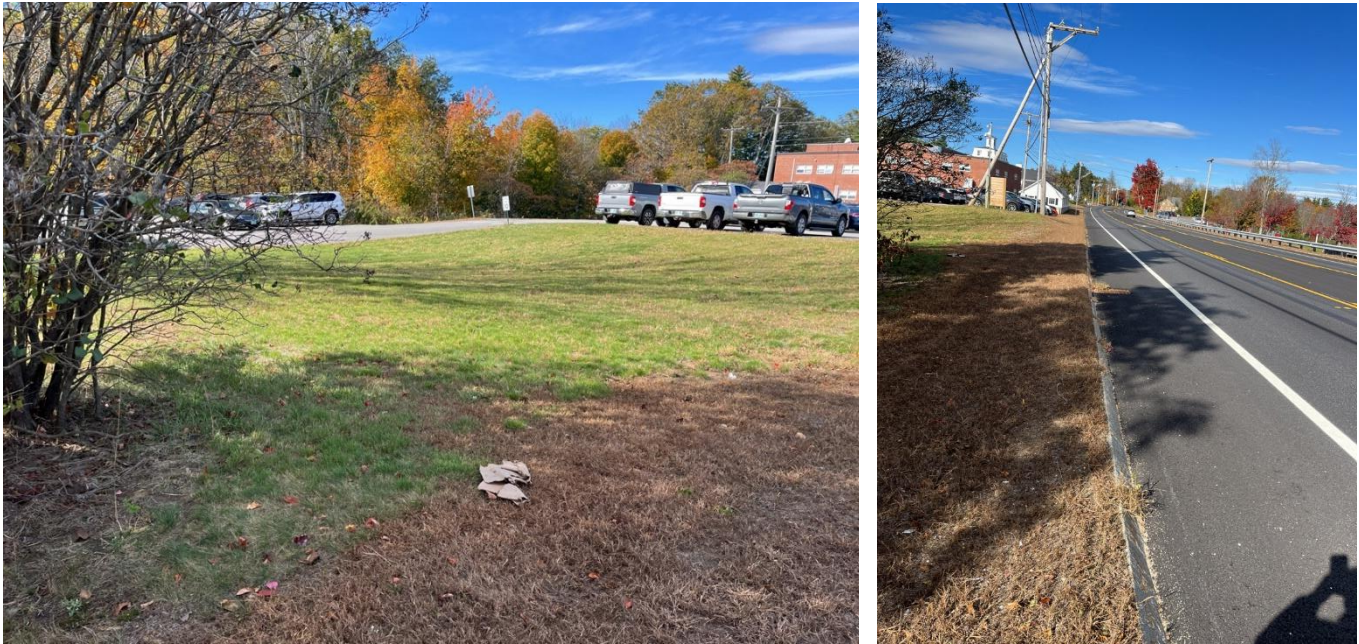
*(Left) Open area near parking lot may be used for a rain garden, vegetated swale or other engineered stormwater control measure. (Right) Untreated stormwater from Route 4 enters catch basins.*

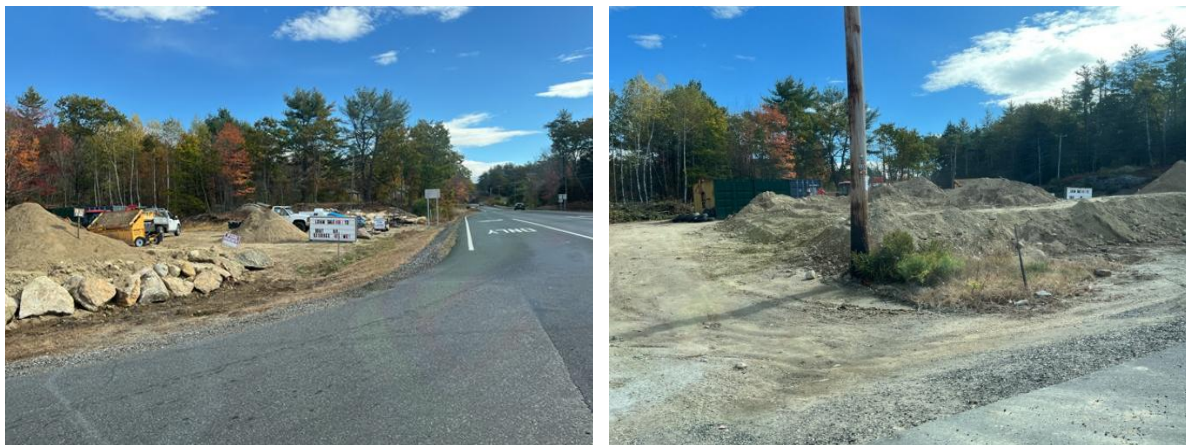
*Bare soil and sediment piles at the construction site on Route 4.*

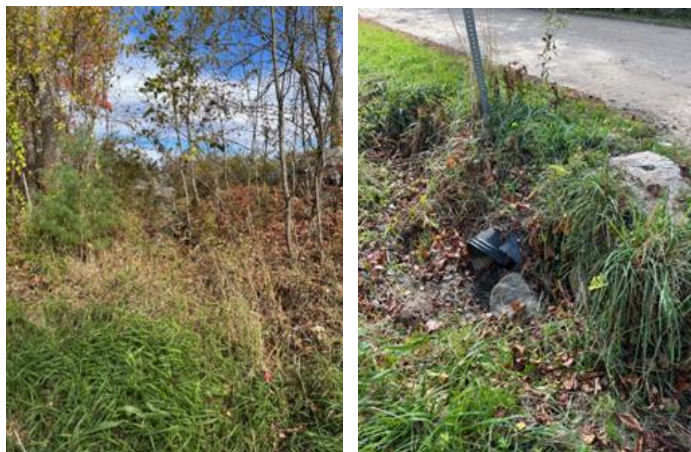
**Observations:** A small strip of rip rap was observed leading from an agricultural property on Catamount Road/Hill Road to a roadside ditch on Hill Road, suggesting that agricultural runoff likely follows this flow path to enter the road shoulder ditch. The ditch leads to a crossroad culvert that ultimately enters a headwater stream. There is minor road shoulder erosion on Hill Road, though eroded sediment is likely attenuated by the large amount of vegetation in the road shoulder ditch.

*(Left) Trail of rip rap leading from an agricultural property to the road shoulder ditch, obscured by vegetation in the photo. (Right) Slightly crushed culvert outlet at the site.*

**Recommendations:** Engage with farmers about agricultural BMPs and stormwater control measures that can retain and treat all stormwater onsite. The plastic culvert at the site is also crushed and may merit replacement.

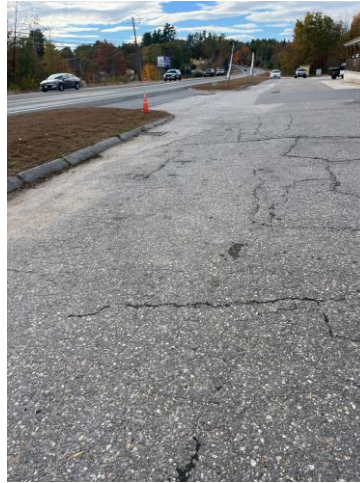
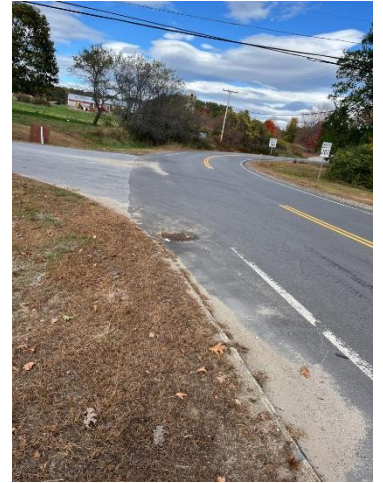
**Observations:** Catch basins on School Street and in the parking lot of the Heritage Market collect stormwater from impervious surfaces. Untreated stormwater contains pollutants from various sources such as atmospheric dust, winter sand, soil, automotive chemicals, leaf litter, other organic matter, and pet/animal waste. Large pervious surfaces also restrict infiltration and increase the volume of stormwater runoff traveling to more downhill areas.

*(Left) The catch basins in the market parking lot by the orange cone. (Right) The catch basin along School Street.*

**Recommendations:** Multiple opportunities exist to utilize engineered urban stormwater control measures onsite. On School Street, planter bump outs may be used to capture and infiltrate stormwater in the road shoulder apron. A large open space area is present adjacent to the parking lot, which could be converted to a rain garden, vegetated swale, or other engineered green stormwater infrastructure. There is already a catch basin in this area, meaning it is already connected to stormwater infrastructure. Investigate the location of the catch basin outlet(s). Engage with the property owner about winter salt use and opportunities for reducing the extent of impervious cover on the parking lot.

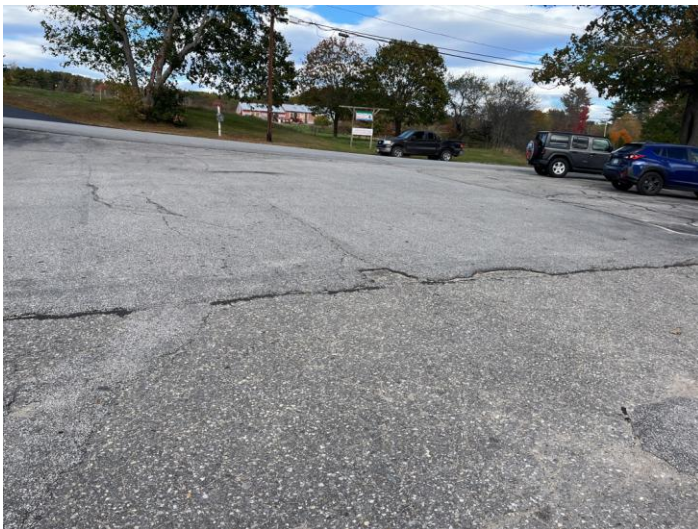
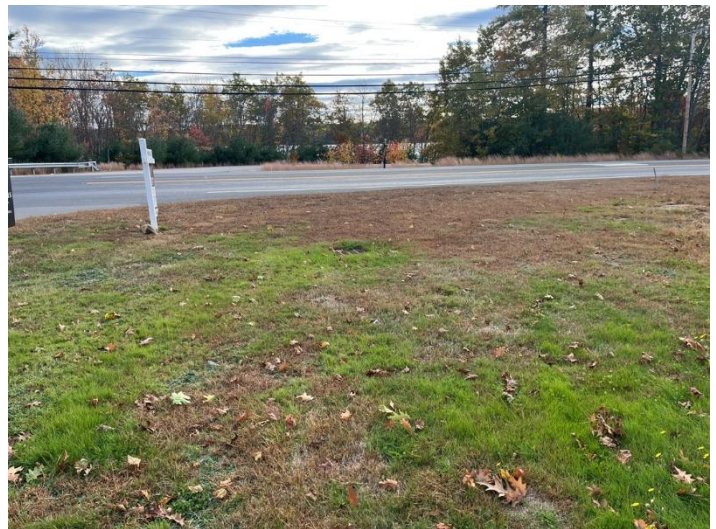
*(Left) The large impervious parking lot. (Right) An open space area with a catch basin in the center may be a suitable location for engineered green stormwater infrastructure.*

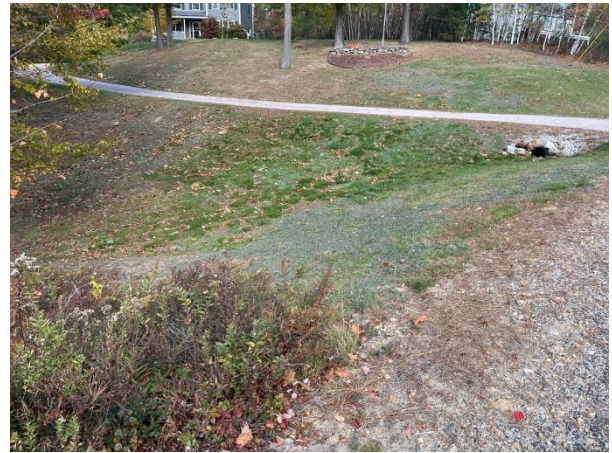
### Site NWL-24: McEvoy Lane

**Observations:** Stormwater from McEvoy Lane discharges through an under-driveway culvert and leads to a stream channel. No erosion was observed at the site. Improving vegetation at the site would enhance pollutant and nutrient uptake from stormwater and decrease pollutant loads downstream while also reducing the volume of stormwater reaching the stream.

*Stormwater exits the under-driveway culvert and enters the stream after traveling through a sloped, grassed area.*

**Recommendations:** Stormwater management could be improved at the site by increasing stormwater infiltration, through installations such as a rain garden or vegetated swale. Alternatively, letting the current vegetation grow freely between the culvert outlet and stream would provide additional pollutant filtering capacity and some nutrient uptake by plants. A minimal improvement would be to increase the mower height to at least four inches.

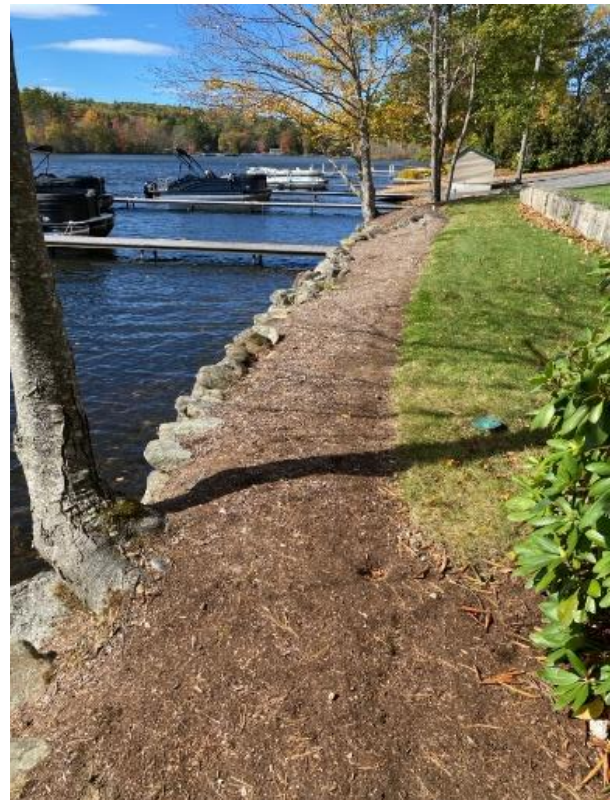
### Site NWL-33: Boat House

**Observations:** No vegetated shoreline buffer was observed along the boat house property at the marina. Only a few small plants were present. An apron of soil and mulch is present and ready for planting.

*The shoreline of the Boat House.*

**Recommendations:** Plant a vegetated buffer with native, deep rooting species for stability against winds and weather. Refer to the [Native Shoreland/Riparian Buffer Plantings for New Hampshire guide](#) for species suggestions. Ensure soil and mulch are not being pushed over the top of the retention wall and into the lake.

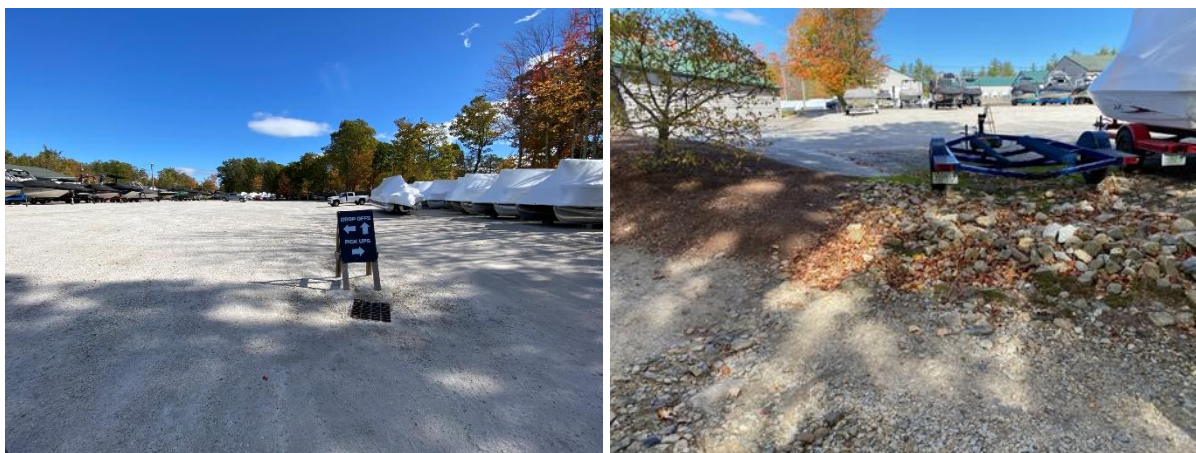
*The boat yard catch basin (left) and the original retention basin and breakthrough path during the watershed survey (right).*

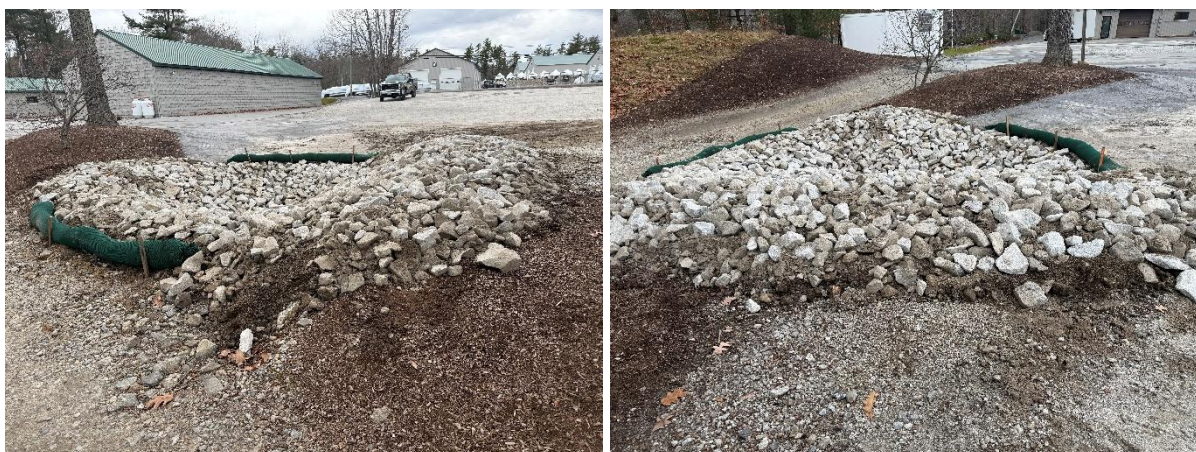
**Site NWL-34: Side of Boat Yard**

**Observations:** At the time of the watershed survey, a smaller retention basin was present at the south western corner of the boat storage yard. Stormwater that falls on the yard (paved) travels to a series of catch basins, but some also enters the south western corner of the lot. The previous retention basin was dug and lined with rip rap, but has since filled in after years of infiltrating stormwater and settling out sediment. Additionally, a small breakthrough channel was observed leading to Lake Road and the homes along the shoreline.

*Photos of the improved retention basin, deeper, lined with rip rap, and stabilized with coir logs. Photos provided by MacCallum's Boathouse.*

**Recommendations:** Following the site visit, the MacCallum's Boathouse staff promptly enlarged the retention basin by making it both deeper and wider, and building up the side walls to decrease the chance of breakthrough flow paths. A sediment coir log is also present along both the inlet and outlet sides to provide further stability and sediment/pollution retention capabilities. No further recommendations are provided at this time, great work!

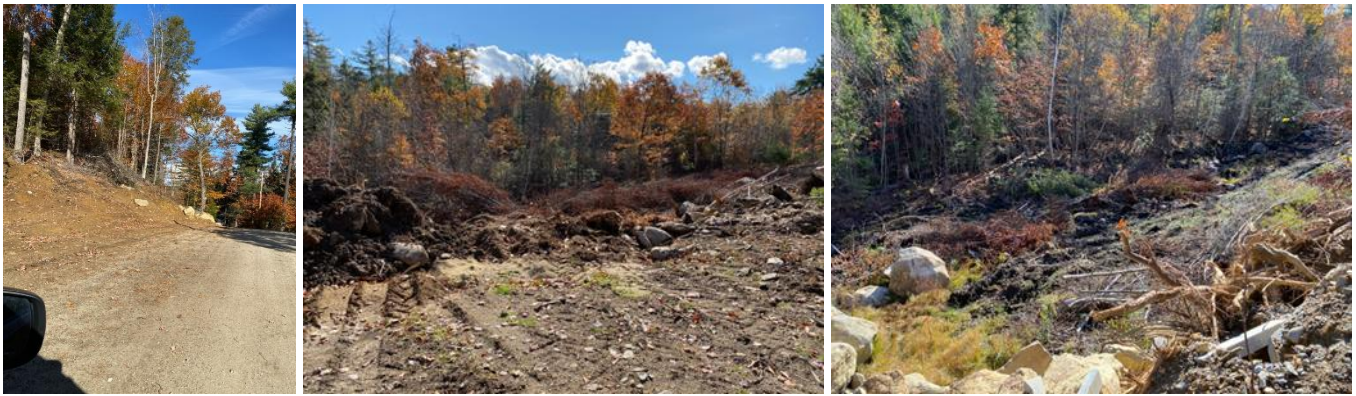
**Site NWL-49: Sand Pit Avenue**

**Observations:** A large clear-cut area was observed along the eastern side of Sand Pit Avenue not too far south from the intersection with Klopp Avenue. Large piles of slash and soil are present on this steeply sloped lot. A stream flows parallel to Sand Pit Ave at the bottom of the recently cleared hill. The stream has minimal buffer on the cleared side, debris within the stream, and no stormwater control measures were observed such as silt fences or coir logs to keep the disturbed land and slash from eroding into the stream and to Northwood Lake. There is approximately 400 feet of stream length between this site and Northwood Lake. The ground appears to be comprised of very loose soil.

*(Left) View north down Sand Pit Ave towards Klopp Ave. (Middle and right) the recent clear-cut and stream at the bottom.*

**Recommendations:** Contact the landowner and work to remove slash from the stream channel and to install erosion control measures along the stream bank. Ensure the future land use intended for this area has erosion control measures because of the steep grade down to the stream.
