# Northwood Lake

## DRAFT Watershed-Based Management Plan

August 2026

Prepared by  
FB Environmental Associates

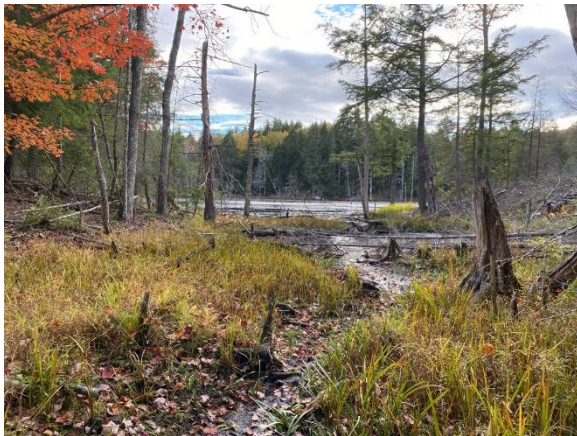
**Observations:** The quarry ponds located between Winding Hill Rd and Gulf Road were visited to determine the influence, if any, they have on Northwood Lake's water quality. During the visit, which was conducted in a drought, water levels in the ponds were very low, and were not discharging to an outlet stream. However, had the field visit been conducted during a wetter time of year, we would expect water levels to be higher and discharge could be possible.

(1) The first pond from an inlet stream. Water does not appear unusual, a lot of aquatic vegetation is present.

**Recommendations:** None. Continue to monitor the water quality of "the Gulf" tributary where it outlets into Northwood Lake.

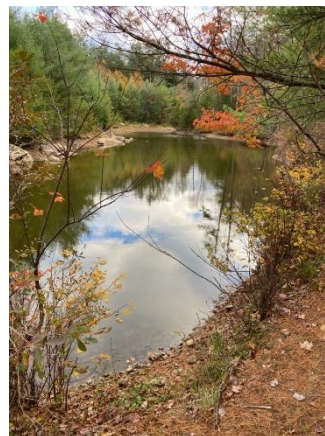
(2) The second pond has a greenish hue. Water level is low, no outlet was found.

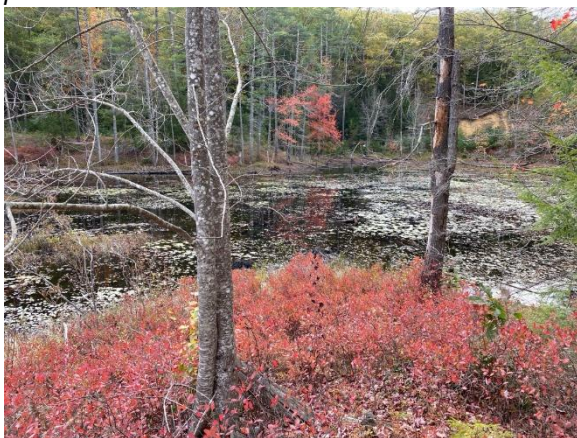
(3) The third pond also had lots of aquatic vegetation growing in it, and the water did not appear unusual. Water level was too low to outlet.

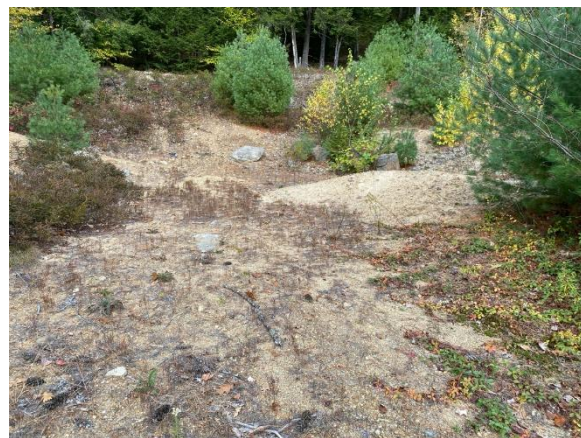
Loose sand piles were present to the east of pond #3, though a berm between the piles and the pond would keep any of this sediment from entering the pond.
