# Northwood Lake | Watershed Survey Results

**TO:** Brian Lobao, Northwood Lake Watershed Association (NLWA)  
**FROM:** Christine Bunyon, FB Environmental Associates (FBE)  
**SUBJECT:** **Northwood Lake Watershed Survey Results**  
**DATE:** July 23, 2026  
**CC:** Laura Diemer & Evan Ma, FB Environmental Associates

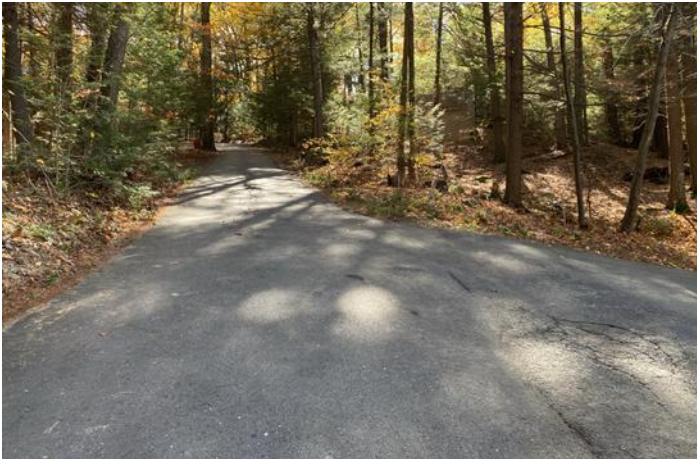
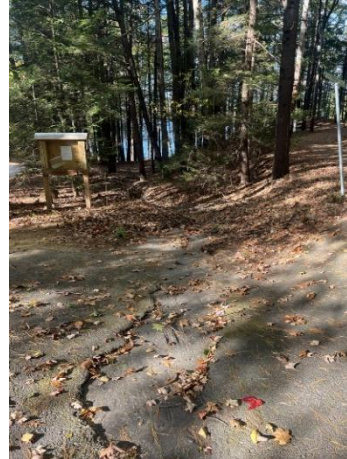
**Observations:** A community beach is present at the end of Cole Road. This beach has a small parking area, a large sandy beach area, and a clubhouse. Many stormwater management initiatives have been completed at this site already and are quite effective, transforming a potentially high impact site into a low impact site. Stormwater flows down the paved and unpaved sections of Cole road to the fork with Pine Point Lane. At this intersection, a paved swale was created to direct stormwater runoff into the forested area between these two roads. Stormwater then is directed via a riprapped swale to a series of infiltration basins. It is evident that the retention basins are working due to the accumulation of sediment within them and lack of large break-through flow paths. Eventually, stormwater might make its way to the last retention basin near the clubhouse steps where it would travel through a grate (next to the orange cone in the photo) and through a pipe that outlets about 10 feet from the lake.

*(Left) View up Cole Road with the paved swale in the bottom right corner, (right) the paved swale entering the forest.*

**Recommendations:** Continue maintaining the series of infiltration basins and check dams through the wooded area. To increase storage potential, periodically remove accumulated sand and debris from the retention basins and maintain as needed to the stabilizing edges. Deepen the last basin, closest to the lake, so the outlet serves as an overflow outlet rather than a drain. Consider adding water-tolerant plants this last basin as well to promote nutrient uptake. Consider adding an educational sign about the use of rain gardens for pollinators and stormwater/nutrient management for the lake.

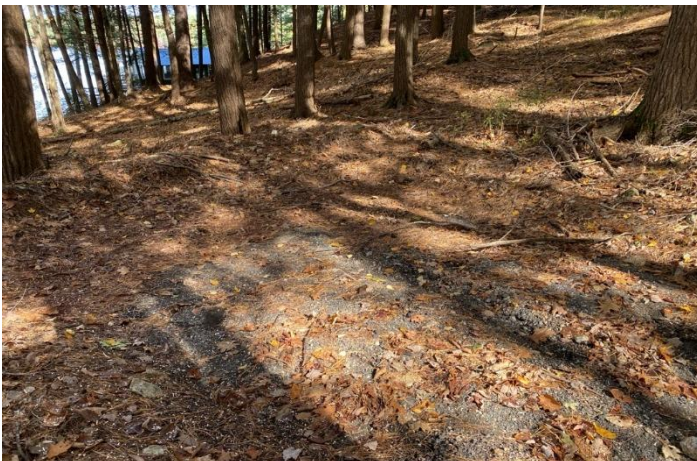
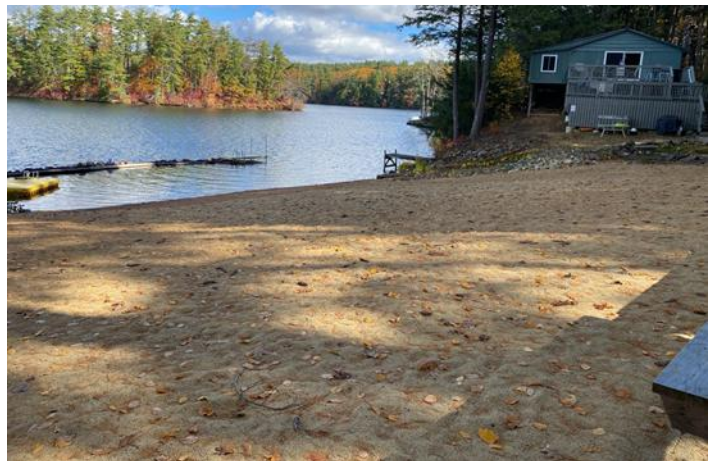
*(Left) The first retention basin with lots of accumulated road surface material. (Right) No large erosion gullies were observed across the beach area.*

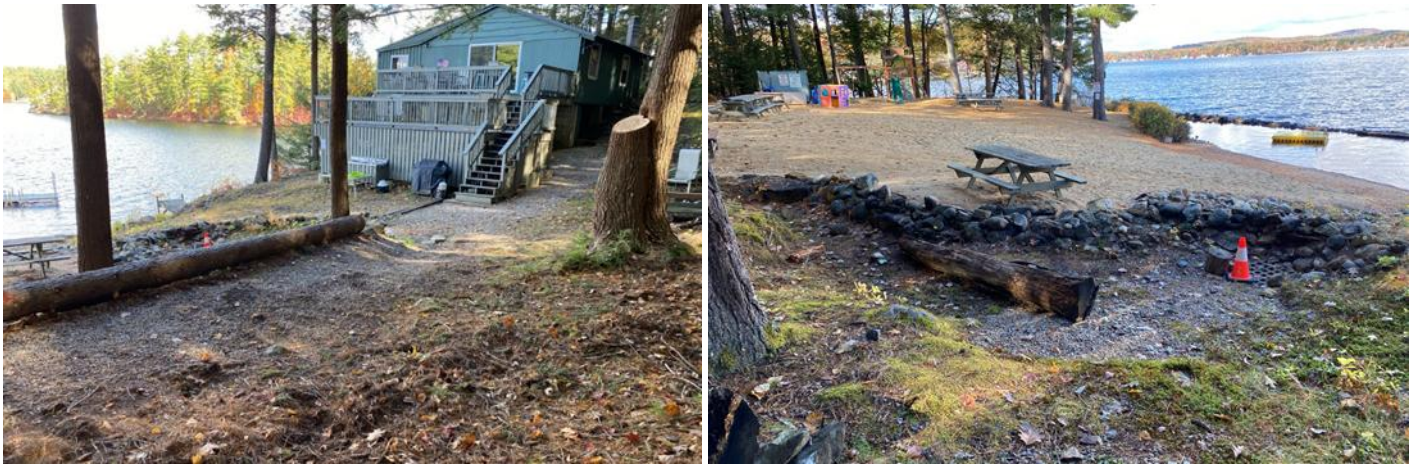
*(Left) a walkway leading to the club house with a tree trunk for stabilization. (Right) The last retention basin with the outflow grate next to the orange cone.*

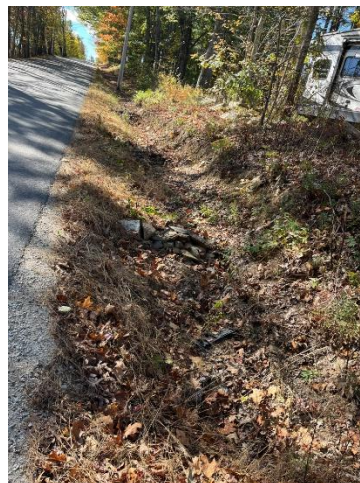
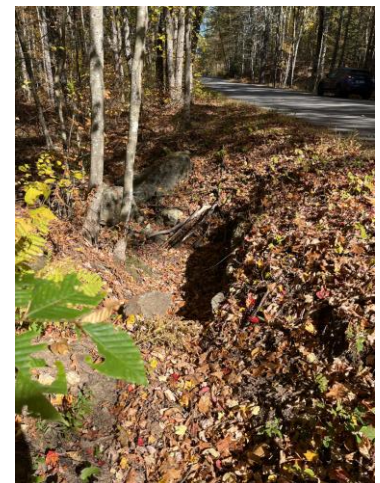
**Observations:** There is minor ditch erosion on Jenness Pond Road. In some stretches, the ditch is bare (beneath the leaves). This ditch leads directly to an intermittent stream. There is one check dam installed further uphill at the site. The intermittent stream likely flows into Durgin Pond.

*(Left) The backslope of the road shoulder ditch. (Middle) The ditch on Jenness Pond Road. (Right) Stormwater from the ditch enters the intermittent stream at the culvert.*

**Recommendations:** Reshape the ditch into a U-shape and armor it with rip rap. Use multiple check dams to slow stormwater flow and settle out sediment before it reaches the stream.

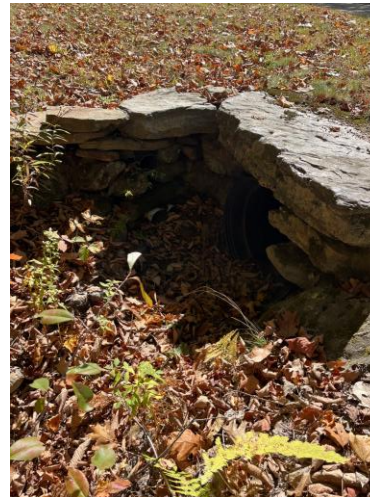
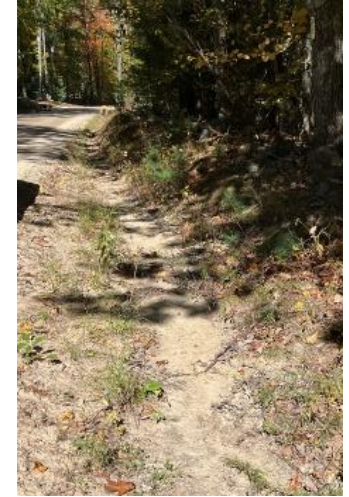
**Observations:** The road shoulder on Clough Road (unpaved) is eroding, depositing sediment into a nearby stream channel. At the culvert outlet of the stream crossing, the banks are slightly incised, suggesting that there may be high or flashy stormwater flows here. There are also three pipes leading to the culvert from a nearby home; the sources of these pipes are unknown.

(Left) Three pipes appear to route water from a nearby home to the culvert inlet. (Right) Road shoulder ditch erosion at the site.

**Recommendations:** Remove accumulated sediment from the road shoulder ditch. Vegetate the road shoulder wherever possible. Armor the road shoulder ditch with rip rap where vegetation is not feasible. Install check dams across the ditch and at the end of the ditch to slow down stormwater and settle out sediment. Investigate the source of the three pipes and consider re directing pipe outflows into residential BMPs. For examples of residential BMPs, see the [New Hampshire Homeowner's Guide to Stormwater Management](#).

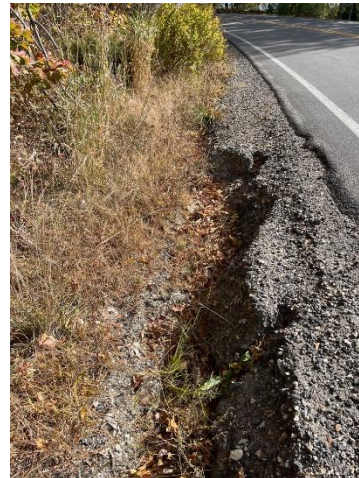
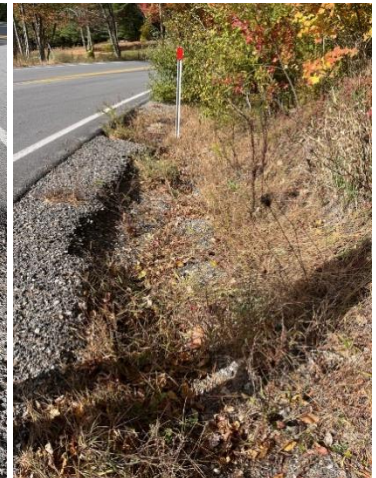
## Site NWL-19: Catamount Road #1

**Observations:** Very heavy road shoulder material is eroding into a catch basin on Catamount Road. Based on the weight of the material and design of the catch basin, it is likely that this stretch of the road experiences high stormwater flows. This catch basin is located in a headwater stream area.

Road shoulder erosion on Catamount Road. Eroded material enters a catch basin designed for high stormwater velocities.

**Recommendations:** Re-form the road shoulder ditch with more erosion resistant material, such as rip rap. If needed, convert the road shoulder ditch into a paved swale, and route stormwater from the catch basin to an engineered BMP downhill where it can be treated. An engineered BMP may be an infiltration basin, a vegetated swale basin. A standard rain garden may not be large enough to handle the amount or velocity of flow capable of causing this erosion.

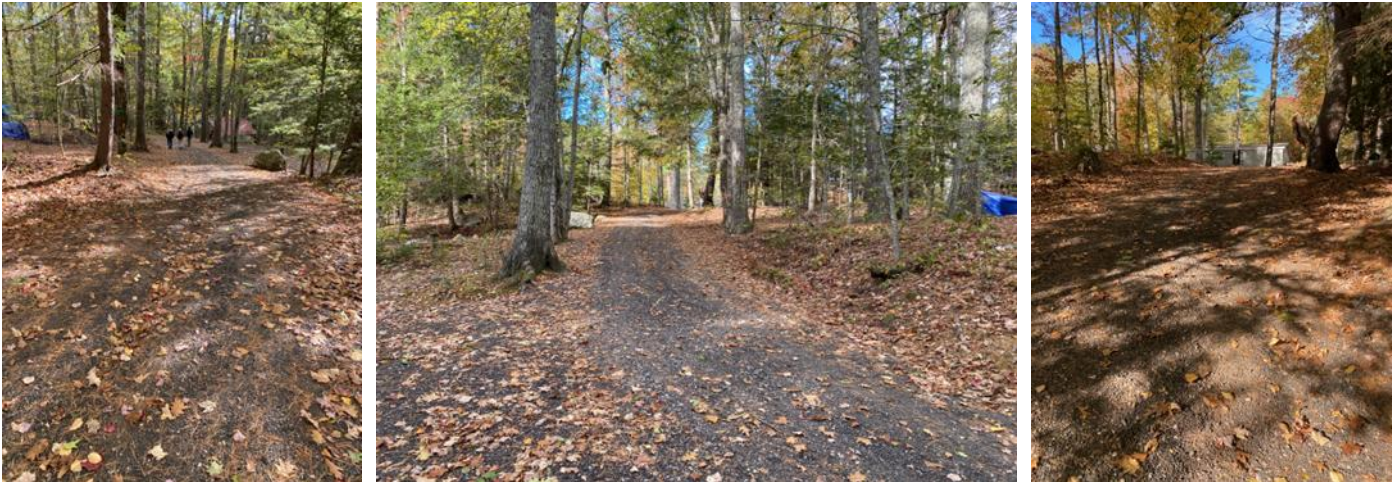
**Observations:** Frary Road (unpaved) is known to wash out frequently with rain events, causing a loss of surface material. Frary Road was resurfaced earlier in 2025, and there is a small drainage ditch on the eastern side of the road behind the houses that leads to the lake.

*(Left) Looking down Frary Road, (center) looking up Frary Road, (right) looking up Frary Road near the top.*

**Recommendations:** To prevent future washouts, consider installing water bars across Frary Road to direct stormwater runoff into the adjacent forested area.

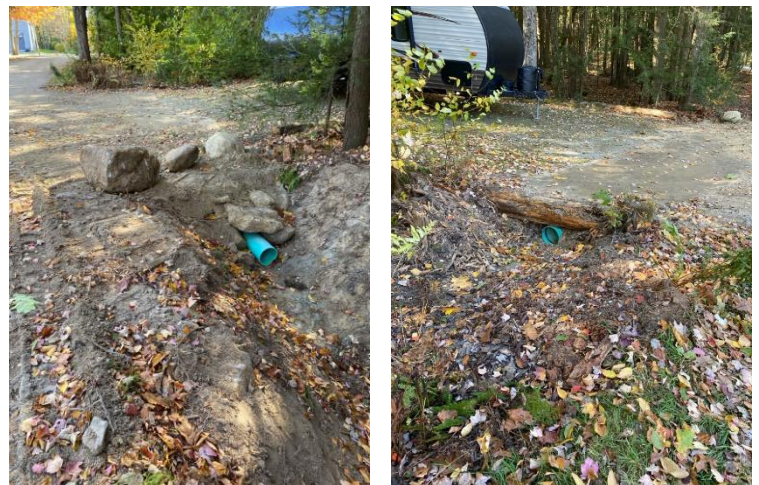
**Observations:** A relatively new stormwater infiltration basin/ditch has been established along the eastern arm of Sleepy Hollow Road next to a driveway on the southwest side of the road. The soil surface of the dug area does not appear to be stabilized, though boulders were placed at the top for vehicle safety.

*Eastern (left) and western (right) views of the small infiltration area.*

**Recommendations:** Add large, crushed stone to the basin's walls and bottom to stabilize the loose soil and prevent erosion. Additionally, the basin could be seeded and planted with water-tolerant plants and shrubs.

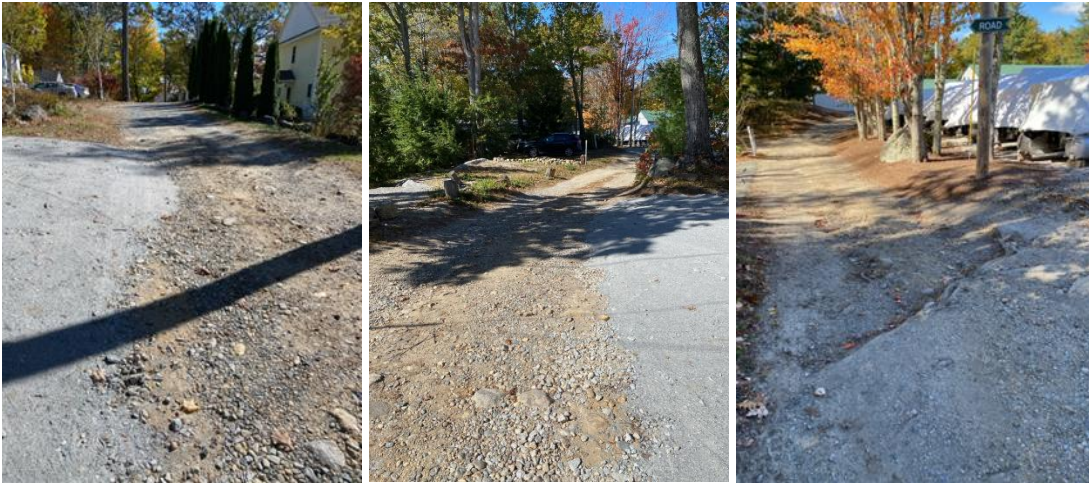
### Site NWL-35: Lake Road Behind Boat Yard

**Observations:** Lake Road, located behind the boat yard is a combination of both paved and unpaved surfaces. Where unpaved, the loose sandy gravel surface has ruts, gullies, and is at a slightly lower elevation than the paved portion. This could be due to compaction, weathering, and/or erosion.

*(Left) Lake Road facing east, (middle) west, (right) and behind the boat yard.*

**Recommendations:** Regrade the unpaved section of Lake Road with crushed. Consider paving this area and creating infiltration basins within the road shoulders that are regularly cleaned out. Work with homeowners in this area to create residential BMPs for stormwater management to decrease the volume of water flowing across and down Lake Road.

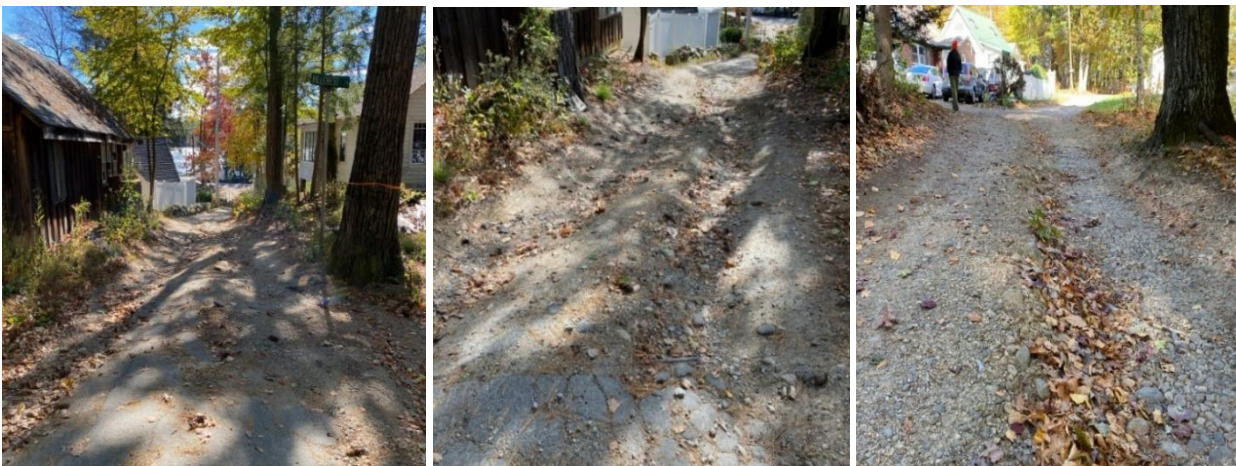
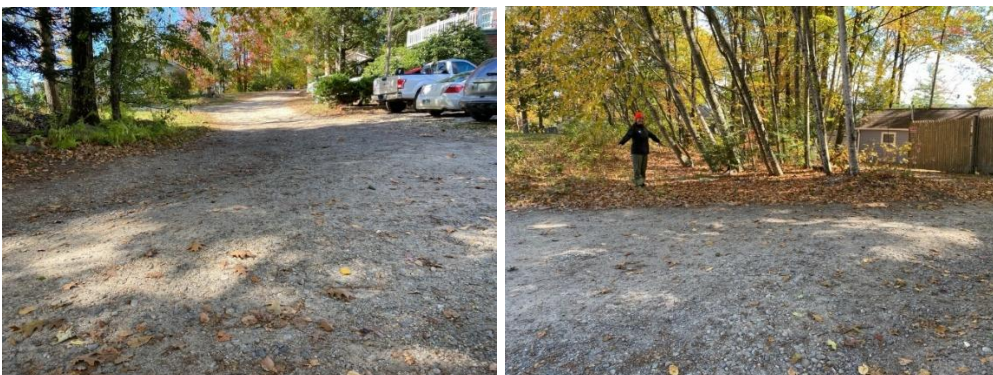
**Observations:** Park Avenue has experienced lots of stormwater erosion as evident in the long and deep gullies present which have left a prominent hump in the middle of the road. Park Avenue is not plowed in the winter or maintained during the other seasons. The road surface is comprised of hard compacted sediment and gravel. Smaller particulates have eroded away to more downhill areas towards the lake. A local resident shared that the road is used by many in the neighborhood and access is sometimes challenging, particularly for the year-round residents. Six years ago, the road was resurfaced but has not been maintained since, indicating all visible erosion occurred in the last six years.

*(Left and middle) Park Avenue looking towards Lakeshore Drive. (Right) Park Avenue looking uphill towards Sawyer Lane.*

*(Left) Intersection of Park Ave and Sawyer Ln where the broad-based dip leading to the potential area for infiltration (right)*

**Recommendations:** Mitigating runoff and erosion at Park Avenue may be challenging due to road, neighborhood, and landscape characteristics which naturally appear to funnel high flows along the road. Collaboration with the neighborhood residents is crucial. We strongly recommend consulting with an engineer to develop a neighborhood site plan. Mitigation should not only focus on the road itself, but the sources of stormwater from residential roofs, driveways, and other areas. Beginning at the top of the hill, our preliminary recommendations are a broad-based dip or drivable berm across the road at the intersection of Sawyer Lane to divert runoff into vegetation to the east. Residential BMPs like gutters to French drains, water barrels (if emptied between storms), rain gardens, driveway rubber razors, and turnouts would decrease the volume of stormwater runoff entering Park Avenue. Once sources of stormwater runoff are mitigated, regrade the road surface and create a road shoulder ditch stabilized with rip rap and many check dams. Maintain the road shoulder ditch by regularly cleaning out any accumulated sediment, debris, and leaf litter. Once the ditch and check dams are established, consider adding an infiltrating catch basin at the bottom of Park Avenue at Lakeshore Drive, as well as at the intersections of Hillcrest and Maple Ave and Maple Lane and Lakeshore Dr. Designate a responsible party to maintain all improvements.

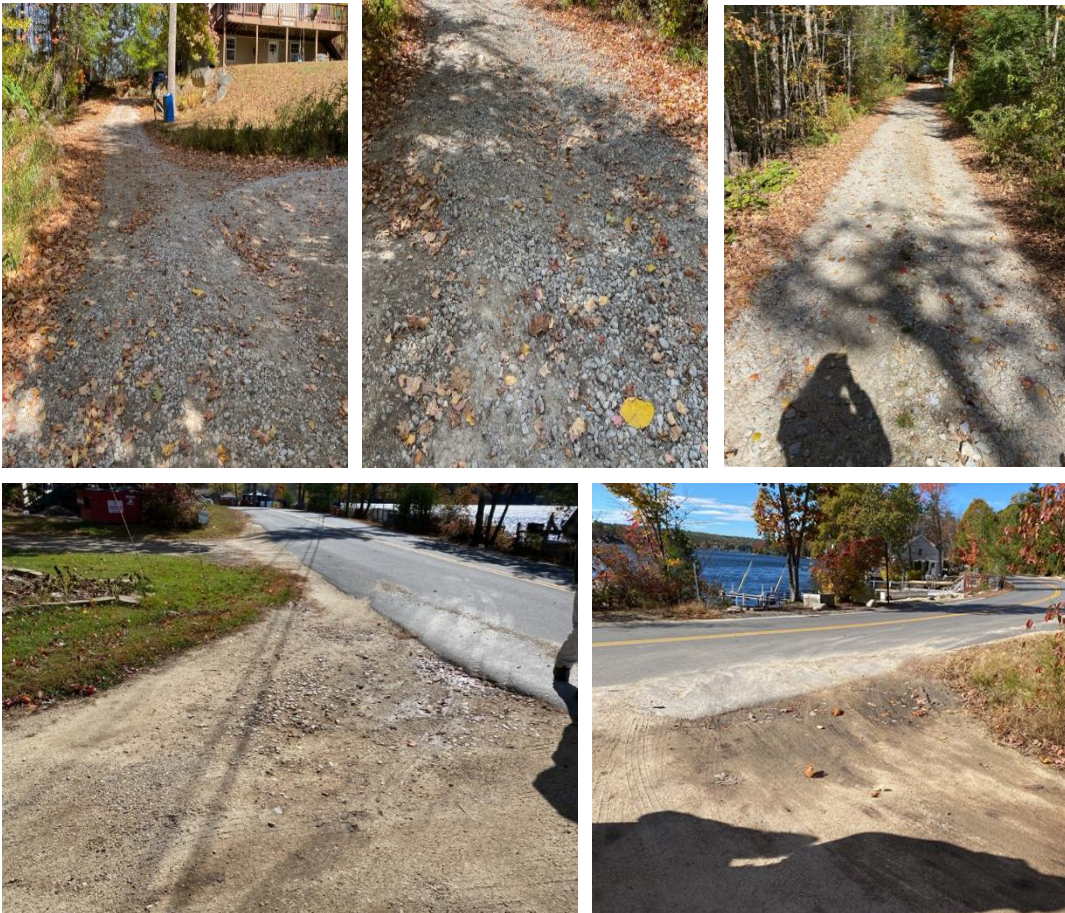
## Site NWL-38: Wildwood Ave to Lakeshore Drive

**Observations:** Wildwood Ave and Park Ave are the two most used roadways into this neighborhood off Lakeshore Dr. Wildwood Ave is unpaved and comprised of a more gravelly substrate than Park Ave. Uphill stormwater issues at sites NWL-36 and NWL-37 are contributing to the erosion occurring on Wildwood Ave, which has evidence of sheet flow erosion and channelization. The road was created less than 10 years ago and has not been maintained since.

*Photos of Wildwood Ave from the intersection with Maple Ave to the intersection with Lakeshore Dr. (paved).*

**Recommendations:** Work with residents in this neighborhood to establish a road maintenance committee. In conjunction with addressing recommendations for sites NWL-36 and NWL-37, consider installing rubber razors across Maple Ln to direct stormwater flow into the vegetated area to the west.

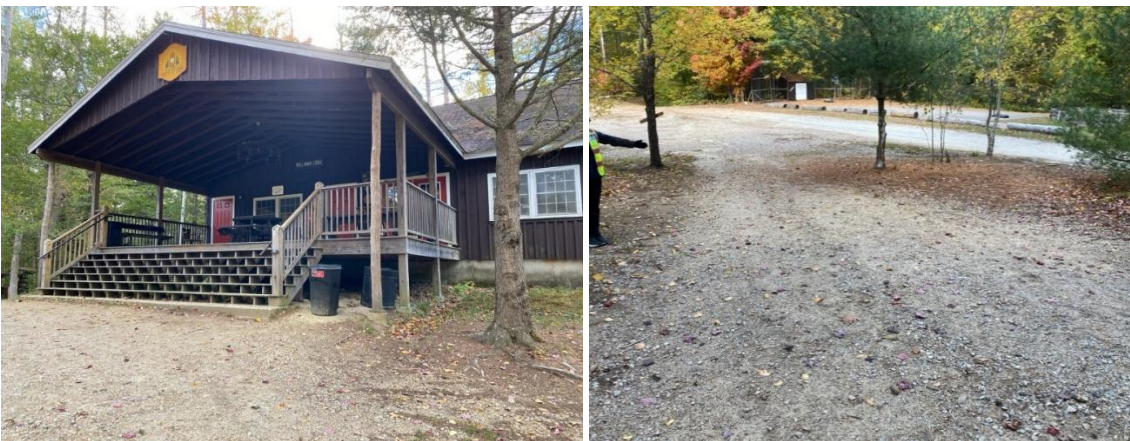
**Observations:** Runoff coming from lodge down towards the parking area washes away wood chips, exposing bare soil across the full path. Path continues to lead onto to site NWL-41, presented above.

*Williams Lodge (left) and the pathway that leads to it (right).*

**Recommendations:** Consider adding residential stormwater BMPs to Williams Lodge such an infiltration dripline trench and a broad base dip in the pathway to divert water into a vegetated area, which could be reconfigured into a rain garden. Consider adding educational signage about the rain garden if installed.

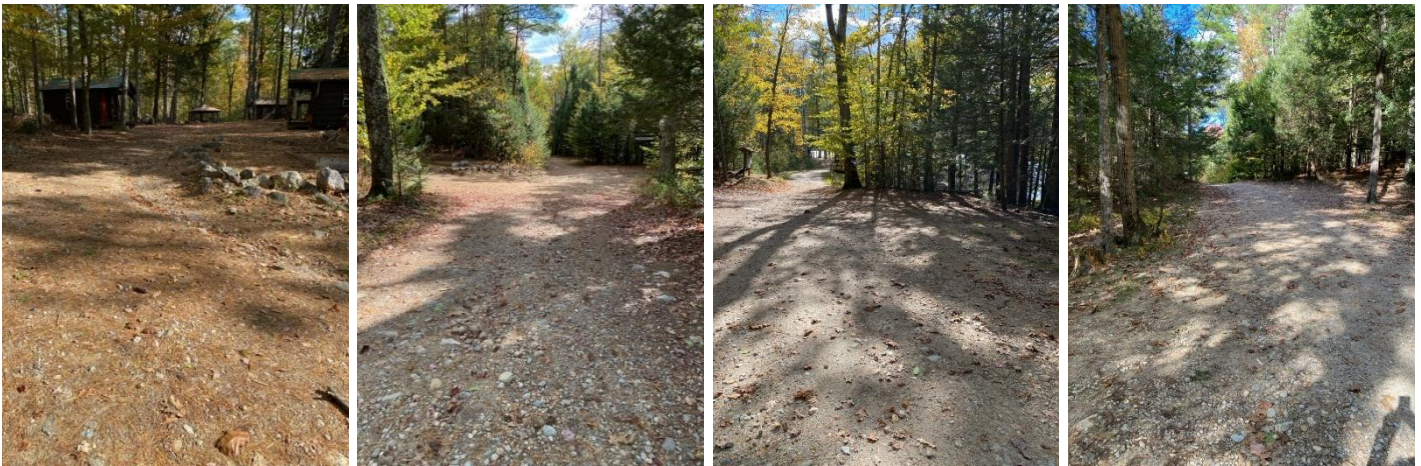
## Site NWL-43: Road to Boat House at Camp

**Observations:** Walking along the primary camp roadway that parallels the lake, evidence of stormwater runoff was observed entering the roadway from the cluster of cabins between Vervaert Lodge and the South Showers. The roadway is sloping to the south in this area, towards boathouse and waterfront.

*(1) Stormwater flow path coming from the cluster of cabins to the primary camp roadway (2). (3 and 4) Two of the three areas along the roadway where it widens and the infiltration basins could be created, minding snow maintenance needs.*

**Recommendations:** Create a broad-based dip or water bar across the top of the pathway that leads to these cabins to direct stormwater flow to the south (right) side of the little stone wall and into a designated area for infiltration (recessed and vegetated, or stabilized with crushed stone). There were also three opportunities along this roadway to create more formalized infiltration areas – the three areas where snowplows pile the snow. Each of these three areas should be accompanied with a broad-based dip to divert sheet flow from the roadway into the retention basins. Consider lining these basins with rip rap rather than vegetation because of the winter snow maintenance, as snow would likely be pushed into and on top of these retention areas.

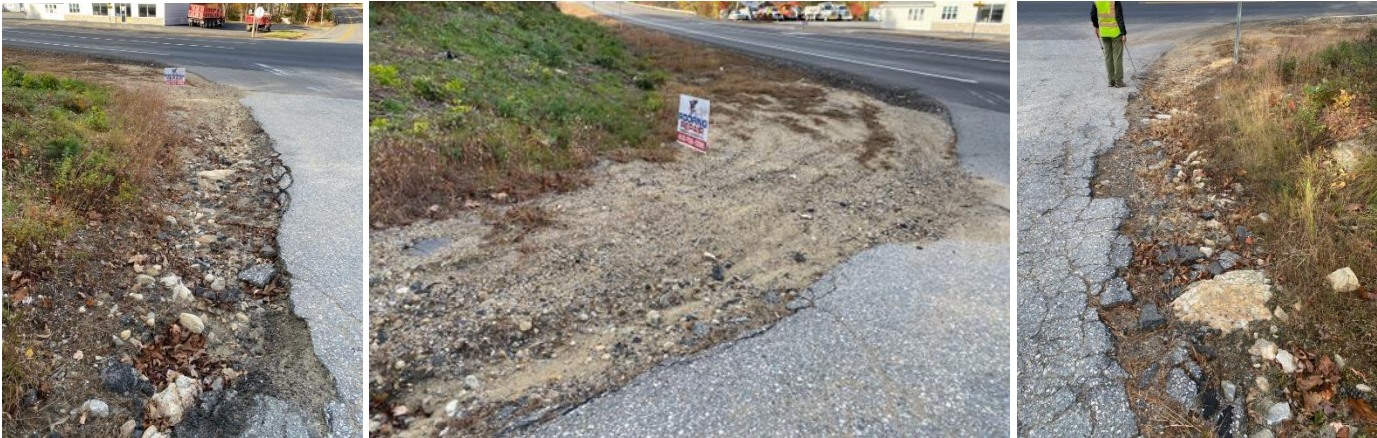
## Site NWL-46: Intersection of Blake's Hill Road & Route 4

**Observations:** Two eroding gullies were observed along the road shoulders of Blake's Hill Road as it slopes to its intersection with Route 4. The road edge was also found to be crumbling into the road shoulder.

*Western road shoulder (left and right), and eastern road shoulder (right).*

**Recommendations:** Establish a road shoulder ditch, stabilized with rip rap, and crossed with check dams to decrease stormwater erosion and sediment transport. Depending on the amount of stormwater volume this site receives, consider also installing an infiltrating catch basin at the western corner (near the small advertisement sign in the first photo).

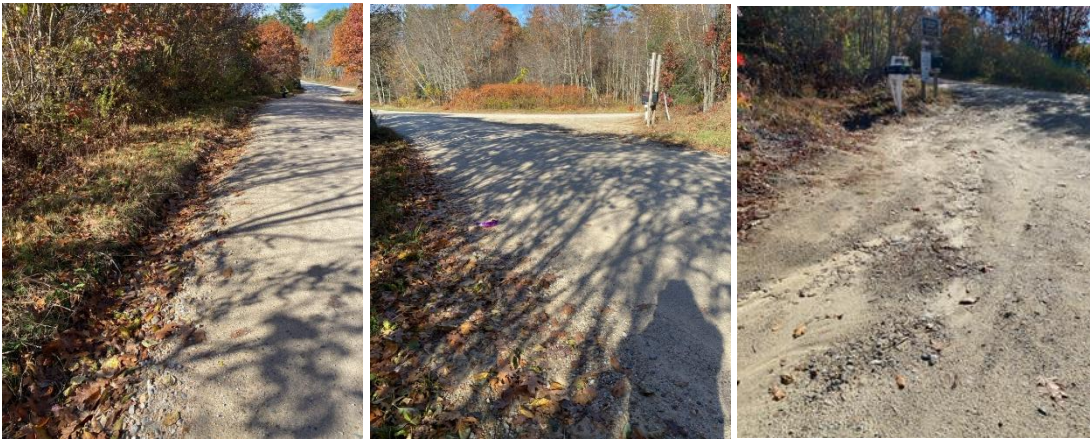
**Observations:** Road shoulder gully erosion was observed along Old Richie Road leading to Griffin Brook (the stream at site NWL-25) that flows through the mowed/hayed field. The gully travels down the hill and then across the road surface towards Northwood Lake Road. The road shoulder ditch has lost its finer sediments, which have been transported downhill and are deposited at the intersection of Northwood Lake Road

*(Right) Southern road shoulder of Old Richie Road facing downhill towards its intersection with Northwood Lake Road (middle and right).*

**Recommendations:** Install a turnout at the top of the hill, near the opening into the hayfield but on the opposite side, so that stormwater flows on the uphill side of the rock wall and into the wooded area. Stabilize road shoulder from further erosion with large crushed stone and check dams. An infiltration area could be created near the mailboxes. Alternatively, consider re-grading the road away from the hayfield and install turnouts on the uphill side of the road before the steep edge on the northern road shoulder.

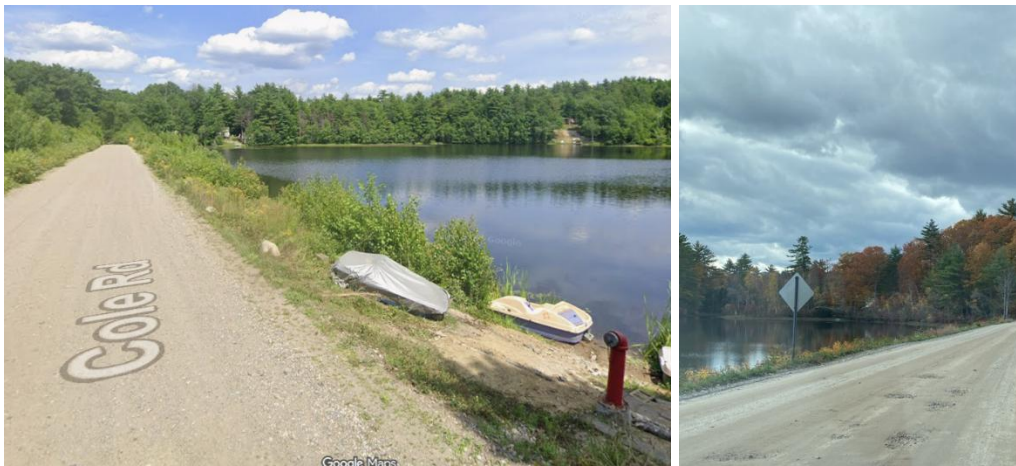
## Site NWL-52: Voydatch Pond Roads

**Observations:** The roadways encircling Voydatch Pond (Cole Road, Rita's Circle, and Jack Street) are unpaved and show signs of erosion with gullies, potholes, and uneven surfaces. Additionally, only a small, vegetated buffer was observed between Cole Rd and Voydatch Pond. The roads are hilly, and many small gullies were observed.

Views of Cole Road from Google street view (left) and from the watershed survey (right) showing the limited buffer.

**Recommendations:** Collaborate with the homeowners in this area to regrade and resurface each road with a more stable surface material. Add turnouts to vegetated areas where possible to keep erosion from progressing down the road surface. Work with homeowners that have pond access to ensure accessways are stable and maintained, and revegetate shoreline areas where possible. Increase the vegetated buffer along Cole Road with hearty native shrubs and trees. Stabilize any access points here with crushed stone, vegetation, and/or perched (and infiltrating) sitting area or dock. Consult shoreline regulations and permitting needs before conducting work so close to the shoreline.

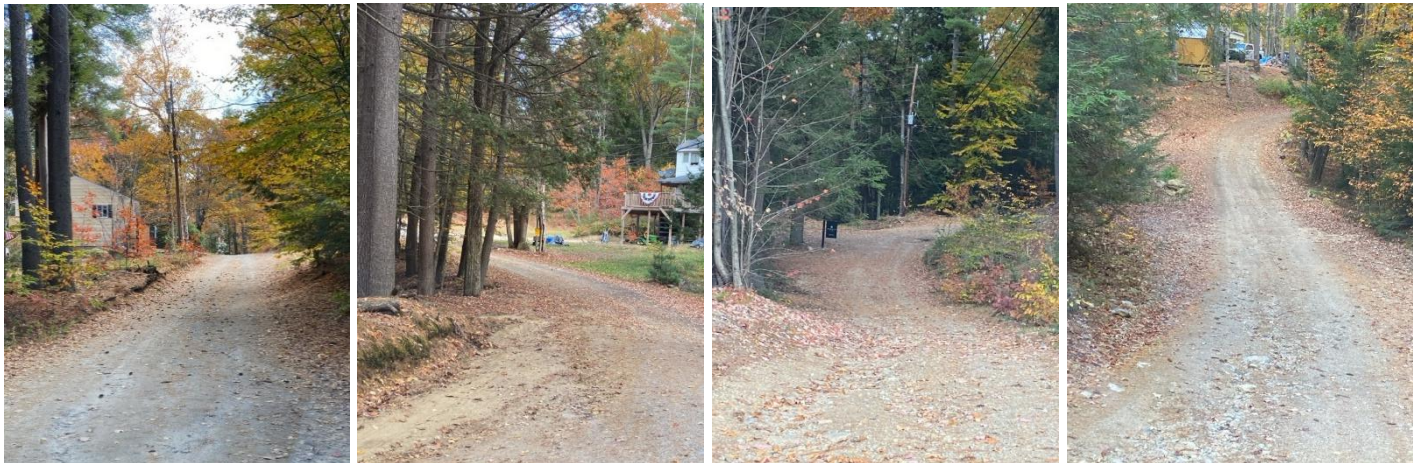
*Erosion gullies and stormwater flow paths on the road surfaces of Rita's Circle and Jack Street.*

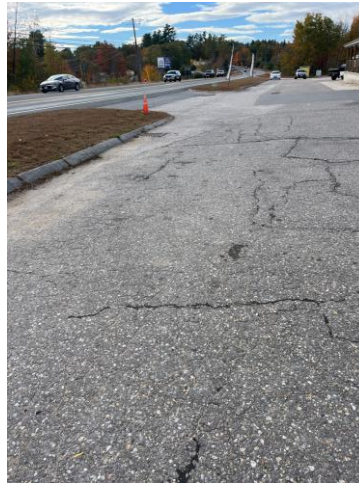
**Observations:** Catch basins on School Street and in the parking lot of the Heritage Market collect stormwater from impervious surfaces. Untreated stormwater contains pollutants from various sources such as atmospheric dust, winter sand, soil, automotive chemicals, leaf litter, other organic matter, and pet/animal waste. Large pervious surfaces also restrict infiltration and increase the volume of stormwater runoff traveling to more downhill areas.

*(Left) The catch basins in the market parking lot by the orange cone.*

**Recommendations:** Multiple opportunities exist to utilize engineered urban stormwater control measures onsite. On School Street, planter bump outs may be used to capture and infiltrate stormwater in the road shoulder apron. A large open space area is present adjacent to the parking lot, which could be converted to a rain garden, vegetated swale, or other engineered green stormwater infrastructure. There is already a catch basin in this area, meaning it is already connected to stormwater infrastructure. Investigate the location of the catch basin outlet(s). Engage with the property owner about winter salt use and opportunities for reducing the extent of impervious cover on the parking lot.

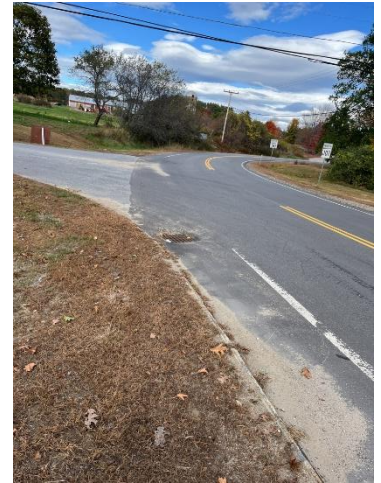
*(Right) The catch basin along School Street.*

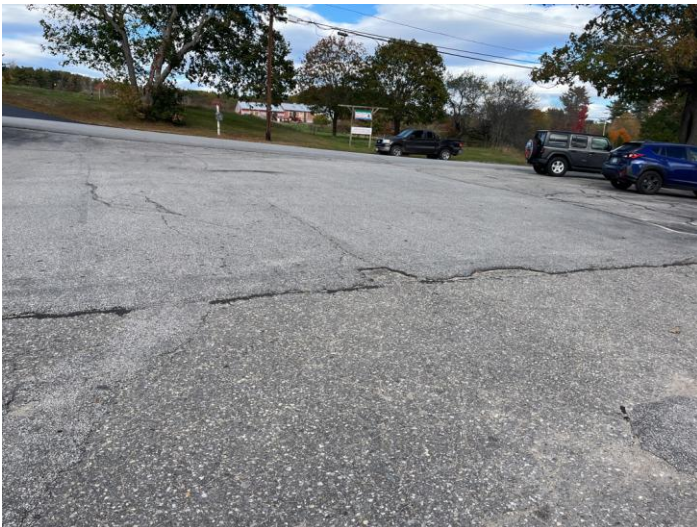
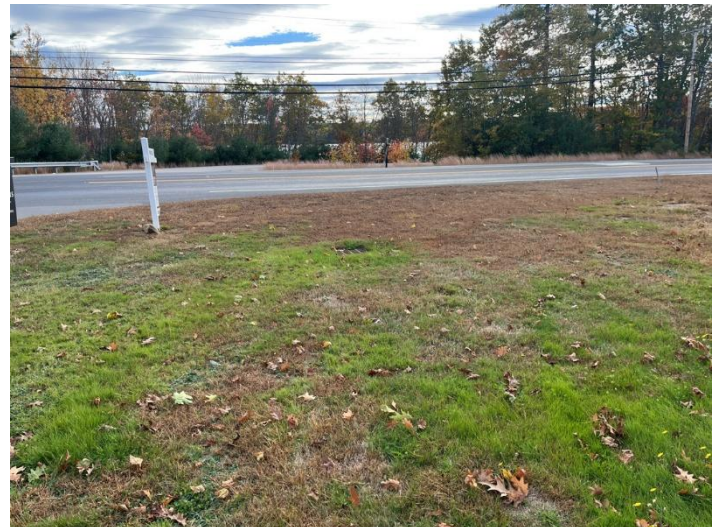
*(Left) The large impervious parking lot. (Right) An open space area with a catch basin in the center may be a suitable location for engineered green stormwater infrastructure.*

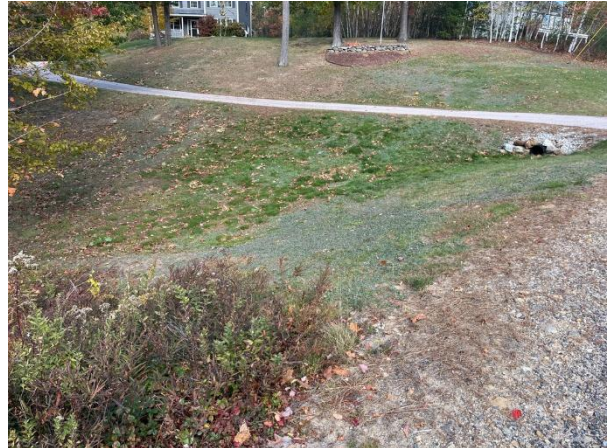
**Observations:** Stormwater from McEvoy Lane discharges through an under-driveway culvert and leads to a stream channel. No erosion was observed at the site. Improving vegetation at the site would enhance pollutant and nutrient uptake from stormwater and decrease pollutant loads downstream while also reducing the volume of stormwater reaching the stream.

*Stormwater exits the under-driveway culvert and enters the stream after traveling through a sloped, grassed area.*

**Recommendations:** Stormwater management could be improved at the site by increasing stormwater infiltration, through installations such as a rain garden or vegetated swale. Alternatively, letting the current vegetation grow freely between the culvert outlet and stream would provide additional pollutant filtering capacity and some nutrient uptake by plants. A minimal improvement would be to increase the mower height to at least four inches.

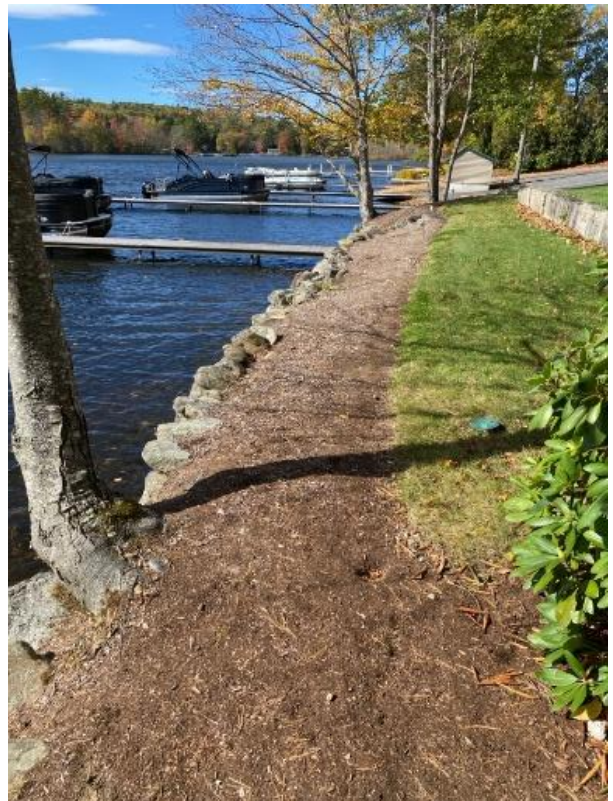
**Observations:** No vegetated shoreline buffer was observed along the boat house property at the marina. Only a few small plants were present. An apron of soil and mulch is present and ready for planting.

*The shoreline of the Boat House*

**Recommendations:** Plant a vegetated buffer with native, deep rooting species for stability against winds and weather. Refer to the [Native Shoreland/Riparian Buffer Plantings for New Hampshire guide](#) for species suggestions. Ensure soil and mulch are not being pushed over the top of the retention wall and into the lake.

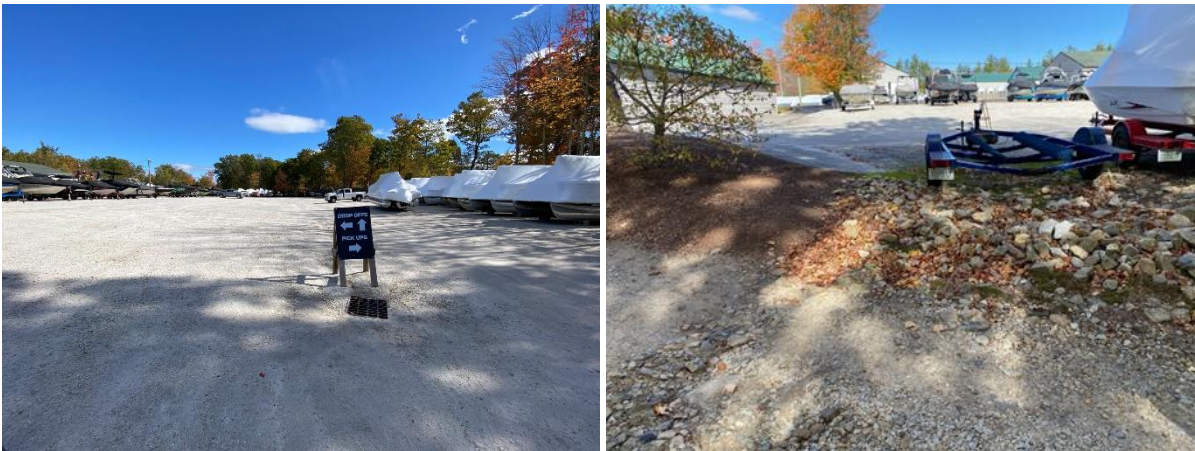
**Observations:** At the time of the watershed survey, a smaller retention basin was present at the south western corner of the boat storage yard. Stormwater that falls on the yard (paved) travels to a series of catch basins, but some also enters the south western corner of the lot. The previous retention basin was dug and lined with rip rap, but has since filled in after years of infiltrating stormwater and settling out sediment. Additionally, a small breakthrough channel was observed leading to Lake Road and the homes along the shoreline.

*The boat yard catch basin (left) and the original retention basin and breakthrough path during the watershed survey (right).*

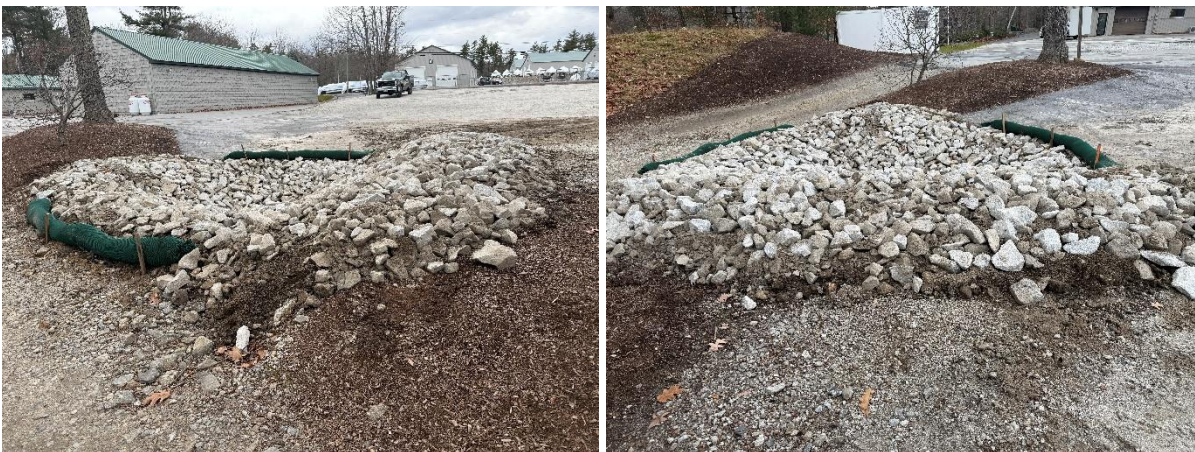
*Photos of the improved retention basin, deeper, lined with rip rap, and stabilized with coir logs. Photos provided by MacCallum's Boathouse.*

**Recommendations:** Following the site visit, the MacCallum's Boathouse staff promptly enlarged the retention basin by making it both deeper and wider, and building up the side walls to decrease the chance of breakthrough flow paths. A sediment coir log is also present along both the inlet and outlet sides to provide further stability and sediment/pollution retention capabilities. No further recommendations are provided at this time, great work!

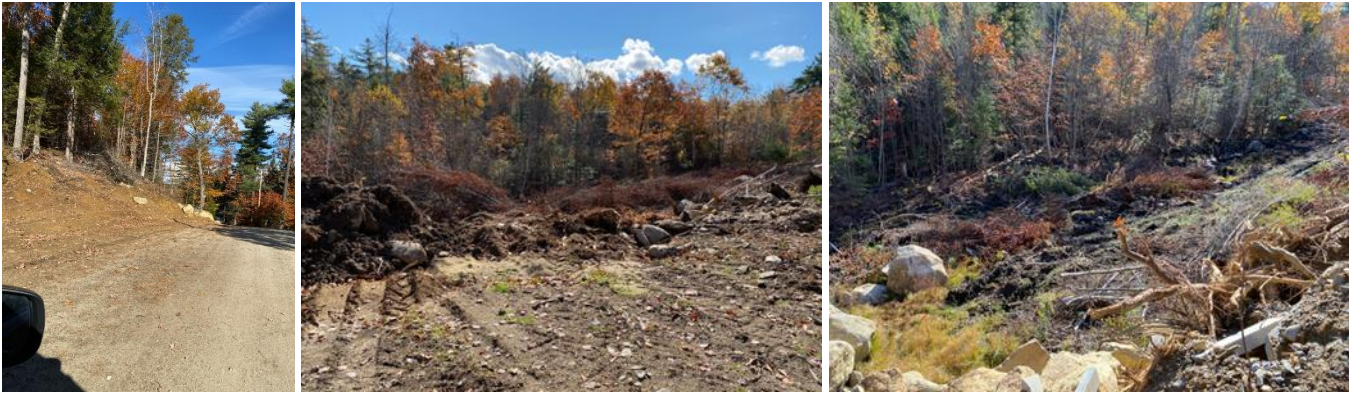
**Observations:** A large clear-cut area was observed along the eastern side of Sand Pit Avenue not too far south from the intersection with Klopp Avenue. Large piles of slash and soil are present on this steeply sloped lot. A stream flows parallel to Sand Pit Ave at the bottom of the recently cleared hill. The stream has minimal buffer on the cleared side, debris within the stream, and no stormwater control measures were observed such as silt fences or coir logs to keep the disturbed land and slash from eroding into the stream and to Northwood Lake. There is approximately 400 feet of stream length between this site and Northwood Lake. The ground appears to be comprised of very loose soil.

*(Left) View north down Sand Pit Ave towards Klopp Ave. (Middle and right) the recent clear-cut and stream at the bottom.*

**Recommendations:** Contact the landowner and work to remove slash from the stream channel and to install erosion control measures along the stream bank. Ensure the future land use intended for this area has erosion control measures because of the steep grade down to the stream.

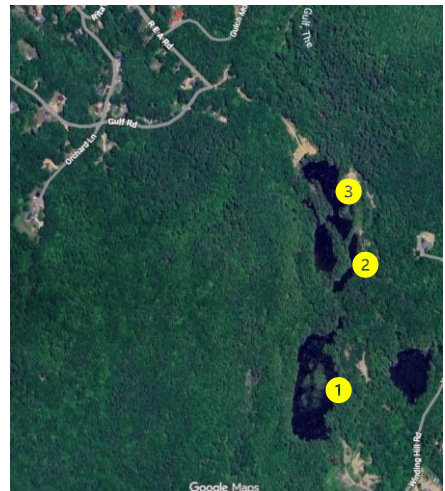
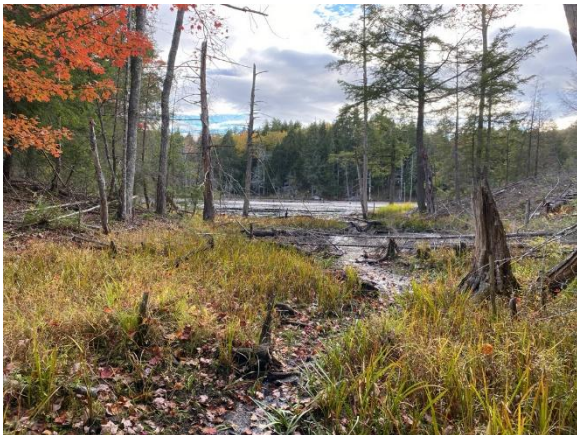
**Observations:** The quarry ponds located between Winding Hill Rd and Gulf Road were visited to determine the influence, if any, they have on Northwood Lake's water quality. During the visit, which was conducted in a drought, water levels in the ponds were very low, and were not discharging to an outlet stream. However, had the field visit been conducted during a wetter time of year, we would expect water levels to be higher and discharge could be possible.

(1) The first pond from an inlet stream. Water does not appear unusual, a lot of aquatic vegetation is present.

**Recommendations:** None. Continue to monitor the water quality of "the Gulf" tributary where it outlets into Northwood Lake.

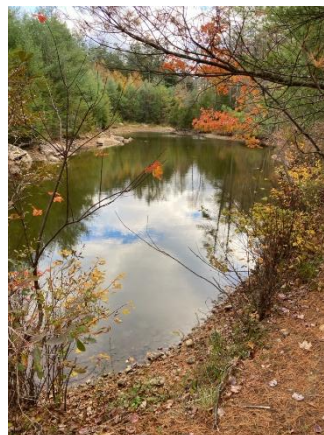
(2) The second pond has a greenish hue. Water level is low, no outlet was found.

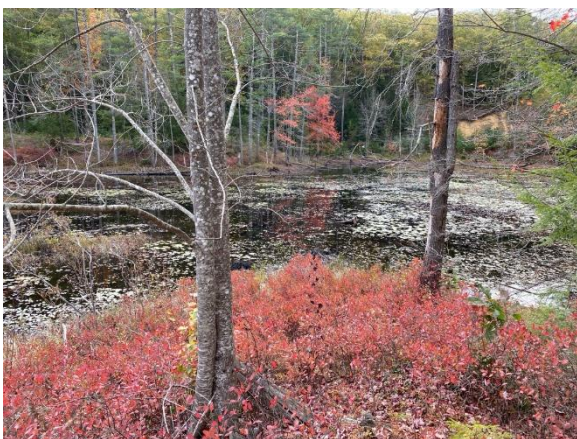
(3) The third pond also had lots of aquatic vegetation growing in it, and the water did not appear unusual. Water level was too low to outlet.
